LOWLANDS LAGOONS (ANEMBO LAKES) WATERBODY MANAGEMENT PLAN

VERSION 4

DesignFlow
Prepared for Fraser Coast Regional Council
November 2019

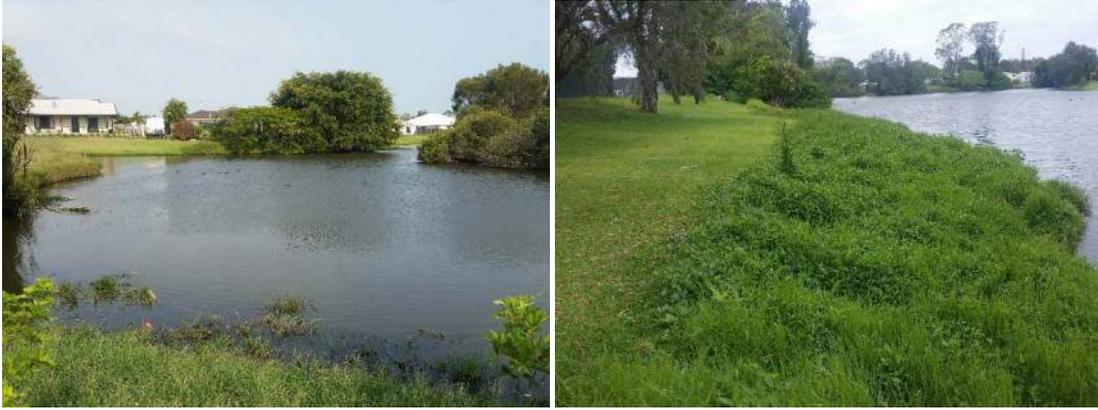
Figure 3-1 Waterbody A – a) Eastern end, and b) Edge buffer zone established by Council.

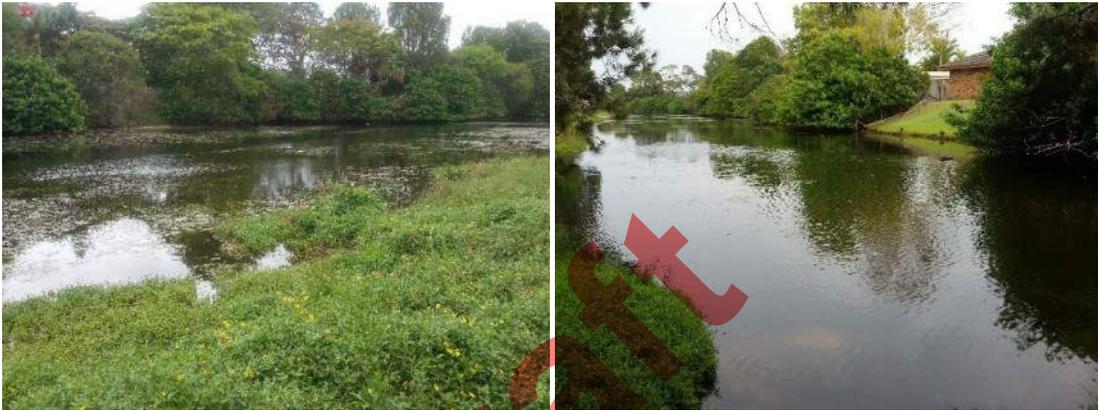
Figure 3-2 Waterbody B – a) Shallow water with dense growth of *Ceratophyllum demersum*, and b) Deeper water at eastern end of waterbody.

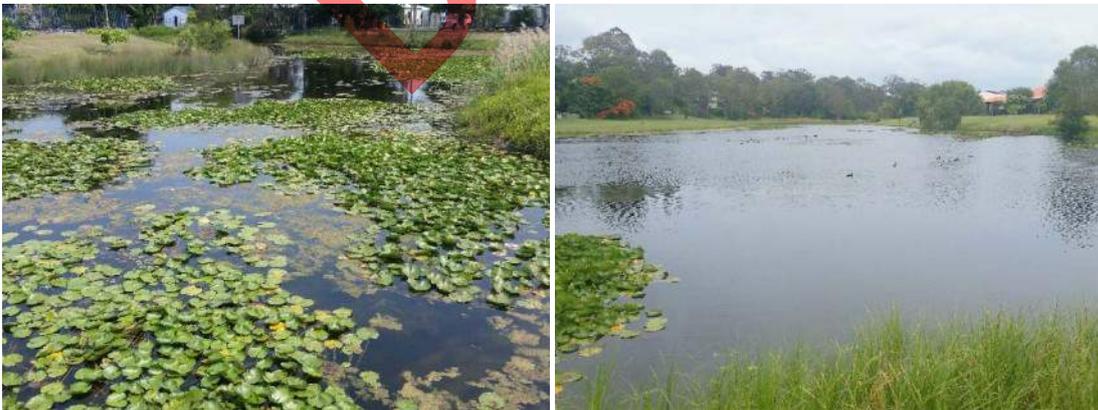
Figure 3-3 Waterbody C – a) Dense cover of *Nymphaea mexicana* near outlet to Waterbody D, and b) Main waterbody.

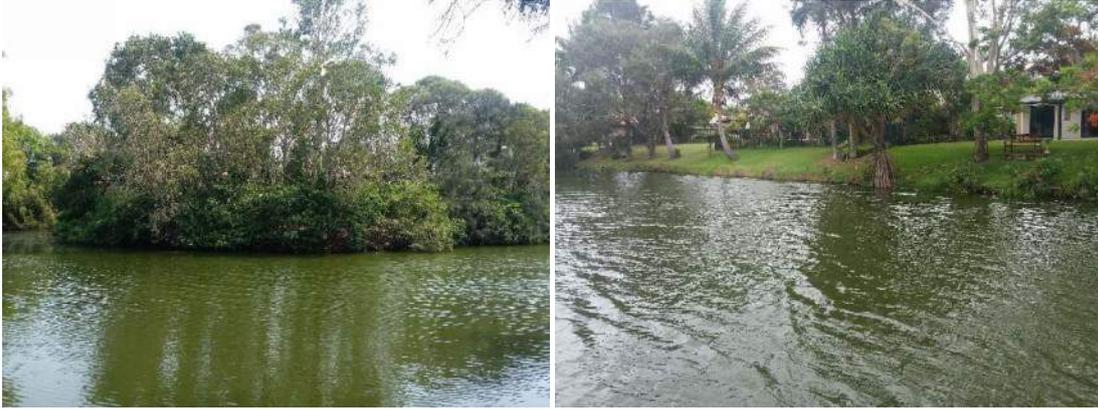
Figure 3-4 Waterbody D – a) Anembo Island – Ibis rookery, and b) Steep batters along the southern edge with steep drop-off at the water's edge.

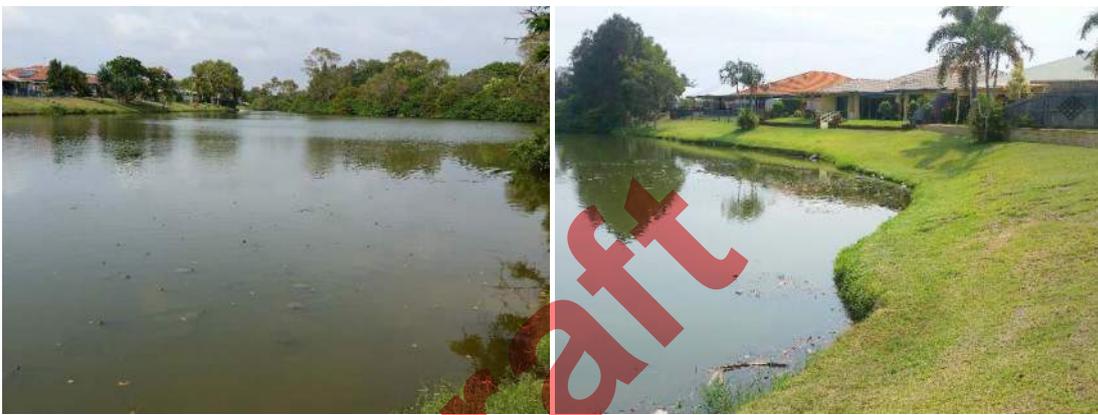
Figure 3-5 Waterbody E – a) Main waterbody (turtles waiting to be fed in foreground), and b) Example of residents mowing batters to the water's edge.

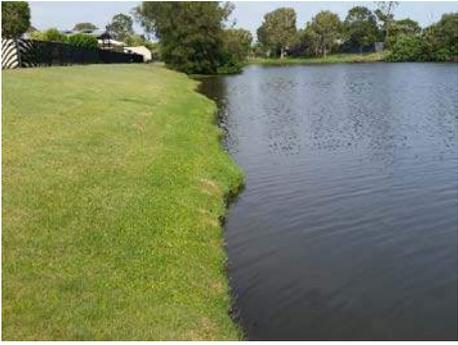
Edge Type	Comments/notes	Photo
Gentle batter +/- sharp drop off into shallow water	Generally >1:3 batter slope, mown grassed edge +/- sharp drop off into shallow (<0.3m) water. Moderate risk but shallow depth of water means exiting is fine. <u>Safe</u>

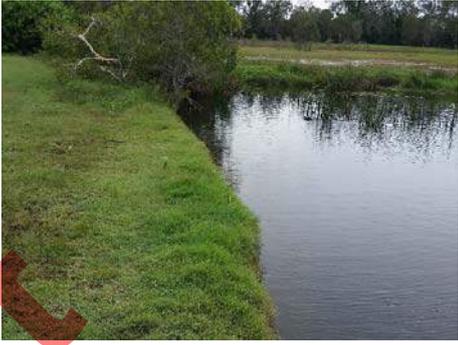
Gentle batter +/- sharp drop off into deep water	Generally >1:3 batter slope, mown grassed edge +/- sharp drop off into deep (>0.3m) water. High risk as deep depth of water means exiting may be difficult. <u>Potentially Hazardous.</u>

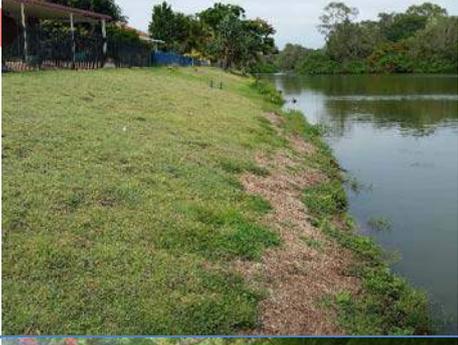
Steep batter +/- sharp drop off shallow water	Generally <1:3 batter slope, +/- sharp drop off into shallow (<0.3m) depth water. Moderate risk but steep batter slope may make it very difficult to exit waterbody (and easy to fall back in). High drowning risk <u>Potentially Hazardous</u>

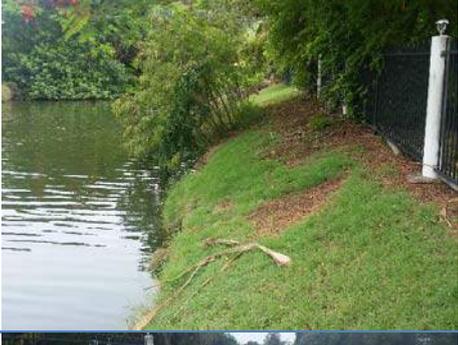
Steep batter +/- sharp drop off deep water	Generally <1:3 batter slope, +/- sharp drop off into deep (>0.3m) water. High risk as steep batter slope and deep depth of water means exiting is extremely difficult (and easy to fall back in). High drowning risk <u>Hazardous</u>

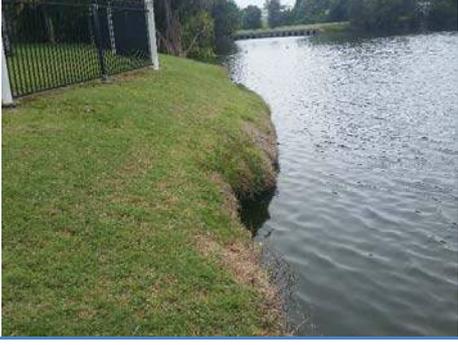
Vertical/highly eroded edge	Vertical waterbody edge with drop off into +/- deep water. Extremely difficult to exit waterbody. Presence of deep water means high drowning risk. <u>Extremely Hazardous</u>

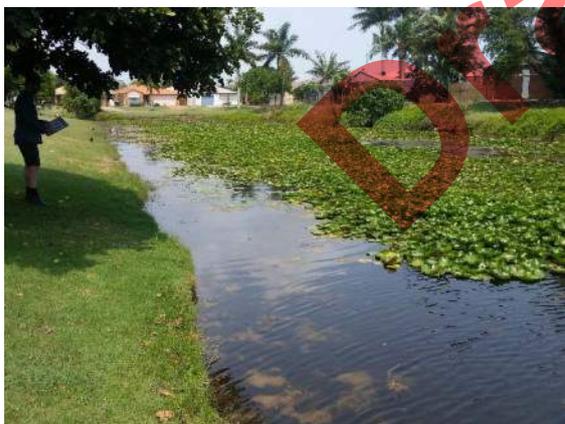
The majority of the lower batters/edges have good vegetation cover and are stable. Many of the waterbody edges comprise of mown grass, and have shallow vertical edges where wave action or waterbird activity has resulted in minor scour (Figure 4-1). These edges are relatively stable but are highly susceptible to further scour due the presence of the bare soils.

Figure 4-1 Minor scour present below grassed edges creating shallow vertical edge.

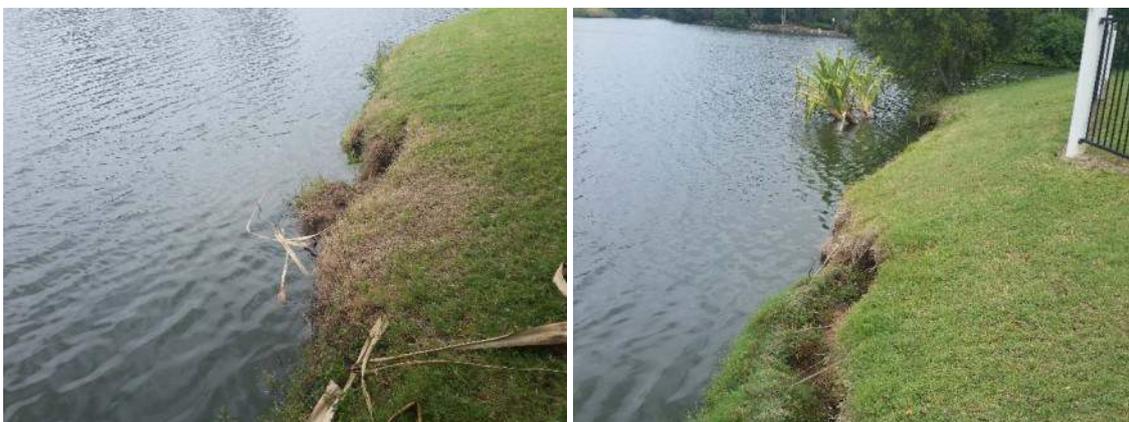
Active erosion and undermining of the waterbody edges along the northern margin of Waterbody D and within the Anembo Drive inlet are of most concern, as the batters are steep to vertical, adjoining deep water and represent a risk to both public safety and the adjoining residential properties.

Of particular concern and requiring urgent attention, the waterbody edge adjacent to the residential property to the east of Anembo Drive inlet is severely undermined, is actively eroding and is retreating towards the property boundary. Intervention will be required to arrest the erosion and protect the residential property boundary. A similar scenario is occurring along the waterbody edges adjacent to this area, but the batters are moderately stable and not endangering the adjacent properties.

Figure 4-2 Eroded areas within Waterbody C: a) northern edge, and b) near Anembo Drive inlet.

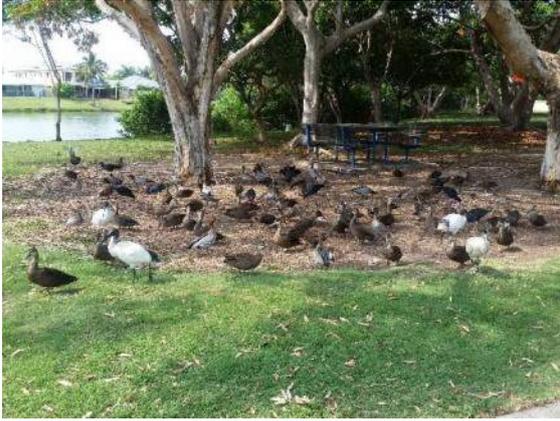
Daily feeding of the waterbirds occurs within the park between Truro Street and Waterbody E, resulting in a major aggregation of the waterbirds every morning and high loads of faecal matter present within the park (Figure 4-4).

Figure 4-4 Bird feeding area within the parkland on Truro St.

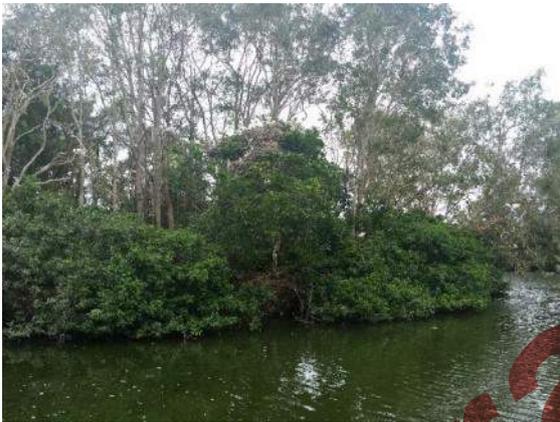
Areas within the waterbodies where waterbirds congregate are considered to be associated with a potentially higher risk, as there is generally higher deposition of bird faeces in these areas. This includes the areas (both the water and waterbody edges) adjacent to the Ibis rookeries (Waterbody D - Anembo Island and small island, Waterbody E - island). The waterbody edges behind the residential properties and adjacent to the Ibis rookery on Anembo Island were notably contaminated and notably odorous during the waterbody inspection (Figure 4-5).

Figure 4-5 Ibis rookery on Anembo Island.

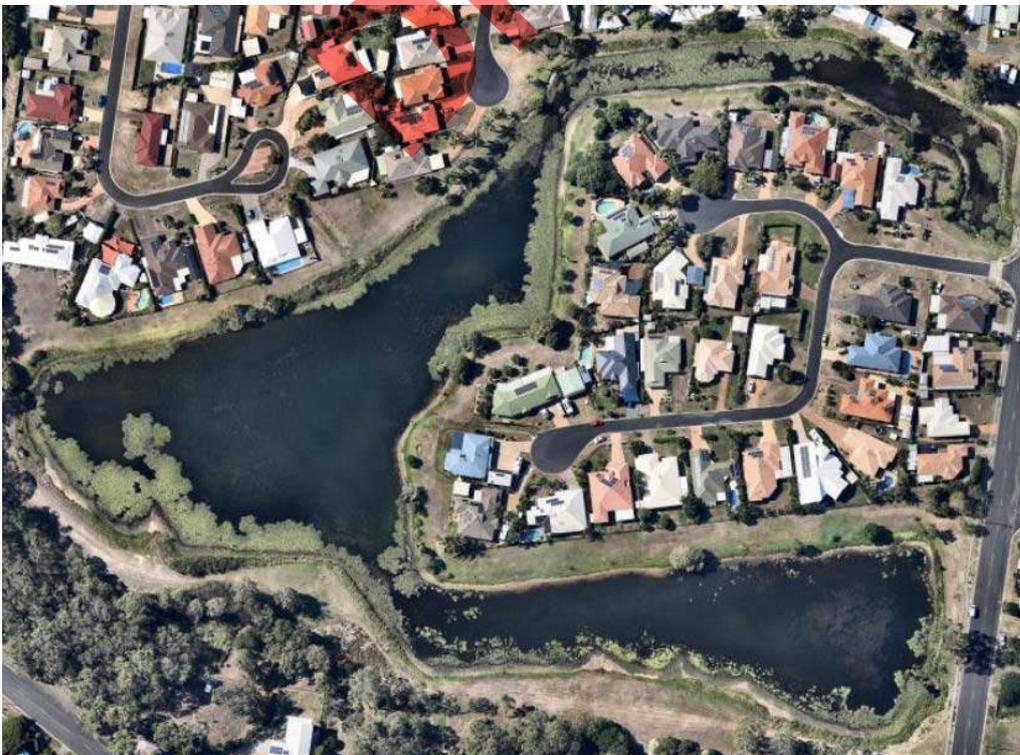
Figure 4-6. *N. mexicana* (light green areas) around margins of Waterbody C.

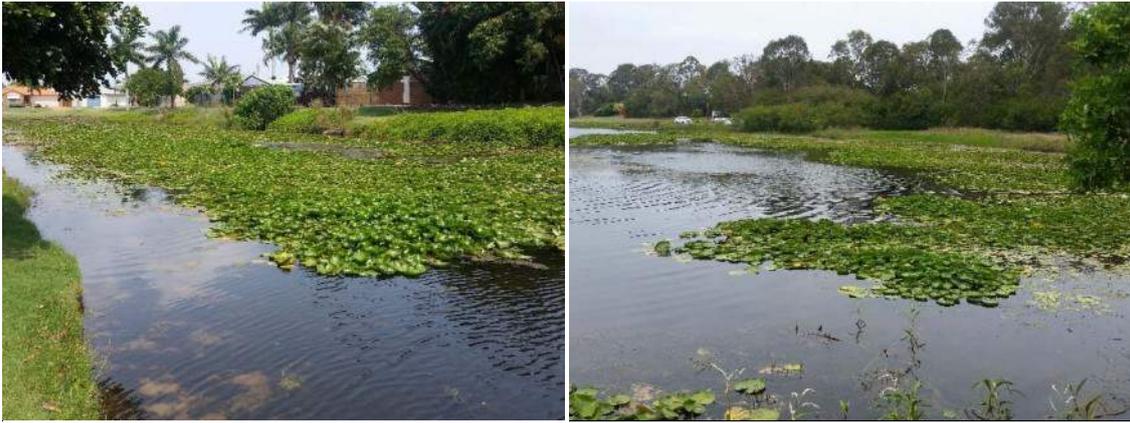
It is understood that Council conducted a trial in late 2018 to reduce the distribution of *N. mexicana* within Waterbody C. This involved repeated harvesting over a short period of time. Discussions with Council staff indicated that the trial appears to have been ineffective at reducing the distribution of *N. mexicana* within Waterbody C, and may have increased overall cover.

Figure 4-7. *N. mexicana* – a) Northern arm of Waterbody C, and b) Extensive population along the southern edge of the waterbody.

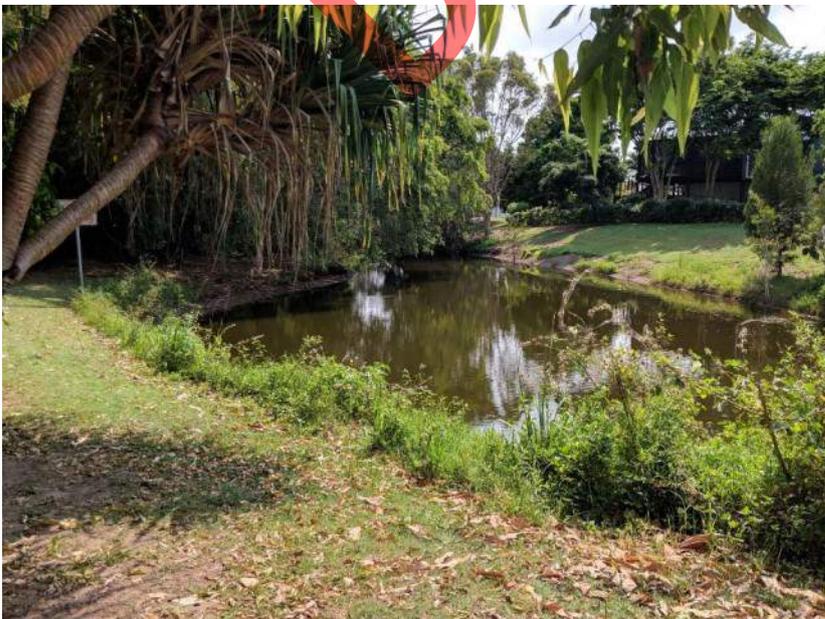
A number of 'backwater' areas were noted in Lowlands Lagoons. Backwater areas within the waterbodies can often have longer residence times as they are poorly flushed. Backwater areas often appear stagnant and are associated with the accumulation and decomposition of organic material. Poorly flushed waterbody water combined with nutrient release (e.g. from anoxic sediments or bird faecal matter) often results in ideal conditions for incubating algal and floating water weed growth (Figure 4-10).

Figure 4-10 Backwatered areas such as Anembo Drive inlet can act as incubators for algal and floating waterplant growth.
