LOWLANDS LAGOONS (ANEMBO LAKES) WATERBODY MANAGEMENT PLAN

DesignFlow
Prepared for Fraser Coast Regional Council
February 2021

Report Title:	Lowlands Lagoons (Anembo Lakes) Waterbody Management Plan
Suggested Reference	Lowlands Lagoons (Anembo Lakes) Waterbody Management Plan (DesignFlow, February 2021)
Version:	FINAL
Previous versions	CONSULTATION DRAFT - 15/11/2019
Client:	Fraser Coast Regional Council
Author(s):	Jason Sonneman, Andrew Cook
Reviewed By:	Andrew Cook
Approved By:	Shaun Leinster
Date:	23/02/2021
File Location:	S:\Projects\4397
Circulation:	Electronic Copies: Fraser Coast Regional Council
	Printed Copies: Nil

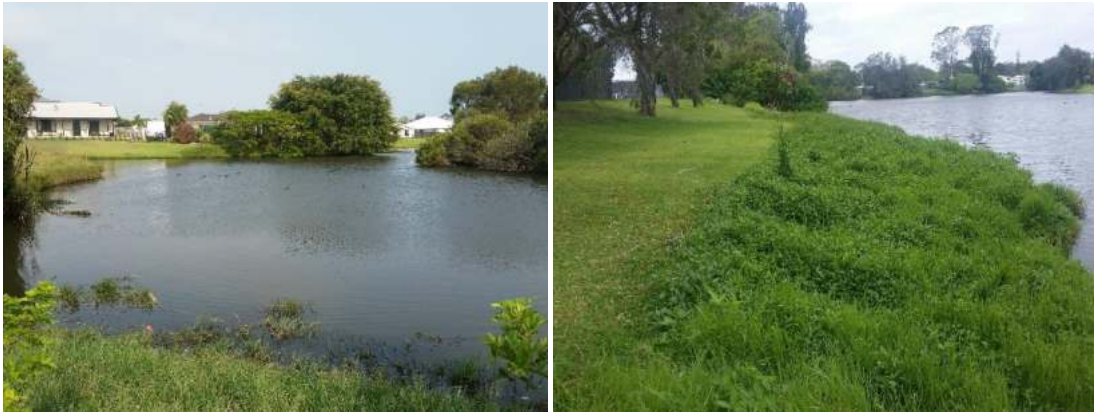
Figure 3-1 Waterbody A – a) Eastern end, and b) Edge buffer zone established by Council.

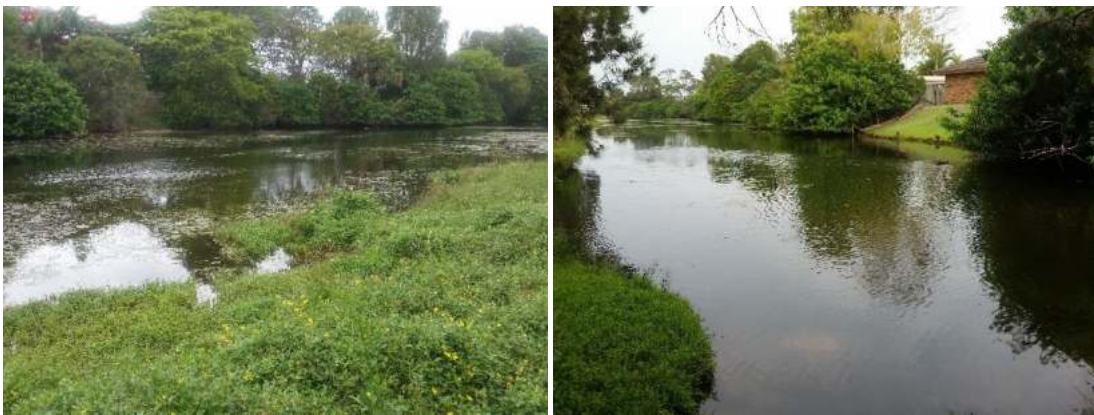
Figure 3-2 Waterbody B – a) Shallow water with dense growth of *Ceratophyllum demersum*, and b) Deeper water at eastern end of waterbody.

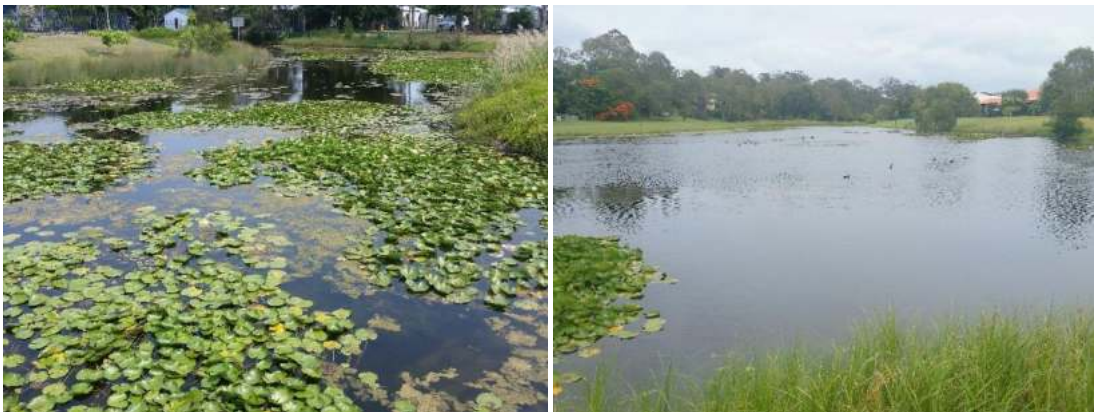
Figure 3-3 Waterbody C – a) Dense cover of *Nymphaea mexicana* near outlet to Waterbody D, and b) Main waterbody.

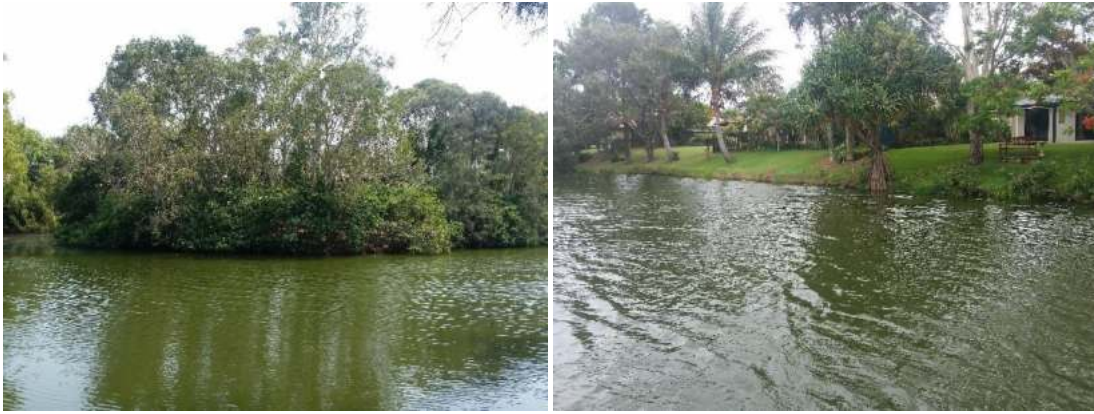
Figure 3-4 Waterbody D – a) Anembo Island – Ibis rookery, and b) Steep batters along the southern edge with steep drop-off at the water’s edge.

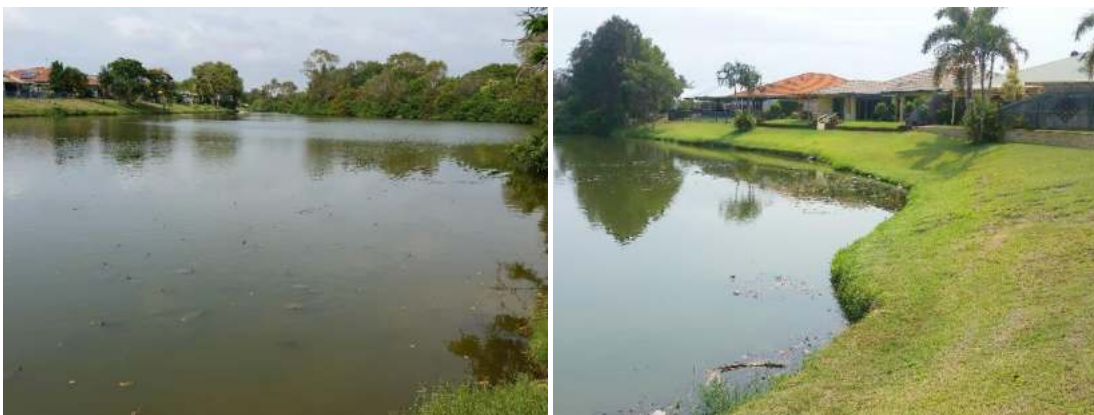
Figure 3-5 Waterbody E – a) Main waterbody (turtles waiting to be fed in foreground), and b) Example of residents mowing batters to the water’s edge.

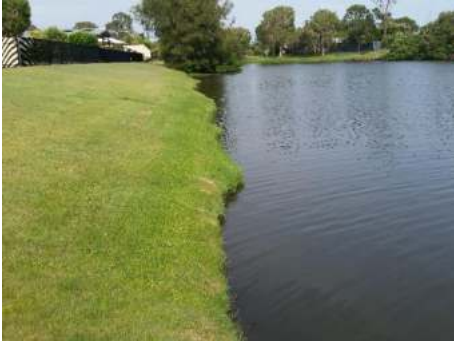
Edge Type	Comments/notes	Photo
Gentle batter +/- sharp drop off into shallow water	Generally >1:3 batter slope, mown grassed edge +/- sharp drop off into shallow (<0.3m) water. Moderate risk but shallow depth of water means exiting is fine. <u>Safe</u>

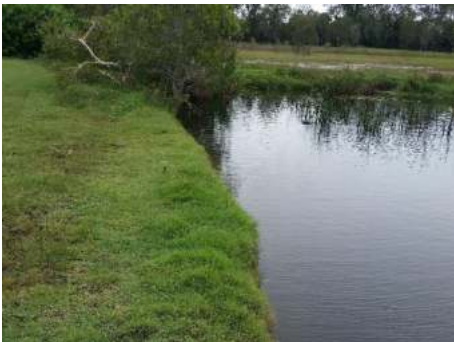
Gentle batter +/- sharp drop off into deep water	Generally >1:3 batter slope, mown grassed edge +/- sharp drop off into deep (>0.3m) water. High risk as deep depth of water means exiting may be difficult. <u>Potentially Hazardous.</u>

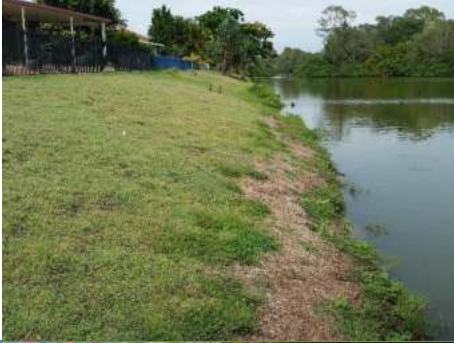
Steep batter +/- sharp drop off shallow water	Generally <1:3 batter slope, +/- sharp drop off into shallow (<0.3m) depth water. Moderate risk but steep batter slope may make it very difficult to exit waterbody (and easy to fall back in). High drowning risk <u>Potentially Hazardous</u>

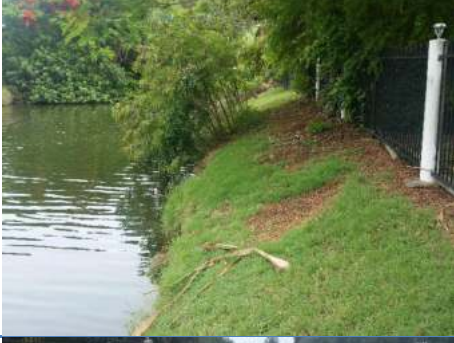
Steep batter +/- sharp drop off deep water	Generally <1:3 batter slope, +/- sharp drop off into deep (>0.3m) water. High risk as steep batter slope and deep depth of water means exiting is extremely difficult (and easy to fall back in). High drowning risk <u>Hazardous</u>

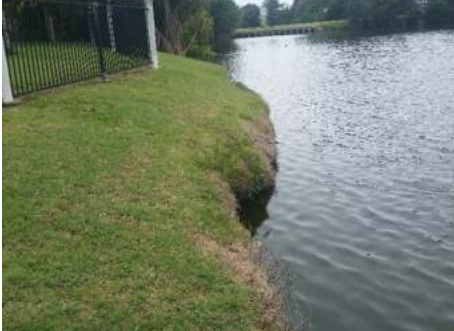
Vertical/highly eroded edge	Vertical waterbody edge with drop off into +/- deep water. Extremely difficult to exit waterbody. Presence of deep water means high drowning risk. <u>Extremely Hazardous</u>

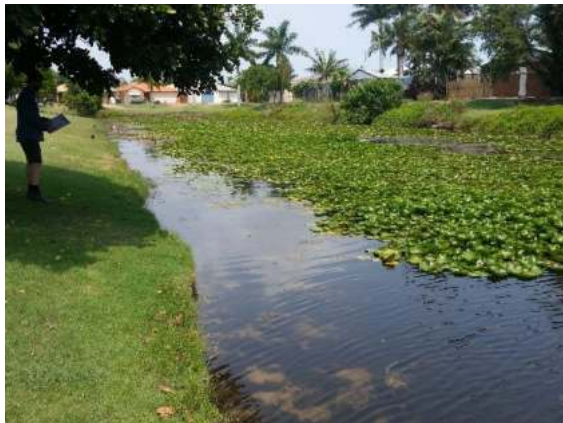
The majority of the lower batters/edges have good vegetation cover and are stable. Many of the waterbody edges comprise of mown grass, and have shallow vertical edges where wave action or waterbird activity has resulted in minor scour (Figure 4-1). These edges are relatively stable but are highly susceptible to further scour due the presence of the bare soils.

Figure 4-1 Minor scour present below grassed edges creating shallow vertical edge.

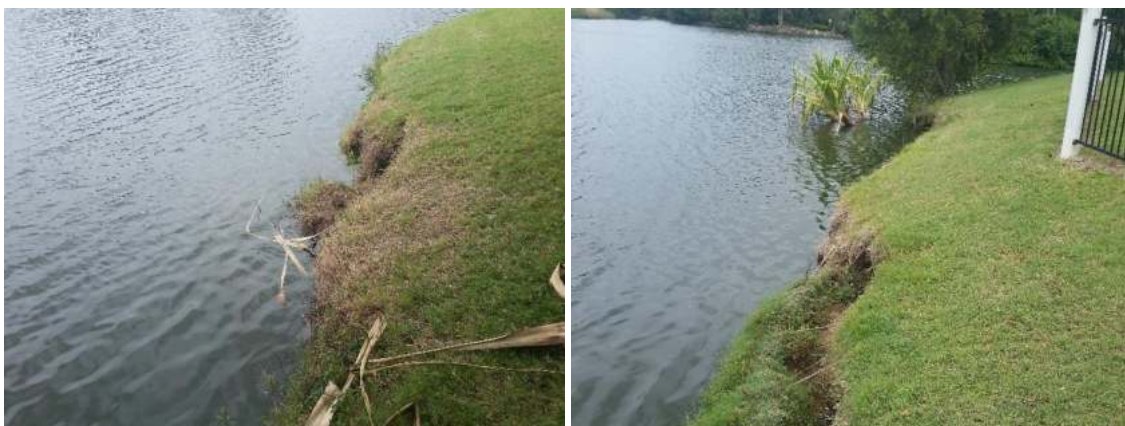
Active erosion and undermining of the waterbody edges along the northern margin of Waterbody D and within the Anembo Drive inlet are of most concern, as the batters are steep to vertical, adjoining deep water and represent a risk to both public safety and the adjoining residential properties.

Of particular concern and requiring urgent attention, the waterbody edge adjacent to the residential property to the east of Anembo Drive inlet is severely undermined, is actively eroding and is retreating towards the property boundary. Intervention will be required to arrest the erosion and protect the residential property boundary. A similar scenario is occurring along the waterbody edges adjacent to this area, but the batters are moderately stable and not endangering the adjacent properties.

Figure 4-2 Eroded areas within Waterbody C: a) northern edge, and b) near Anembo Drive inlet.

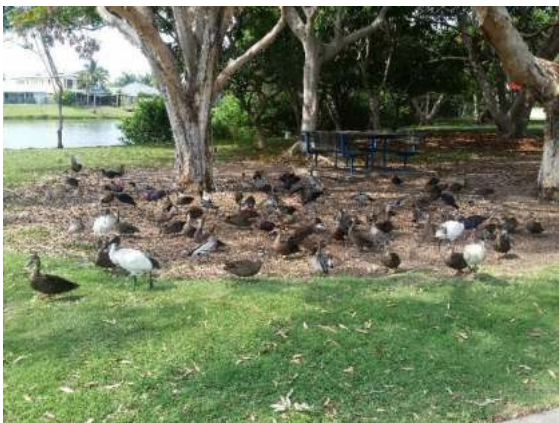
Daily feeding of the waterbirds occurs within the park between Truro Street and Waterbody E, resulting in a major aggregation of the waterbirds every morning and high loads of faecal matter present within the park (Figure 4-4).

Figure 4-4 Bird feeding area within the parkland on Truro St.

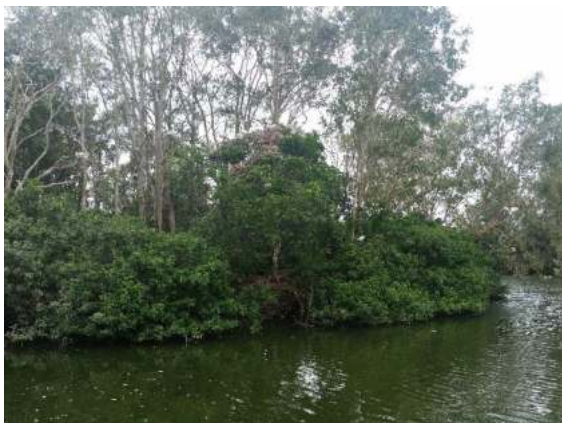
Areas within the waterbodies where waterbirds congregate are considered to be associated with a potentially higher risk, as there is generally higher deposition of bird faeces in these areas. This includes the areas (both the water and waterbody edges) adjacent to the Ibis rookeries (Waterbody D - Anembo Island and small island, Waterbody E - island). The waterbody edges behind the residential properties and adjacent to the Ibis rookery on Anembo Island were notably contaminated and notably odorous during the waterbody inspection (Figure 4-5).

Figure 4-5 Ibis rookery on Anembo Island.

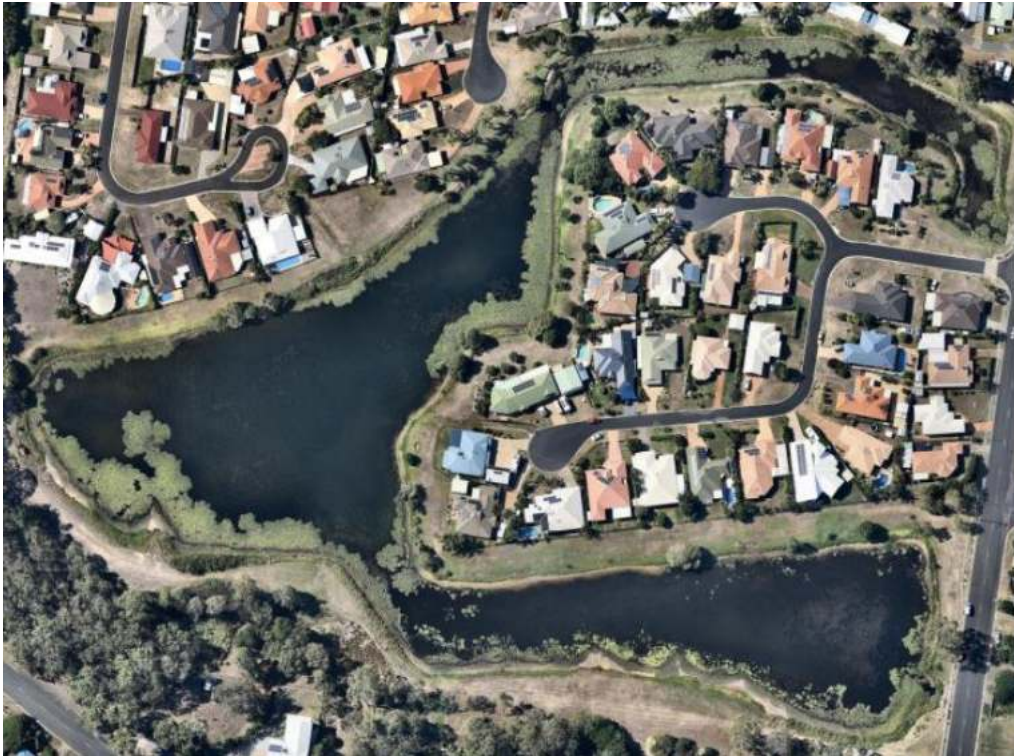
It is understood that Council conducted a trial in late 2018 to reduce the distribution of *N. mexicana* within Waterbody C. This involved repeated harvesting over a short period of time. Discussions with Council staff indicated that the trial appears to have been ineffective at reducing the distribution of *N. mexicana* within Waterbody C, and may have increased overall cover.

Figure 4-6. *N. mexicana* (light green areas) around margins of Waterbody C.

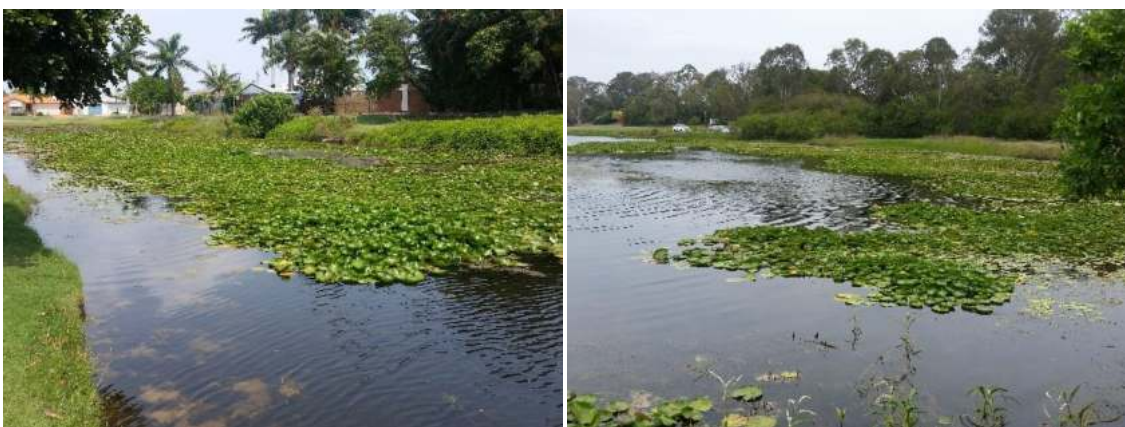
Figure 4-7. *N. mexicana* – a) Northern arm of Waterbody C, and b) Extensive population along the southern edge of the waterbody.

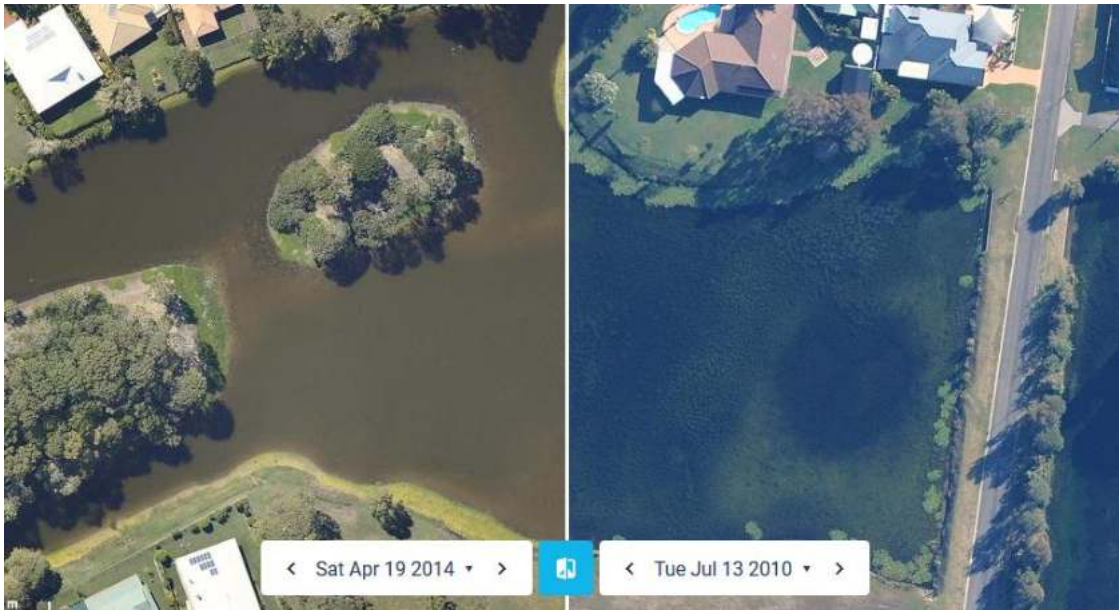
Figure 4-8 Waterbody D – comparison of submerged waterplant cover between 2010 and 2014.

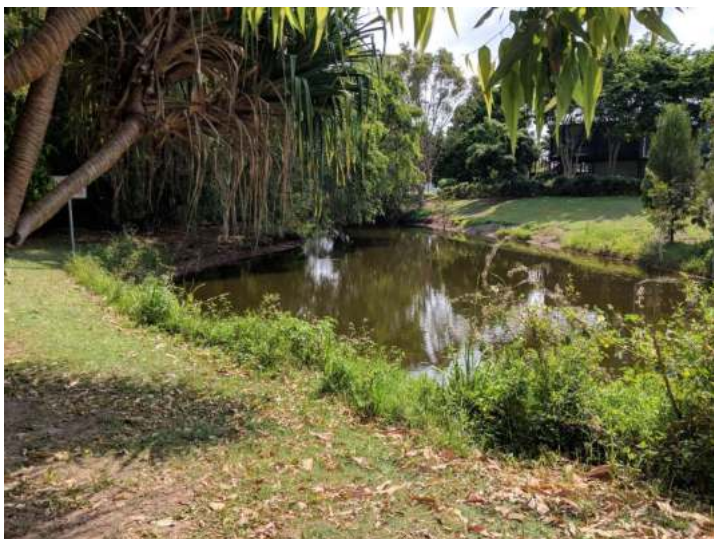
A number of 'backwater' areas were noted in Lowlands Lagoons. Backwater areas within the waterbodies can often have longer residence times as they are poorly flushed. Backwater areas often appear stagnant and are associated with the accumulation and decomposition of organic material. Poorly flushed waterbody water combined with nutrient release (e.g. from anoxic sediments or bird faecal matter) often results in ideal conditions for incubating algal and floating water weed growth (Figure 4-10).

Figure 4-10 Backwatered areas such as Anembo Drive inlet can act as incubators for algal and floating waterplant growth.
