# 2015 | Fraser Coast Water Supply Strategy

August 2015

## Appendices Volume 2

# APPENDIX 5 – WATER RETICULATION

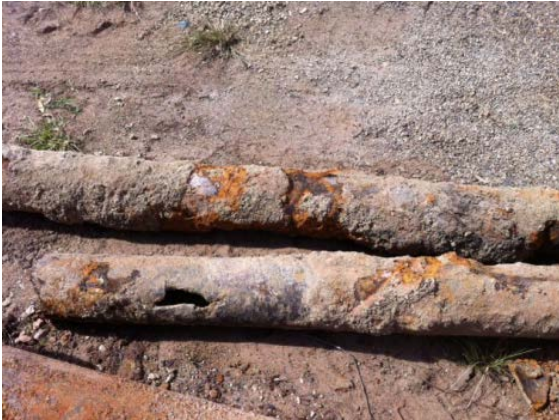
**Figure 5 - Typical pipe corroded from exterior**

The modelling conducted for this report has assumed that the reticulation network is in reasonable condition and the roughness coefficients are those typically used for similar aged pipelines. This means that there is no allowance made for severely tuberculate pipes in the capacity assessment.

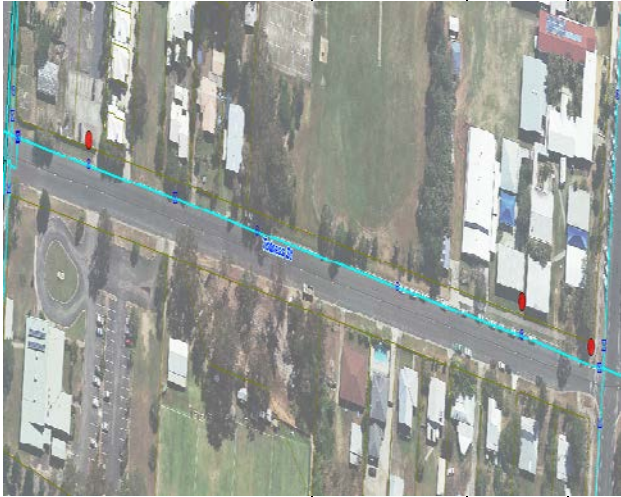
| Site | Street | Location | diameter<br>(mm) | Mate<br>rial | Length<br>(m) | Vol<br>(m3) | flow<br>(L/s) | time<br>(min) |
|---|---|---|---|---|---|---|---|---|
| 1 | Totness Rd | Denman Camp to<br>Tavistock St | 200 | AC | 301.8 | 9.5 | 10 | 16 |

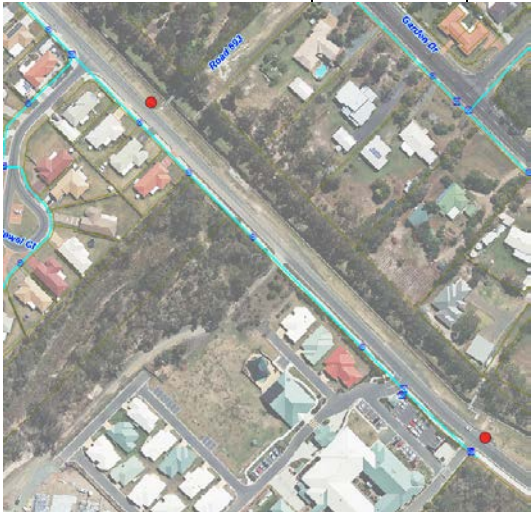
| Site | Street | Location | diameter<br>(mm) | Mate<br>rial | Length<br>(m) | Vol<br>(m3) | flow<br>(L/s) | time<br>(min) |
|---|---|---|---|---|---|---|---|---|
| 2 | Emerald Park<br>Way | Jewel Crt to end of main | 200 | mPVC | 273.3 | 8.6 | 10 | 14 |

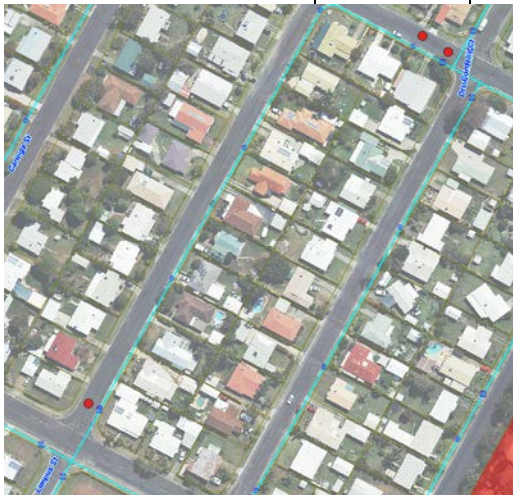
| Site | Street | Location | diameter<br>(mm) | Material | Length<br>(m) | Vol<br>(m3) | flow<br>(L/s) | time<br>(min) |
|---|---|---|---|---|---|---|---|---|
| 3 | Limpus St | Drummond St to past Boat Harbour Drv | 100 | AC | 270.1 | 2.1 | 4 | 9 |

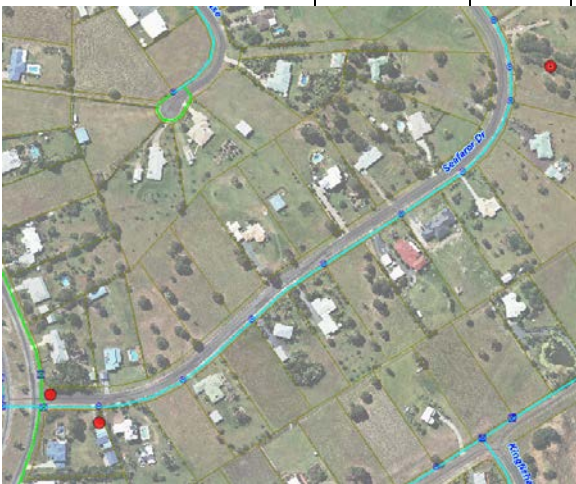
| Site | Street | Location | diameter<br>(mm) | Material | Length<br>(m) | Vol<br>(m3) | flow<br>(L/s) | time<br>(min) |
|---|---|---|---|---|---|---|---|---|
| 4 | Seafarer Drv | Cove Blv to 400m up the road (hyd 2781) | 100 | uPVC | 489 | 3.8 | 5 | 13 |

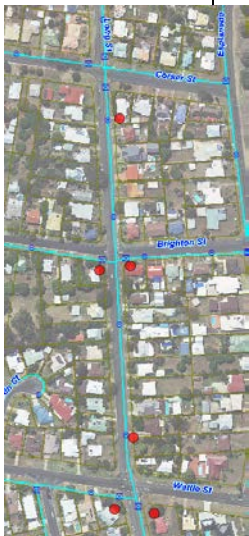
| Site | Street | Location | diameter<br>(mm) | Material | Length<br>(m) | Vol<br>(m3) | flow<br>(L/s) | time<br>(min) |
|---|---|---|---|---|---|---|---|---|
| 5 | Long St | Corser St to Wattle St | 200 | CI | 325 | 10.2 | 15 | 11 |

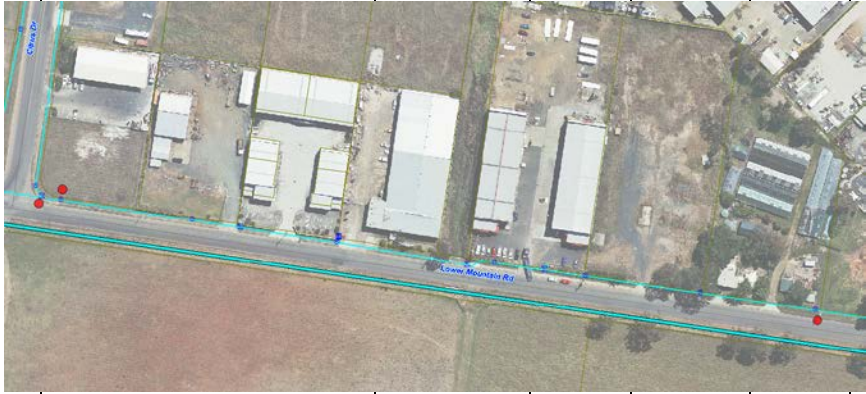
| Site | Street | Location | diameter<br>(mm) | Mate<br>rial | Length<br>(m) | Vol<br>(m3) | flow<br>(L/s) | time<br>(min) |
|---|---|---|---|---|---|---|---|---|
| 6 | Lower Mountain Rd | Citrus Drv to Scrub Hill Rd | 250 | DICL | 220.4 | 10.8 | 15 | 12 |

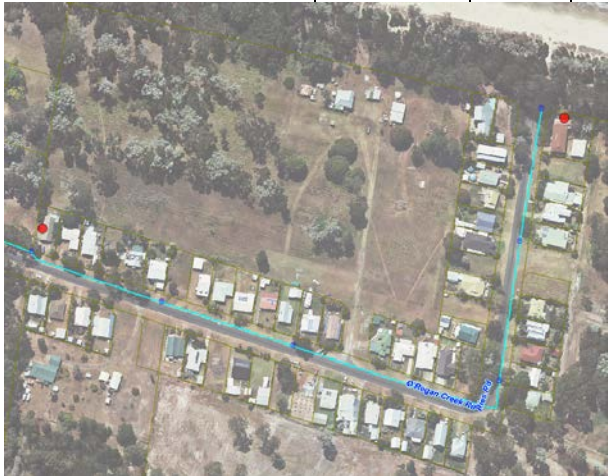
| Site | Street | Location | diameter<br>(mm) | Mate<br>rial | Length<br>(m) | Vol<br>(m3) | flow<br>(L/s) | time<br>(min) |
|---|---|---|---|---|---|---|---|---|
| 7 | Oregean Creek Rd | to end of main | 100 | uPVC | 557 | 4.4 | 10 | 7 |

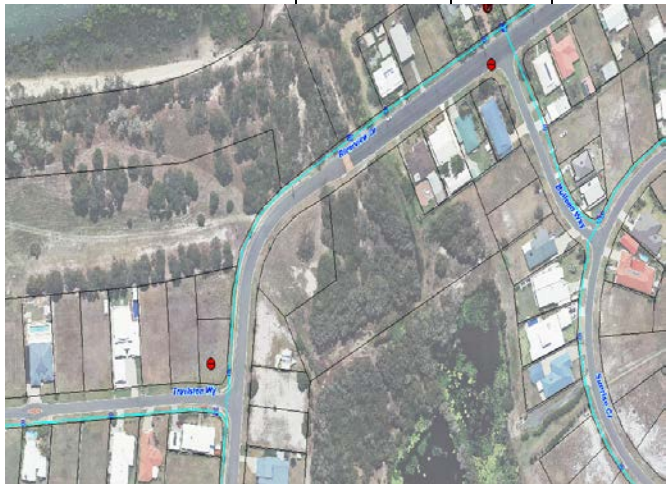
| Site | Street | Location | diameter<br>(mm) | Mate<br>rial | Length<br>(m) | Vol<br>(m3) | flow<br>(L/s) | time<br>(min) |
|---|---|---|---|---|---|---|---|---|
| 8 | Riverview Drv | Bulleen Way to Traviston Way | 100 | AC | 262.5 | 2.1 | 4 | 9 |

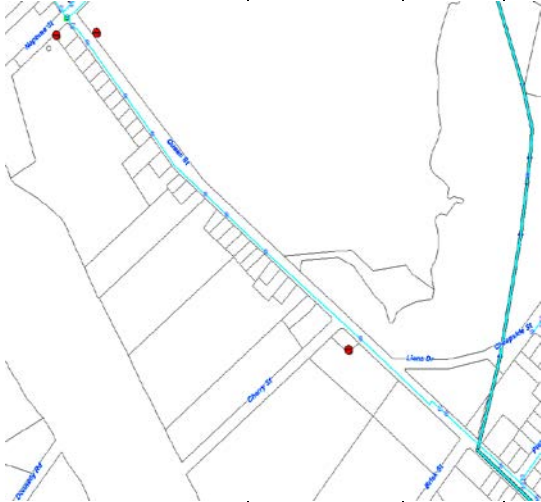
| Site | Street | Location | diameter<br>(mm) | Material | Length<br>(m) | Vol<br>(m3) | flow<br>(L/s) | time<br>(min) |
|---|---|---|---|---|---|---|---|---|
| 9 | Queen St | Neptune St to Cheapside St | 100 | CI | 703 | 5.5 | 10 | 9 |

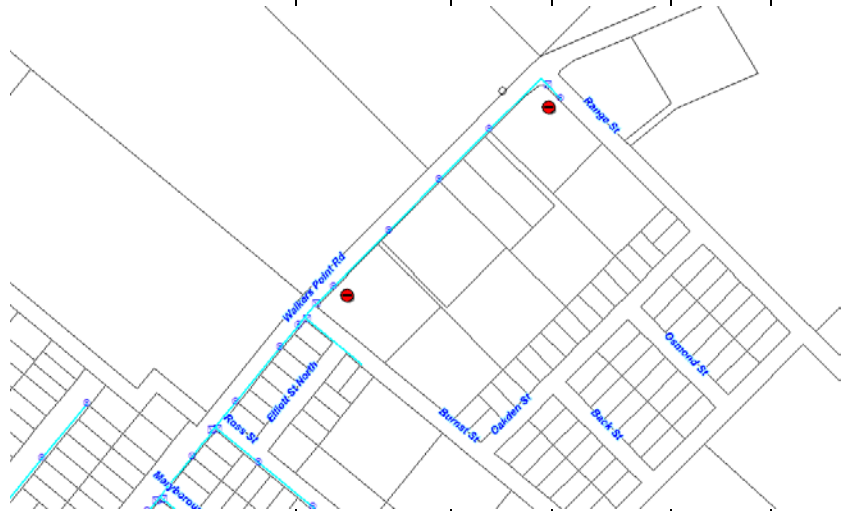
| Site | Street | Location | diameter<br>(mm) | Material | Length<br>(m) | Vol<br>(m3) | flow<br>(L/s) | time<br>(min) |
|---|---|---|---|---|---|---|---|---|
| 10 | Odessa/Water Point Rd | Ross St to Range St | 100 | PVC | 365.7 | 2.9 | 5 | 10 |

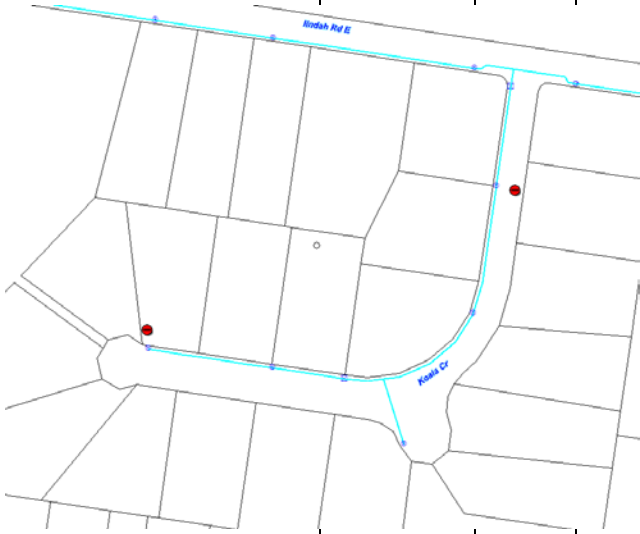
| Site | Street | Location | diameter<br>(mm) | Mate<br>rial | Length<br>(m) | Vol<br>(m3) | flow<br>(L/s) | time<br>(min) |
|---|---|---|---|---|---|---|---|---|
| 12 | Koala Cres | To end of main | 100 | PVC | 303 | 2.4 | 5 | 8 |

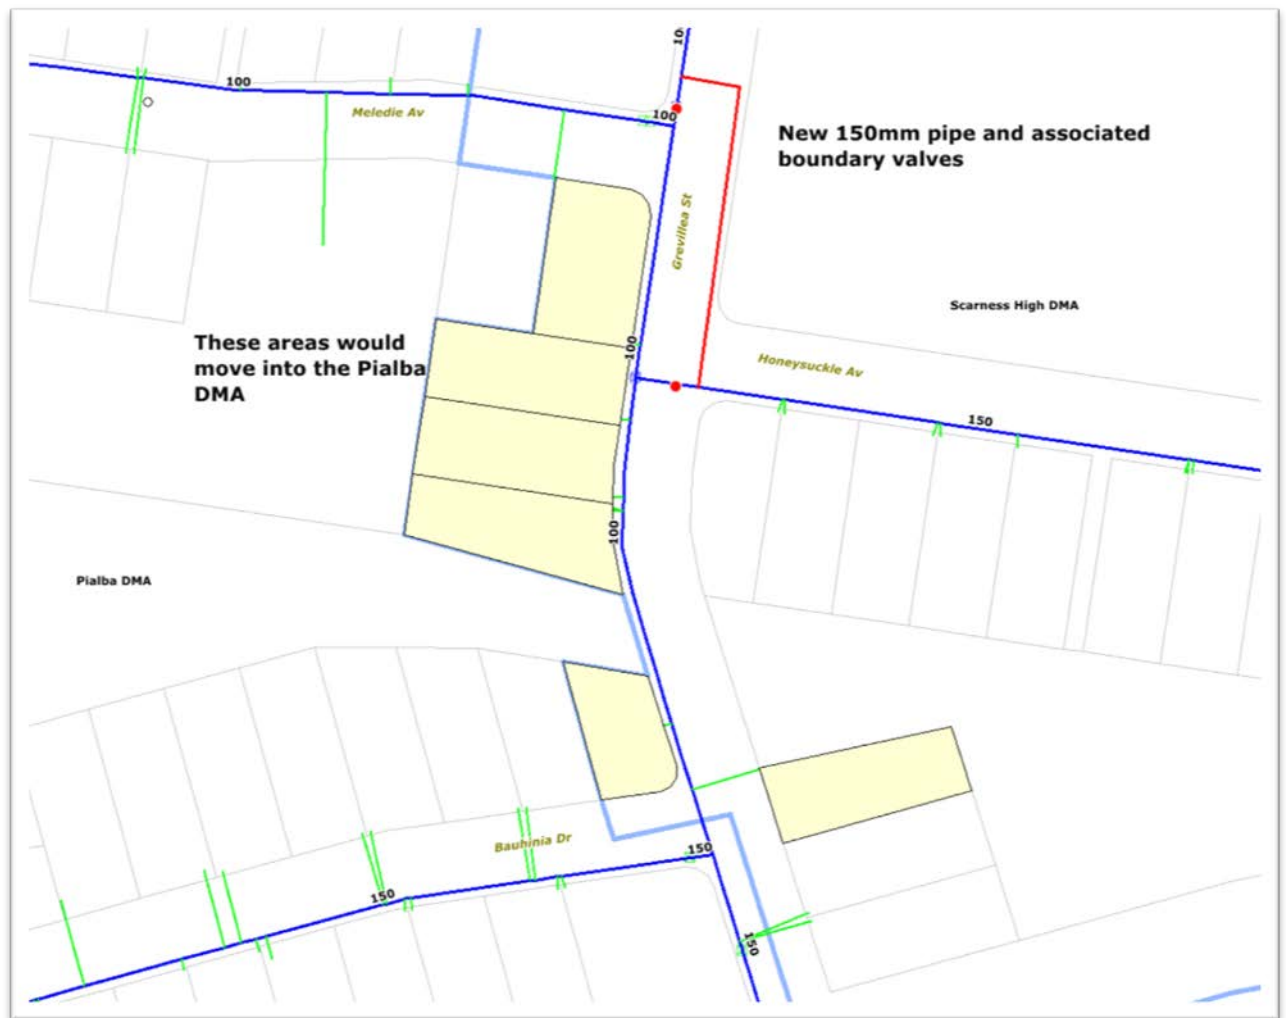
Item HB2 – Grevillea St – Honeysuckle Av to Meledie Av

2 x boundary valves = \$10,000

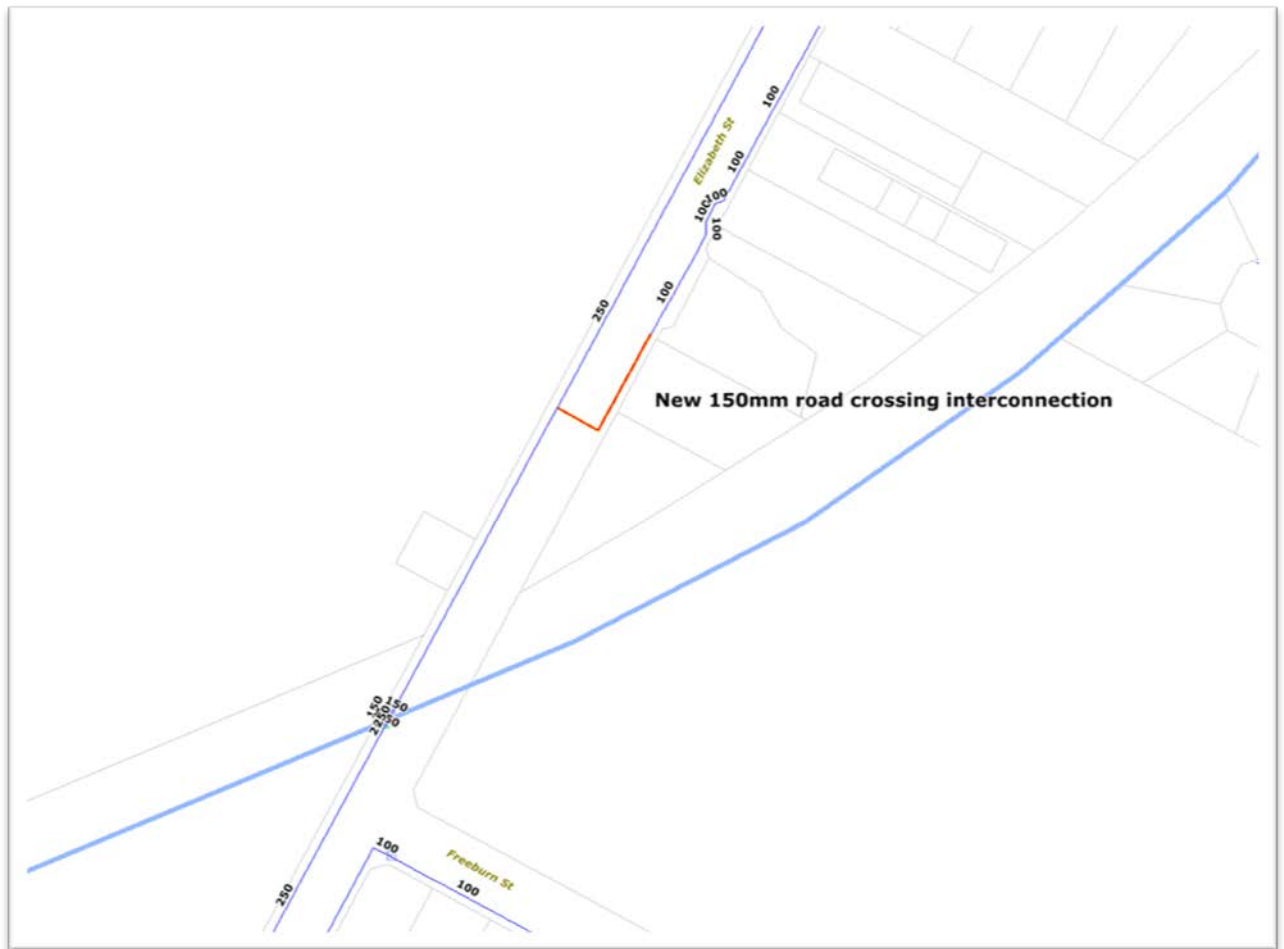
Item HB6 – Elizabeth Street Interconnection

150mm water main interconnection = \$25,000

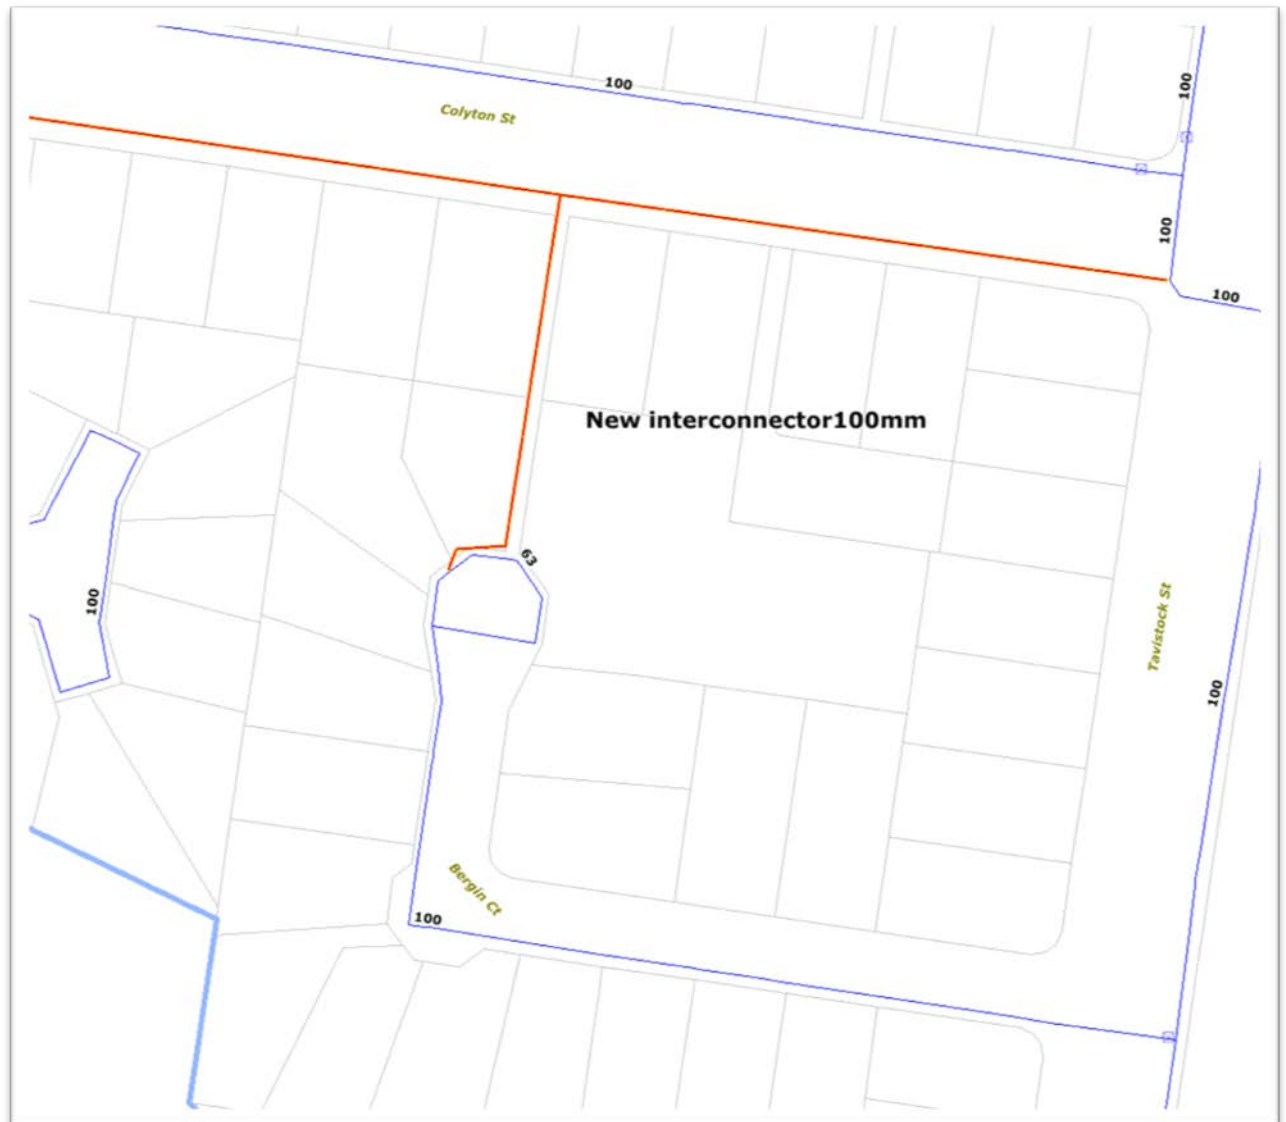
HB7 – Bergin to Colyton St Interconnection

100mm water main interconnection = \$15,000

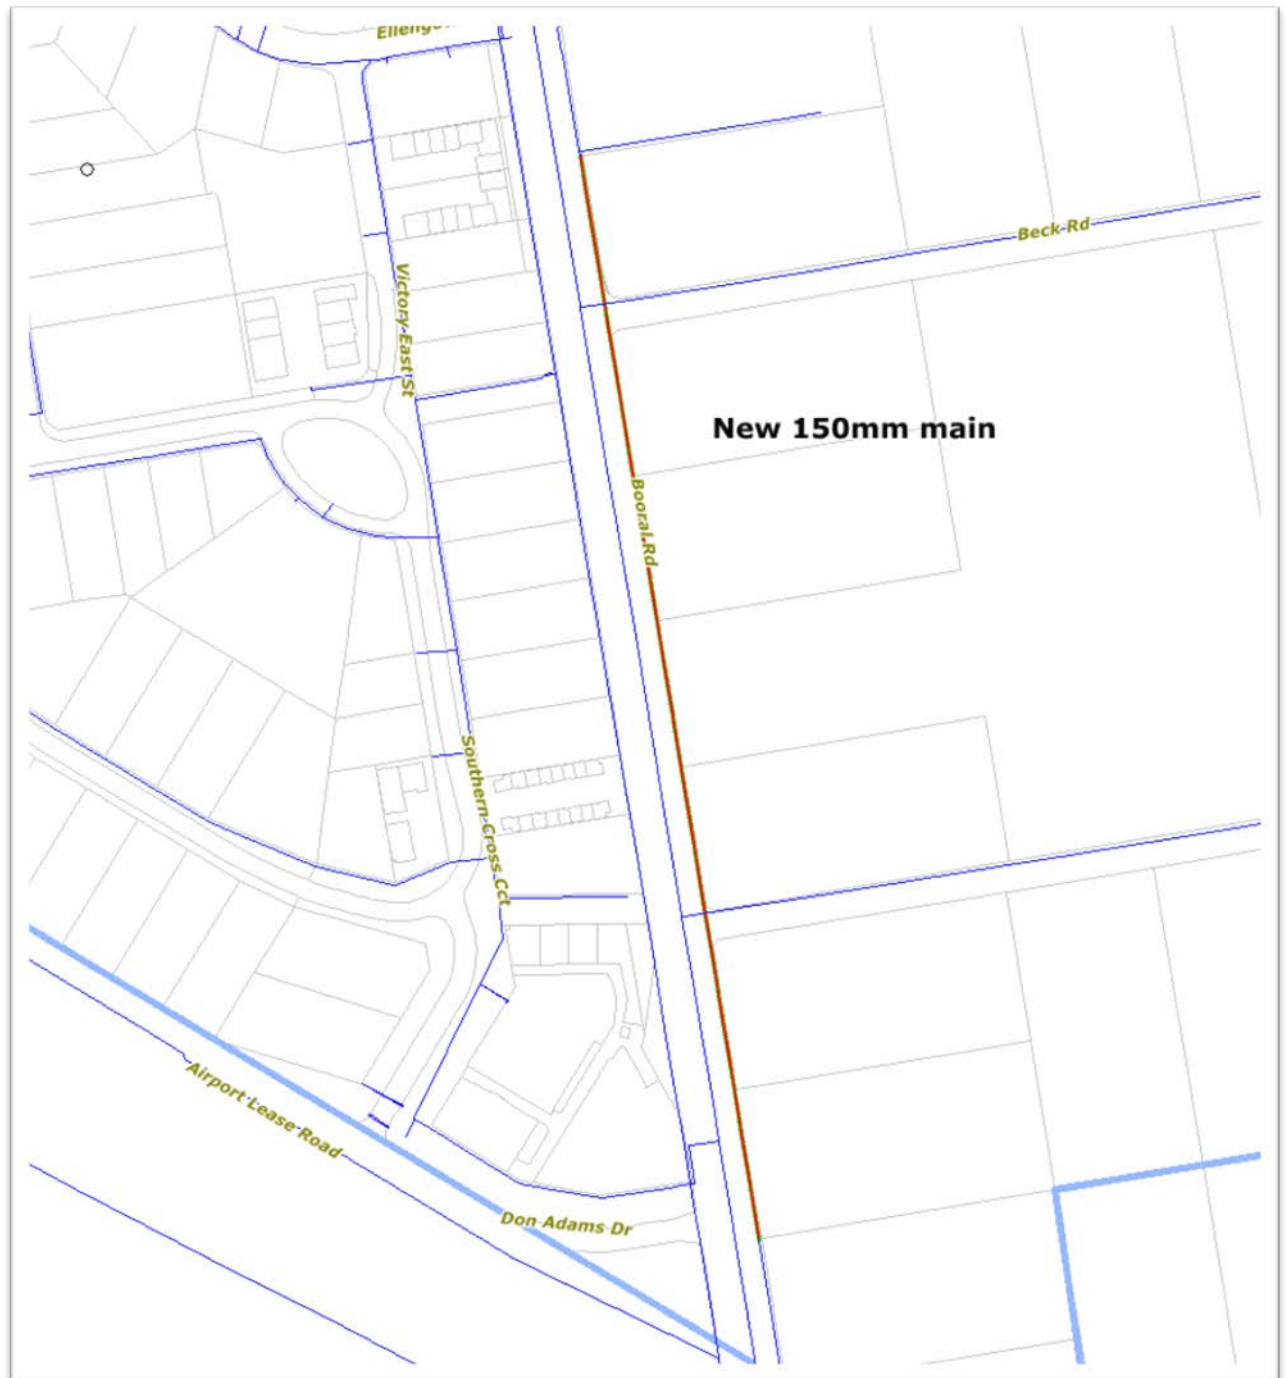
Item HB8 – Booral Rd, Urangan - Beck Rd and Don Adams Dr

150mm 740m water main interconnection = \$154,000

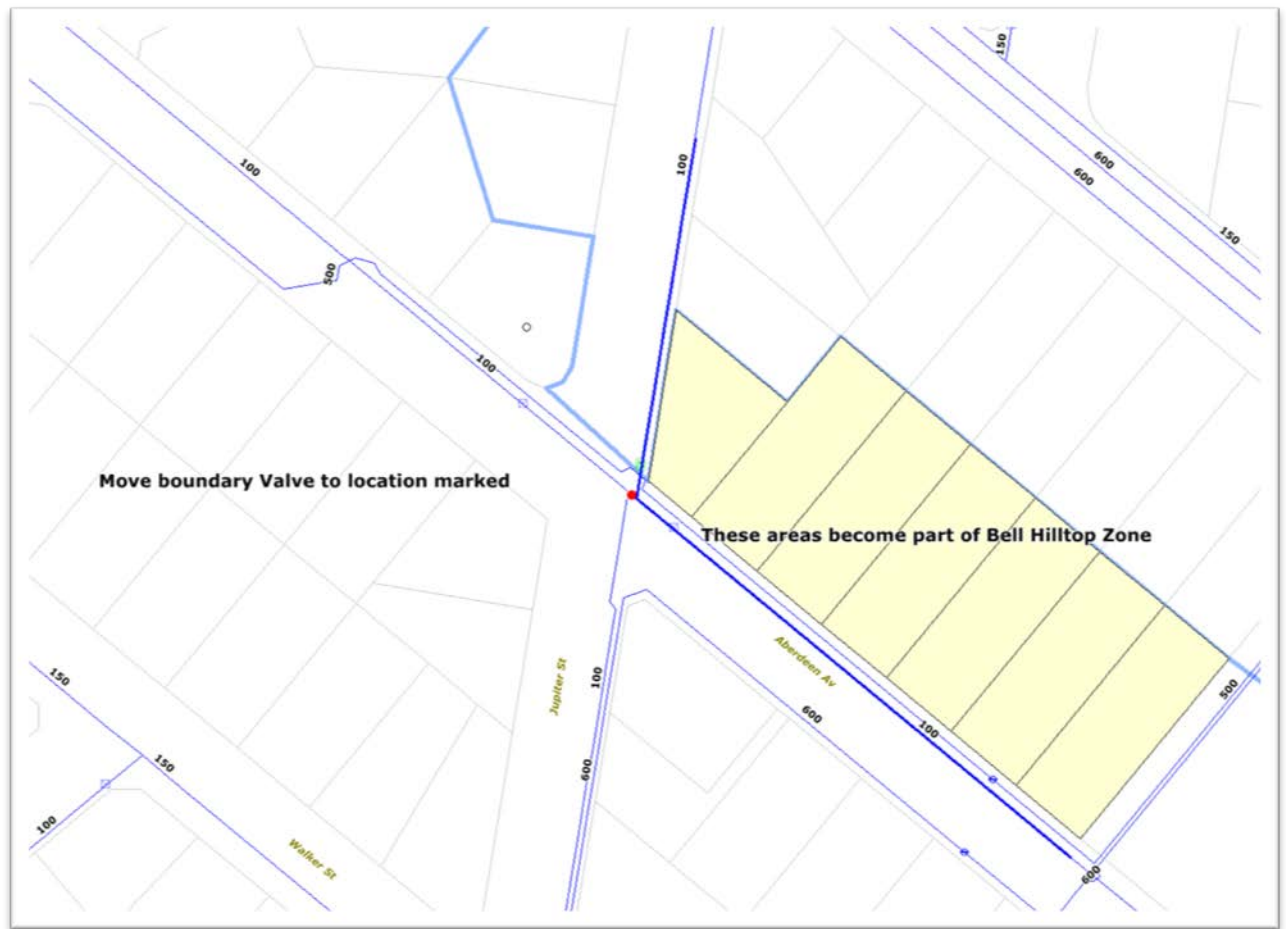
Item MB1 – Jupiter St and Aberdeen Av Boundary Valve Relocation

1 x boundary valve = \$10000

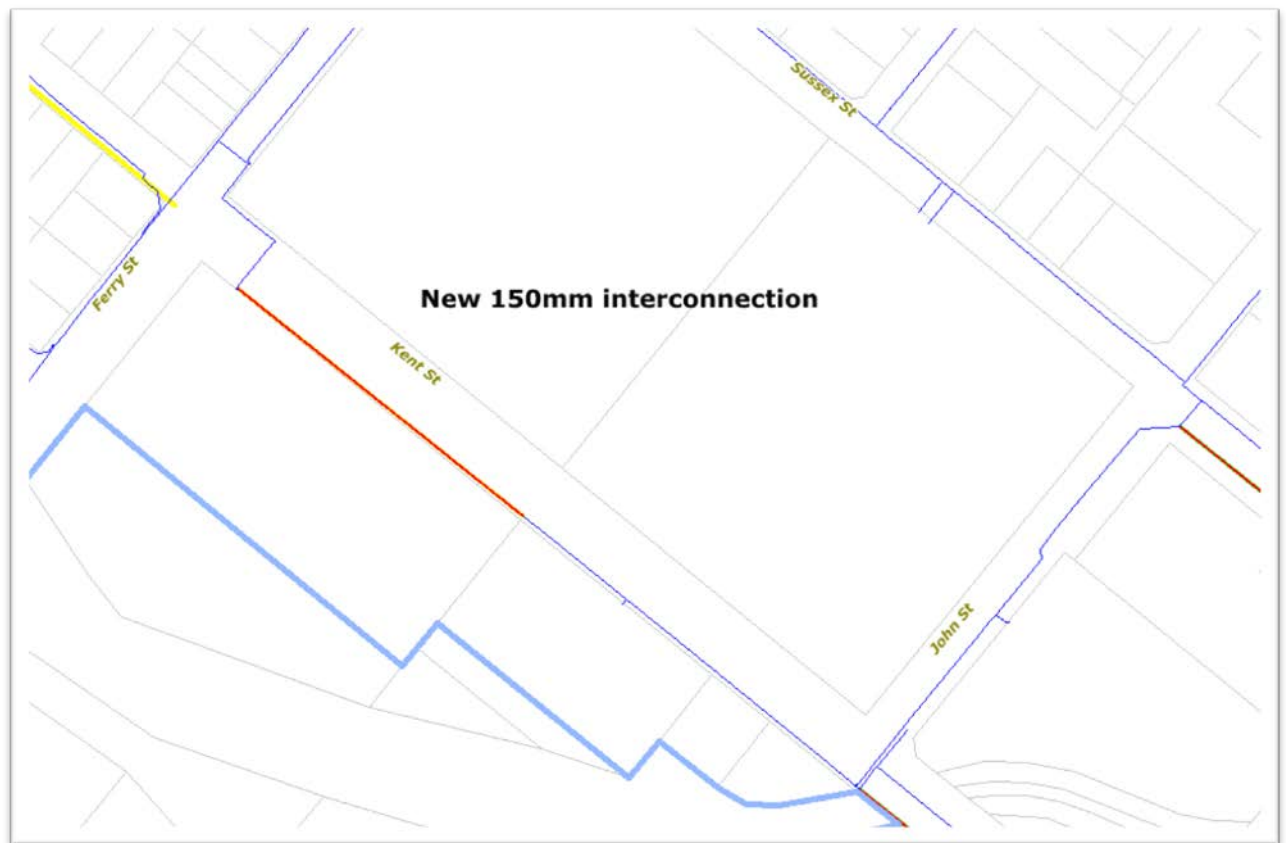
Item MB6 – Kent St, MBH - Ferry to inline with Fort St

100mm interconnection main = \$36,000

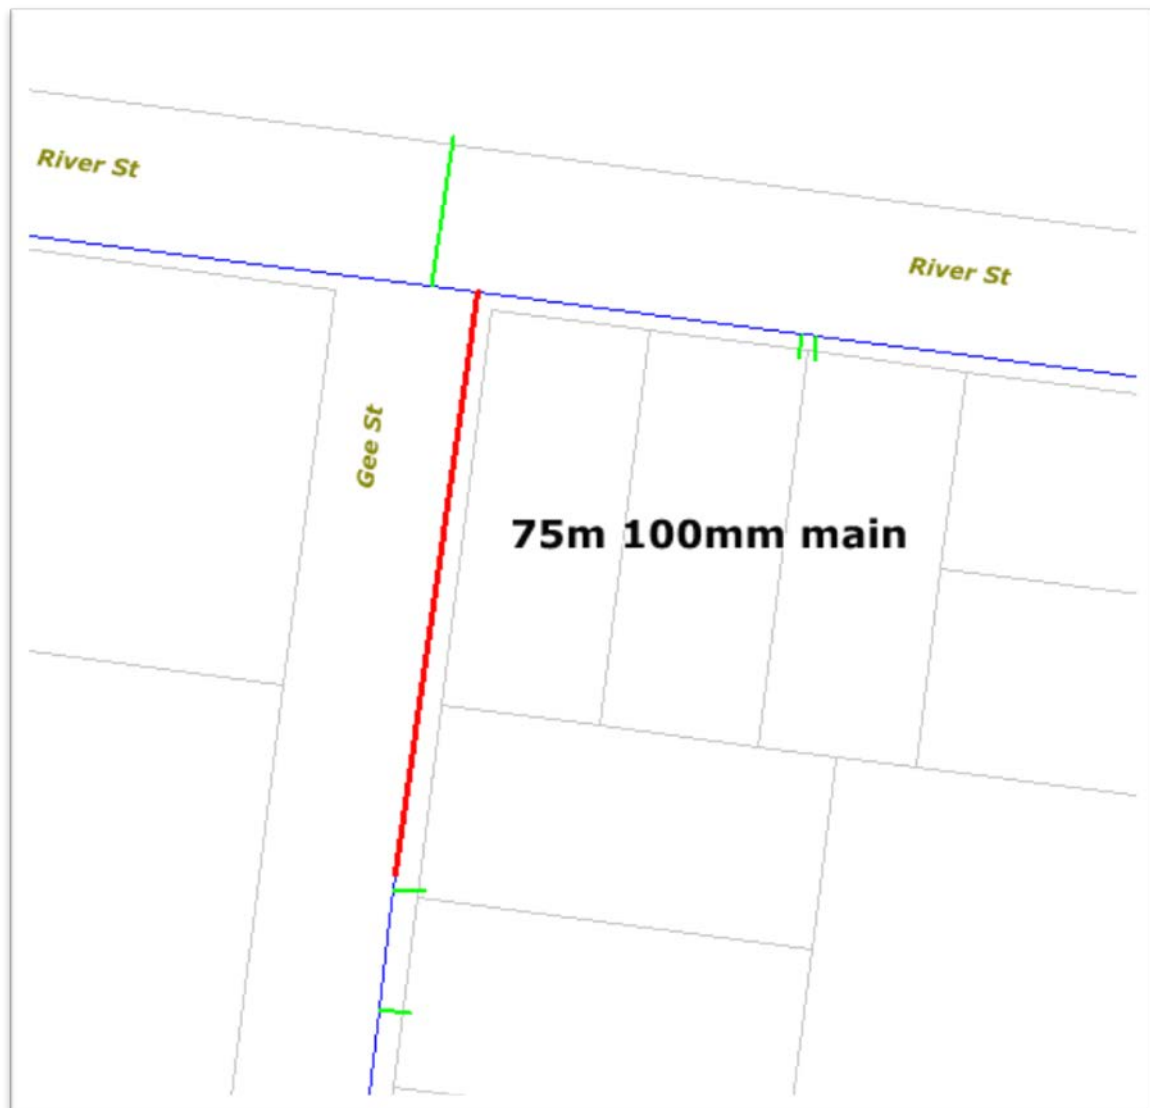
Item T1 – Gee St to River St

75m of 100mm water main = \$25,000

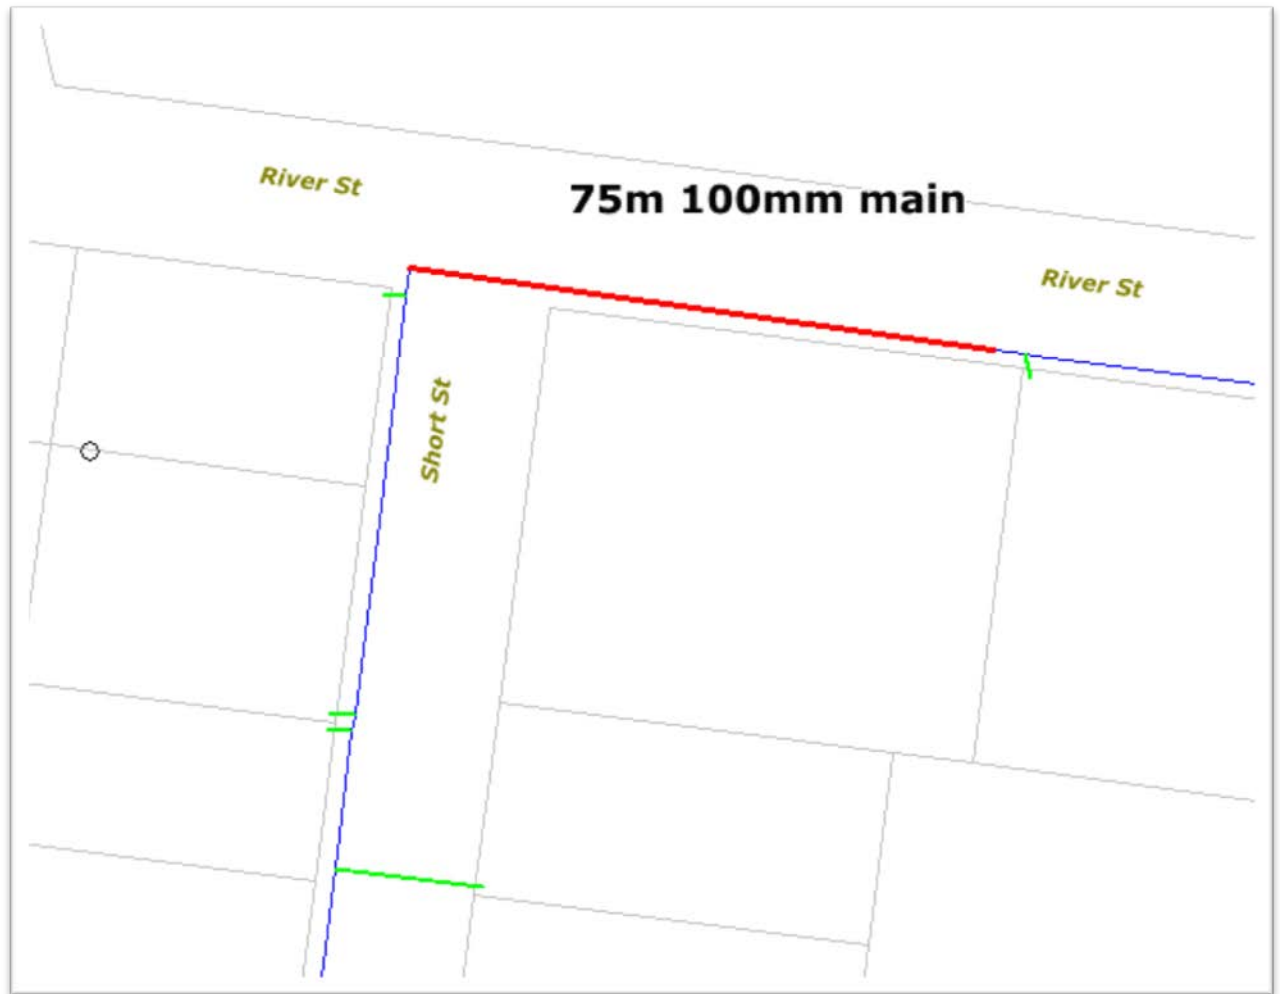
Item T2 – River St to Short St

75m of 100mm water main = \$25,000

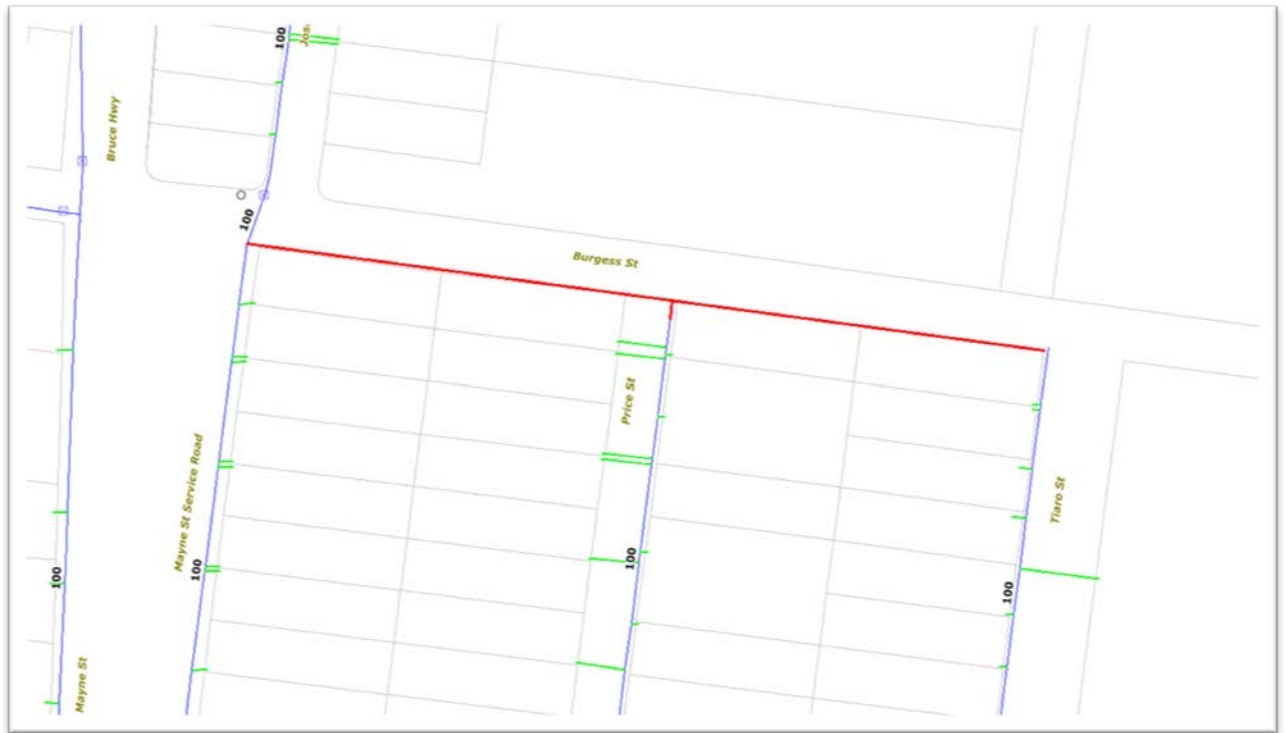
Item T4 – Burgess St – Tiaro St to Bruce Highway

310m of 100mm water main = \$70,000

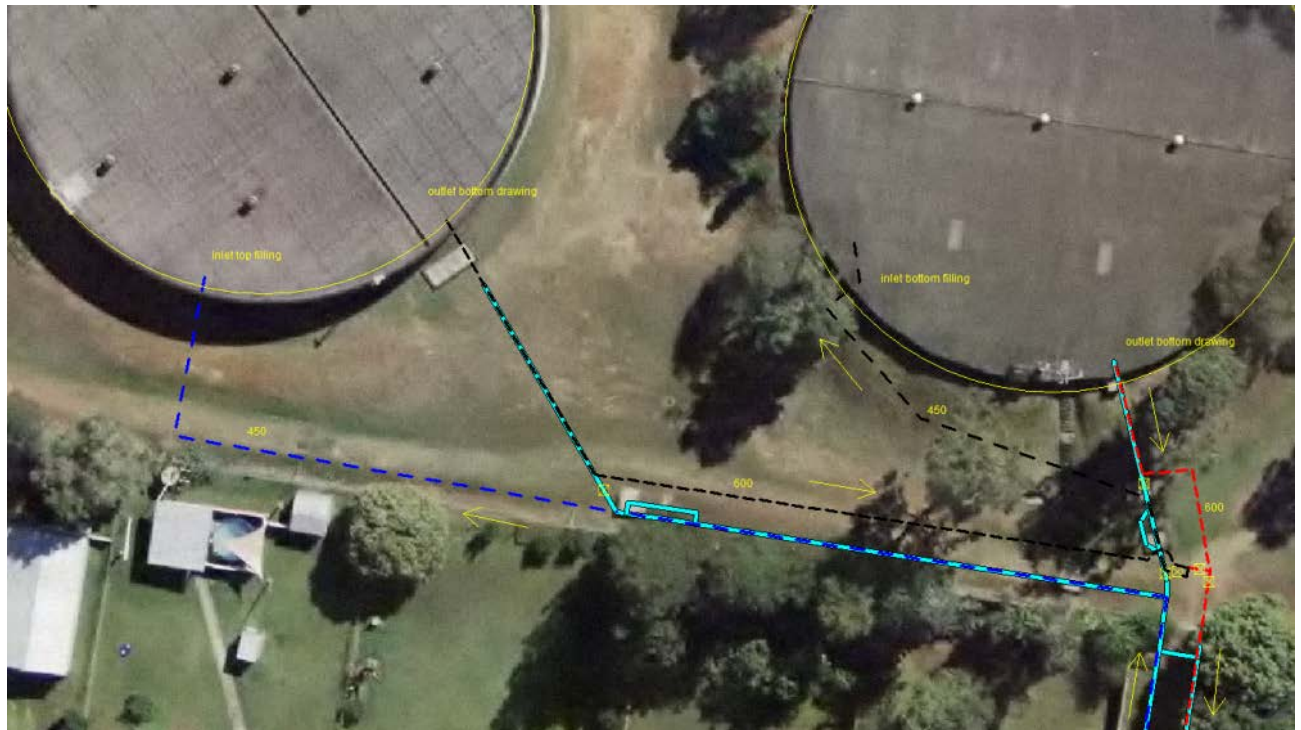
Figure 7 - Boys Ave Pipework Reconfiguration

To effectively use the Boys Avenue reservoirs, some pipeline reconfiguration is required. This reconfiguration maximises the water quality by attempting to create a First in First out (FIFO) system where there are little or no dead areas and the reservoir is changed over regularly. It also allows for the lead reservoir to be used for aeration and removal of any formed THM's. This concept pipe layout is included. Functionally the concept is as shown in the following flowchart.

The Boys Avenue reservoirs are the main ground level storages for Maryborough along with the future recommissioning of the Ann St reservoir.
