ULULAH LAGOONS WATERBODY MANAGEMENT PLAN

VERSION 3

DesignFlow
Prepared for Fraser Coast Regional Council
November 2019

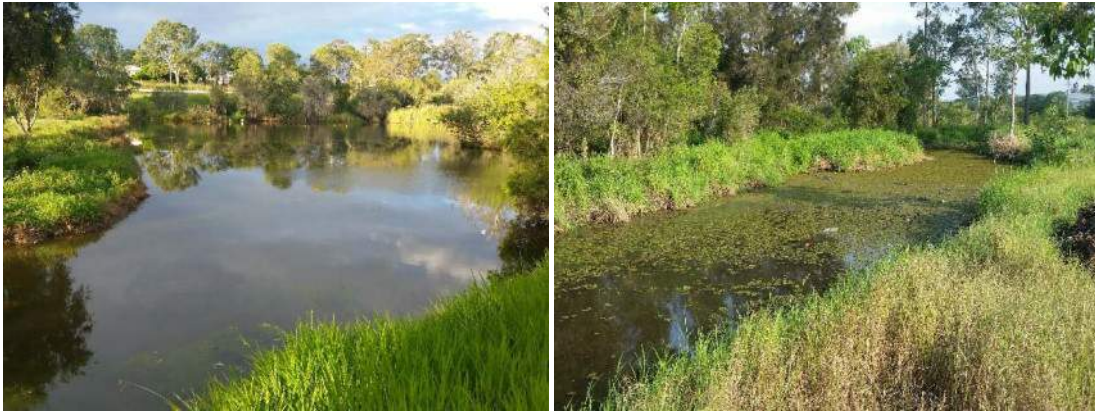
Figure 3-1 Waterbody A – a) Main waterbody, and b) Channel connecting Waterbodies A and B.

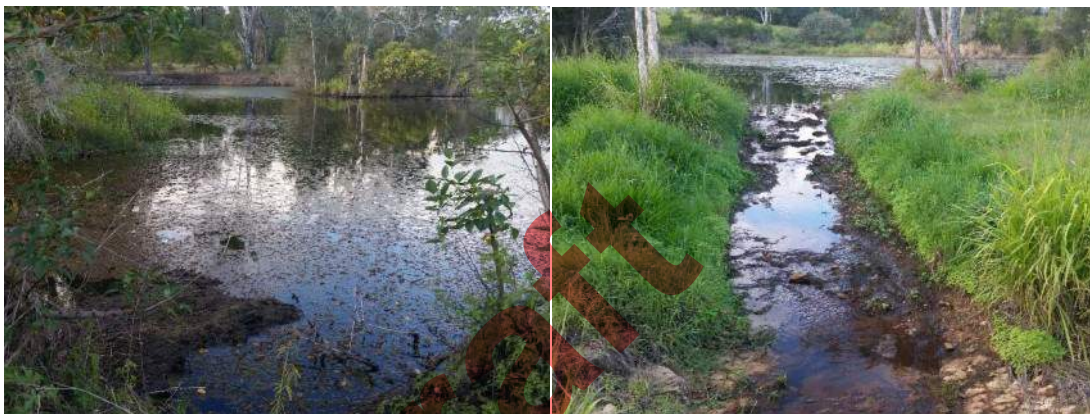
Figure 3-2 Waterbody B – a) Main waterbody, and b) Overflow weir and outlet channel.

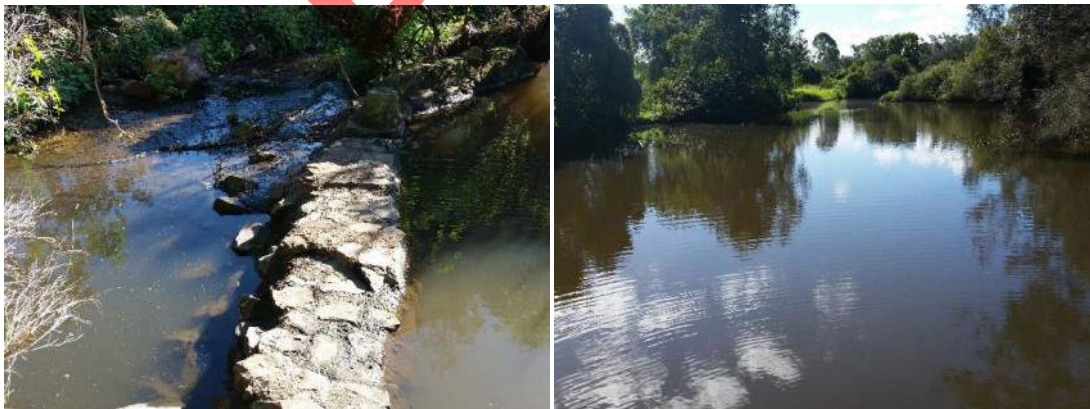
Figure 3-3 Waterbody C – a) Overflow weir, and b) Shallow waterbody upstream from the overflow weir.

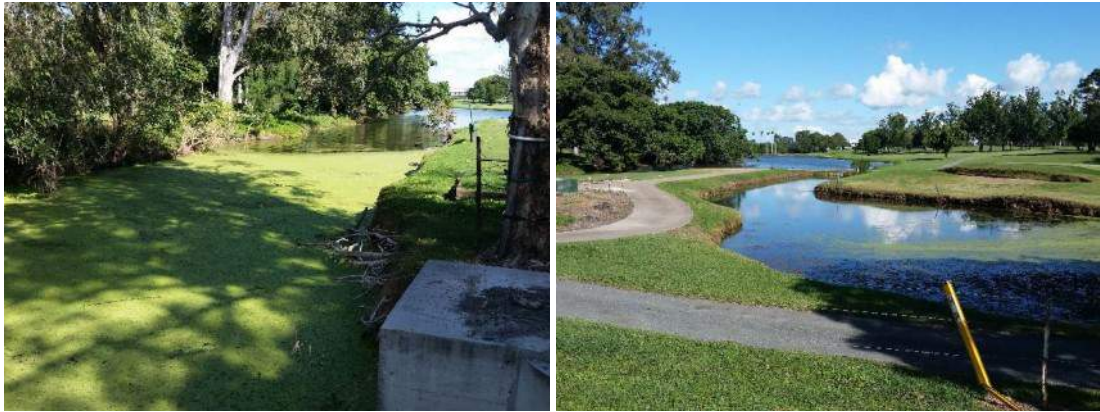
Figure 3-4 Ululah Lagoons – a) Inlet channel below Alice St, and b) Enclosed lagoons within the golf course adjacent to waterbody inlet.

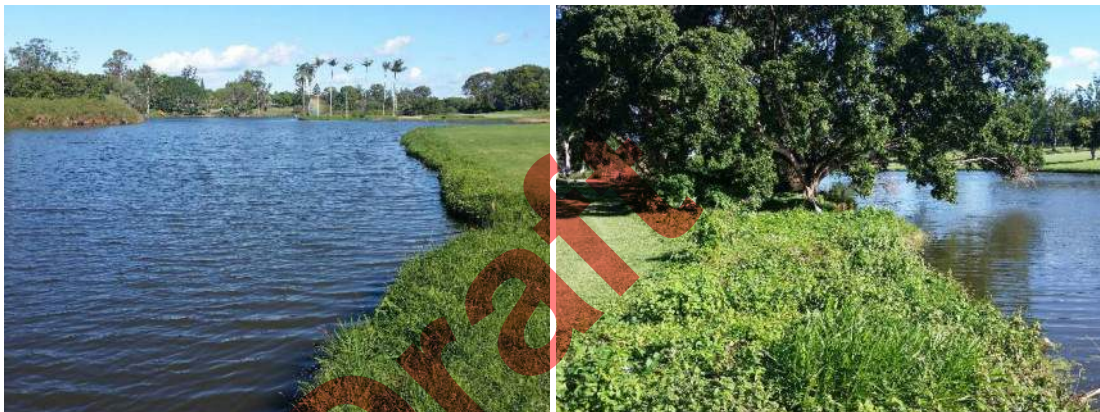
Figure 3-5 Ululah Lagoons – a) Main waterbody, and b) Buffer zone along edge adjacent to Anzac Park.

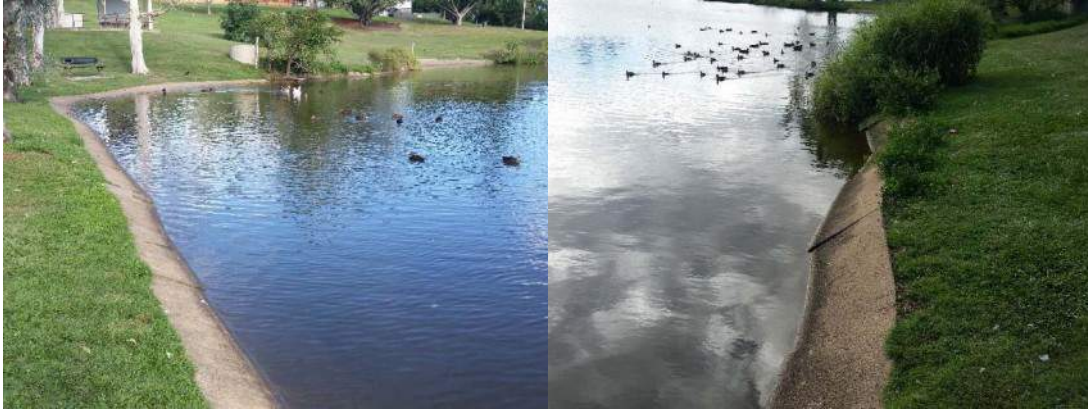
The edges in south-east corner of Ululah Lagoon comprise of concrete revetments which slope from the mown grassed edge into the water to approximately 0.4-0.5 m depth (Figure 4-1). In several locations, the concrete revetment has collapsed resulting in a steeper entry into the water (1:1-1:2 in some locations). Where this has occurred, the revetment slope and presence of deep water would make exiting the waterbody difficult.

Figure 4-1 Concrete revetment in the SE corner of Ululah Lagoon: a) Main section, and b) Collapsed section towards the northern end.

Undertake detailed batter safety risk assessment: A detailed batter safety risk assessment should be conducted to review safety around waterbodies to both the public and for Council workers. The field condition assessment identified some areas around Ululah Lagoons where steep batters lead directly into deep water, and where a potential drowning risk is present. A detailed audit is required to investigate all of the waterbody edges, including the Golf Club, to assess high risk locations where intervention is required to manage public safety risk and minimise the risk of persons falling into the waterbodies.

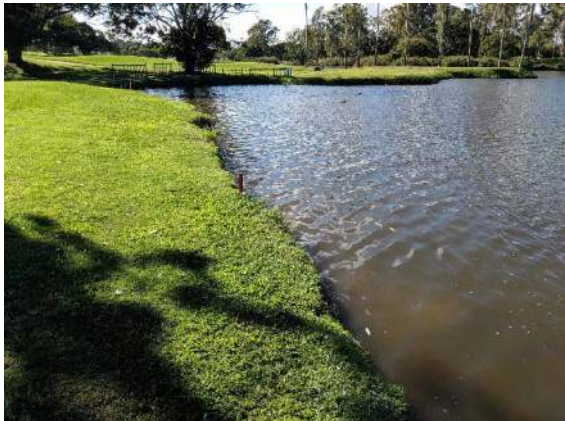
Edge Type	Comments/notes	Photo
Gentle batter +/- sharp drop off into shallow water	Generally >1:3 batter slope, mown grassed edge +/- sharp drop off into shallow (<0.3m) water. Moderate risk but shallow depth of water means exiting is fine. <u>Safe</u>

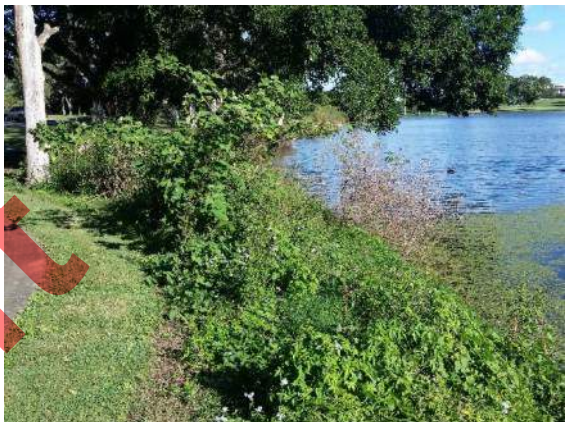
Gentle batter +/- sharp drop off into deep water	Generally >1:3 batter slope, mown grassed edge +/- sharp drop off into deep (>0.3m) water. High risk as deep depth of water means exiting may be difficult. <u>Potentially Hazardous.</u>

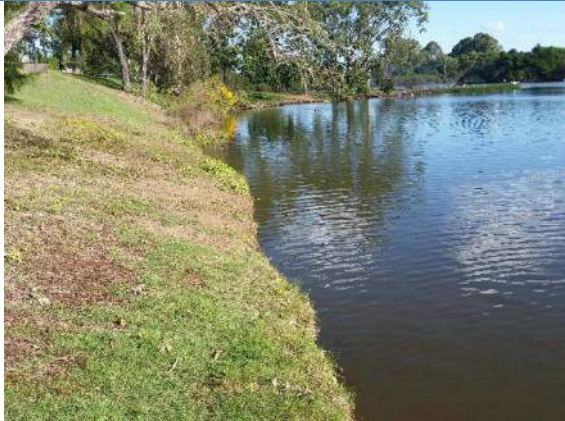
Steep batter +/- sharp drop off shallow water	Generally <1:3 batter slope, +/- sharp drop off into shallow (<0.3m) depth water. Moderate risk but steep batter slope may make it very difficult to exit the water (and easy to fall back in). High drowning risk <u>Potentially Hazardous</u>

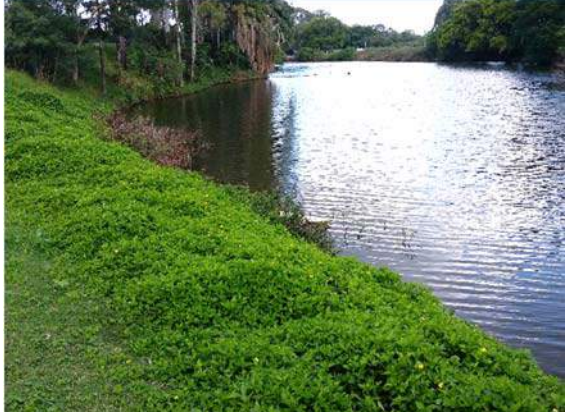
Steep batter +/- sharp drop off deep water	Generally <1:3 batter slope, +/- sharp drop off into deep (>0.3m) water. High risk as steep batter slope and deep depth of water means exiting is extremely difficult (and easy to fall back in). High drowning risk <u>Hazardous</u>

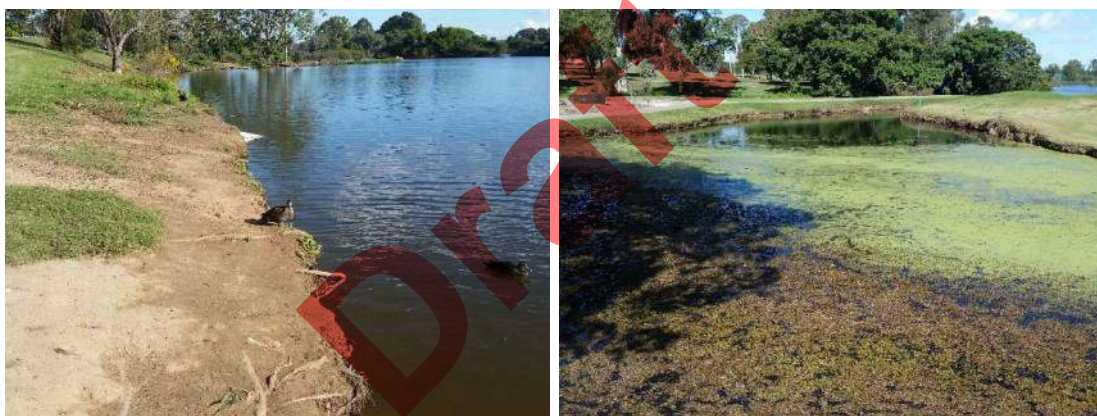
The majority of the publicly accessible edges in Ululah Lagoons (adjacent to Anzac Park), comprise of either mown grass or a vegetated buffer. In most locations, wave action or waterbird activity has resulted in minor scour and the development of shallow vertical edges (Figure 4-2). These edges are relatively stable but are susceptible to further instability due the presence of the bare soils along the exposed edges.

Figure 4-2 Minor scour present below grassed edges creating shallow vertical edge.

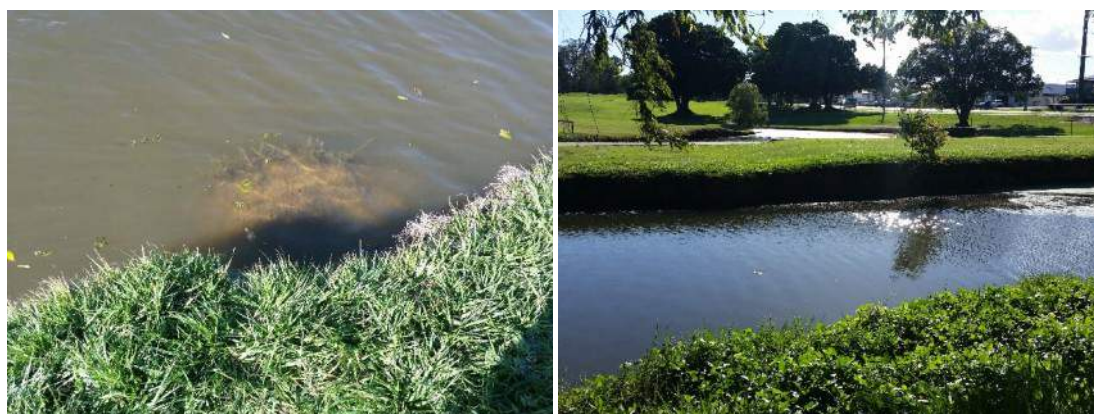
The waterbody edges adjacent to the golf course are grassed and vary in slope from a gentle batter slope to the water's edge to steep vertical drop-offs. The presence of rock protection below the water surface in most cases renders the edges reasonably safe. There are several sections where localised erosion of the waterbody edge has occurred resulting in slumping and the creation of vertical edges Figure 4-3.

Figure 4-3 Localised edge erosion occurring adjacent to the golf course near the inlet to Ululah Lagoon.

MED	Ululah Lagoon	<u>Edge stability</u> B6 – Scour of batters/edges	<ul style="list-style-type: none"> - Stabilize vertical edges to inlet channel and areas adjacent to the golf course. 	<ul style="list-style-type: none"> - Improved edge stability 	<ul style="list-style-type: none"> - None
MED	All waterbodies	<u>Waterbody edge vegetation</u> E1 – Batter/edge vegetation E2 – Terrestrial weeds	<ul style="list-style-type: none"> - Remove declared weed species (priority) - Remove weeds species (focusing on unsafe edges) - Re-establish native vegetation 	<ul style="list-style-type: none"> - Removal of introduced plant species. - Removal of waterbird nesting habitat (i.e. Broad-leaved pepper trees). - Establishment of native vegetated buffers adjacent to unsafe edges – increased public safety. - Establishment of barriers to limit waterbird access to feeding areas. - Increased amenity. 	<ul style="list-style-type: none"> - Temporary loss of vegetation cover in some areas.

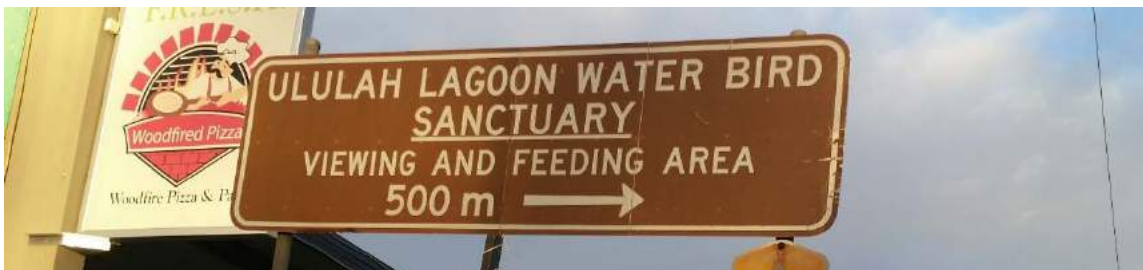
Figure 4-6 Information sign on Alice St promoting the feeding of waterbirds within Anzac Park.

- Remove or modify the signage present on Alice St which promotes waterbird feeding areas within Anzac Park.
- Install signage in the primary bird feeding areas to discourage feeding. An example of signage that could be erected in these areas is illustrated in Figure 5-1.
- Implementing phased removal of Broad-leaved Pepper trees from the margins of the Ululah Lagoons system (and island) will effectively reduce waterbird nesting habitat. Where practical, Broad-leaved Pepper trees should be replaced with native tree species with low nesting habitat potential such as Melaleucas and Eucalypts.
- Establish vegetated barriers to prevent the waterbirds from accessing the main feeding areas within Anzac Park and to limit roosting and loafing areas within Anzac Park.

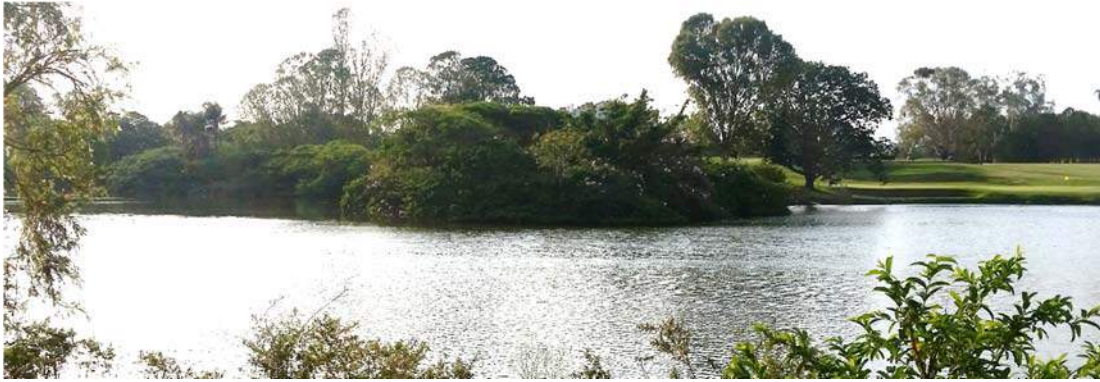
Figure 4-7 Ibis rookery present on the island adjacent to the Golf Clubhouse.

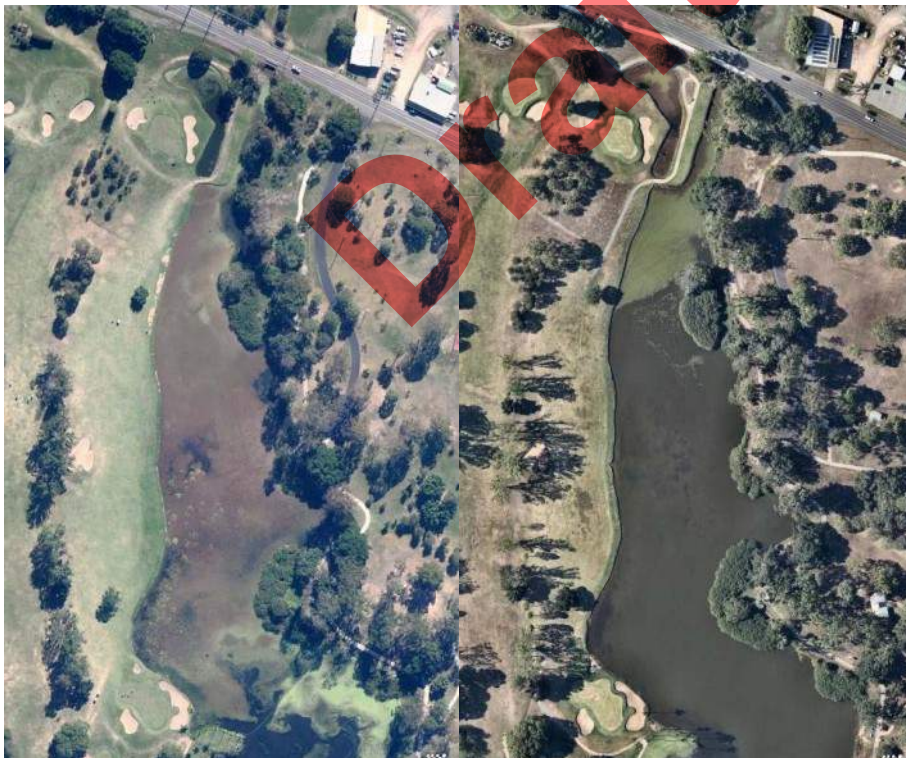
Declared weeds - A number of declared aquatic weeds were observed during the waterbody condition audit including: *Salvinia molesta*, *Cabomba caroliana* and *Hygrophila costata*. A declared terrestrial species, Broad-leaved Pepper tree, was also observed growing throughout the Ululah Lagoons system. Discussion with Council staff and a review of historical aerial imagery indicates that growth of *Salvinia* regularly occurs within all of the waterbodies, and is an ongoing management issue (Figure 4-8).

Figure 4-8 Historical aerial imagery indicating *Salvinia* blooms present within Ululah Lagoons in: a) 2010, and b) 2019.

The growth of *Salvinia* represents a management issue that requires ongoing Council funding and resources. It is recommended that a long term strategy is developed to control *Salvinia* growth within the Ululah Lagoons system. The strategy should adopt a multi-faceted approach to controlling *Salvinia* growth including:

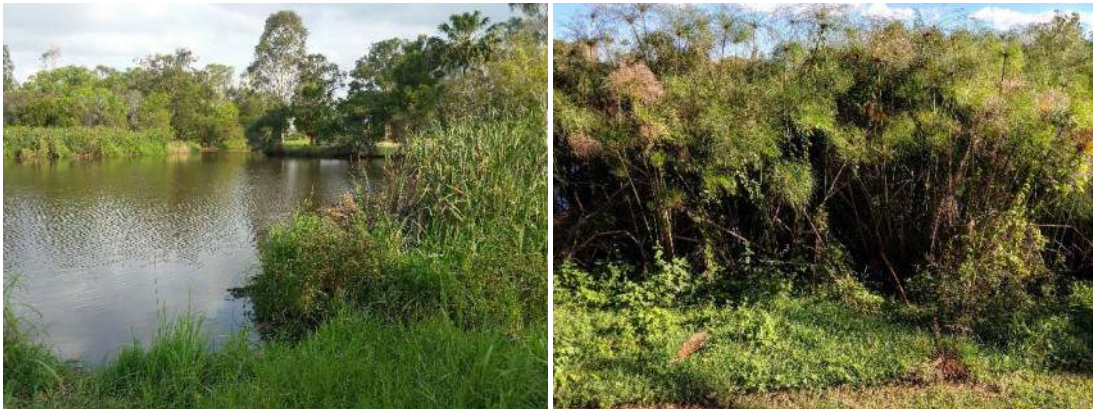
Figure 4-9 Examples of emergent waterplants growing on the edges of Ululah Lagoons system: a) *Typha* sp. (foreground) *Phragmites australis* (background), and b) *Cyperus papyrus*.

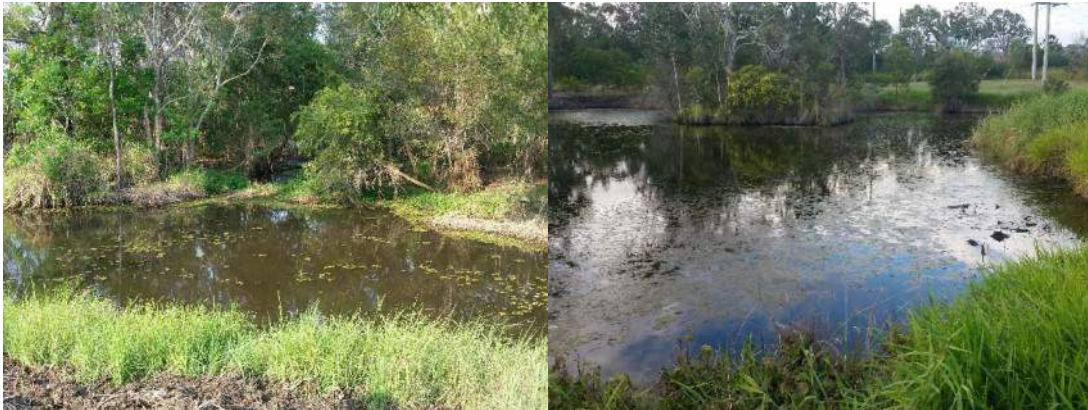
Figure 4-10 Backwater areas present within: a) Waterbody A, and b) Waterbody B

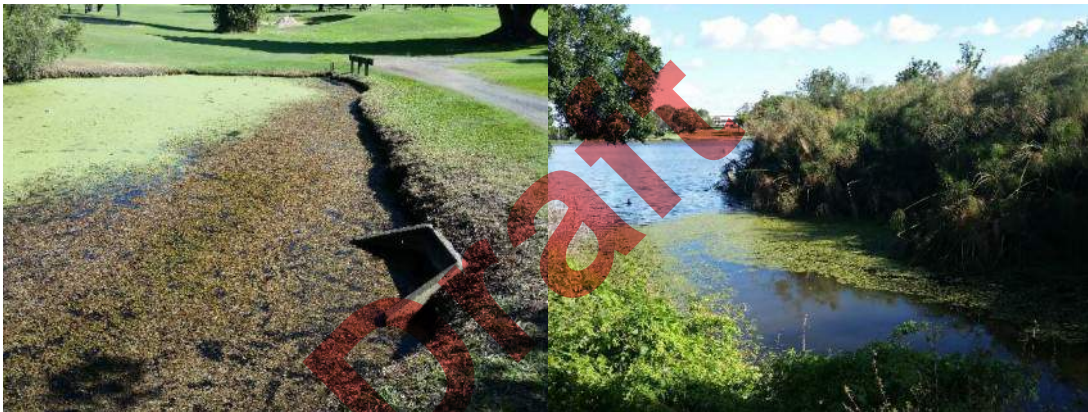
can occur. This includes the enclosed lagoons within the golf course adjacent to the waterbody inlet, inlet channel areas upstream and downstream of Alice St, and areas associated with the large stands of Papyrus within Ululah Lagoons (Figure 4-11).

Figure 4-11 Backwater areas present within Ululah Lagoon: a) Enclosed lagoons within the golf course, and b) Areas within and adjacent to the Papyrus stands (act as incubators for algae and floating waterplants).
