Geotechnical Investigation Report R19000

Poona Boat Ramp Upgrade Project

April 2019

Poona Boat Ramp Upgrade Project - Geotechnical Investigation

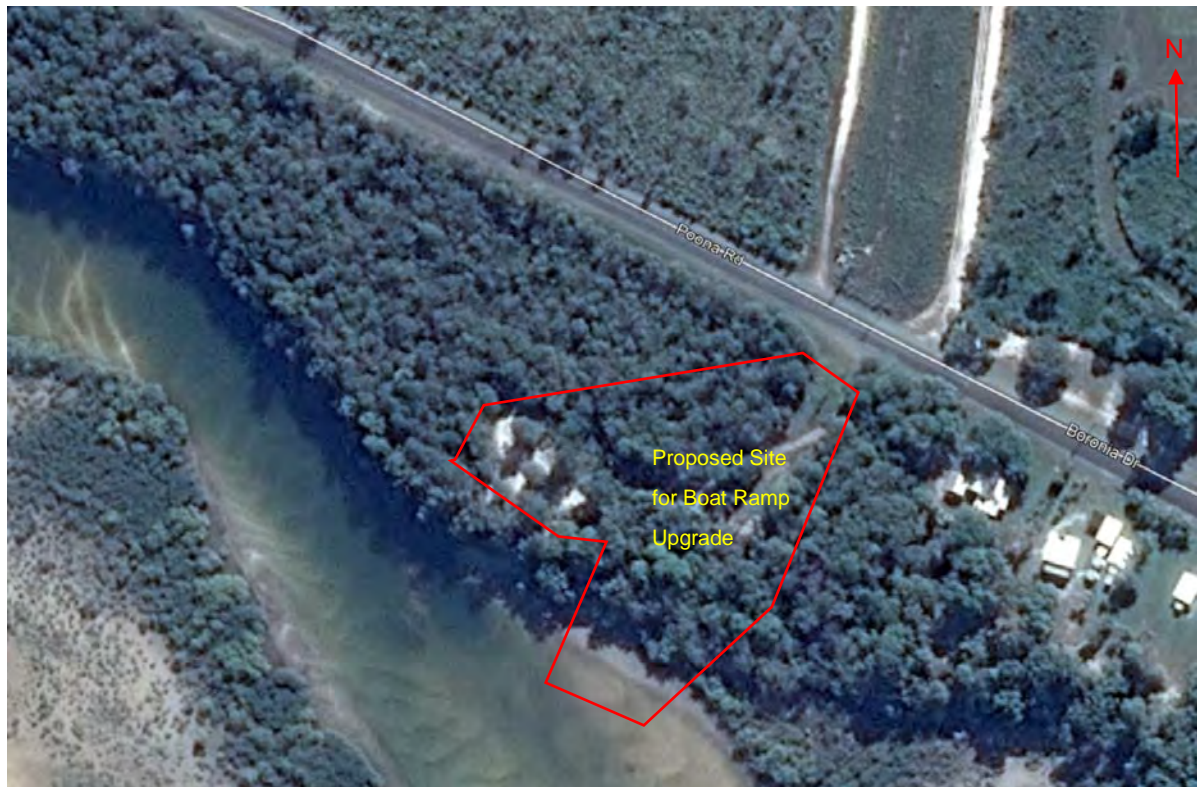
Figure 1 – Poona Boat Ramp Upgrade Project Site

The development is proposed on a currently vacant site, bound by Poona Rd / Boronia Dr to the north, a tidal estuary to the south, vegetation to the north-west and south-east, as well as residents to the west along Boronia Drive. The proposed upgrade site also includes a pre-existing overhead power easement, which trends in a north-east to south-westerly direction. Figure 1 below shows an aerial view of the site.

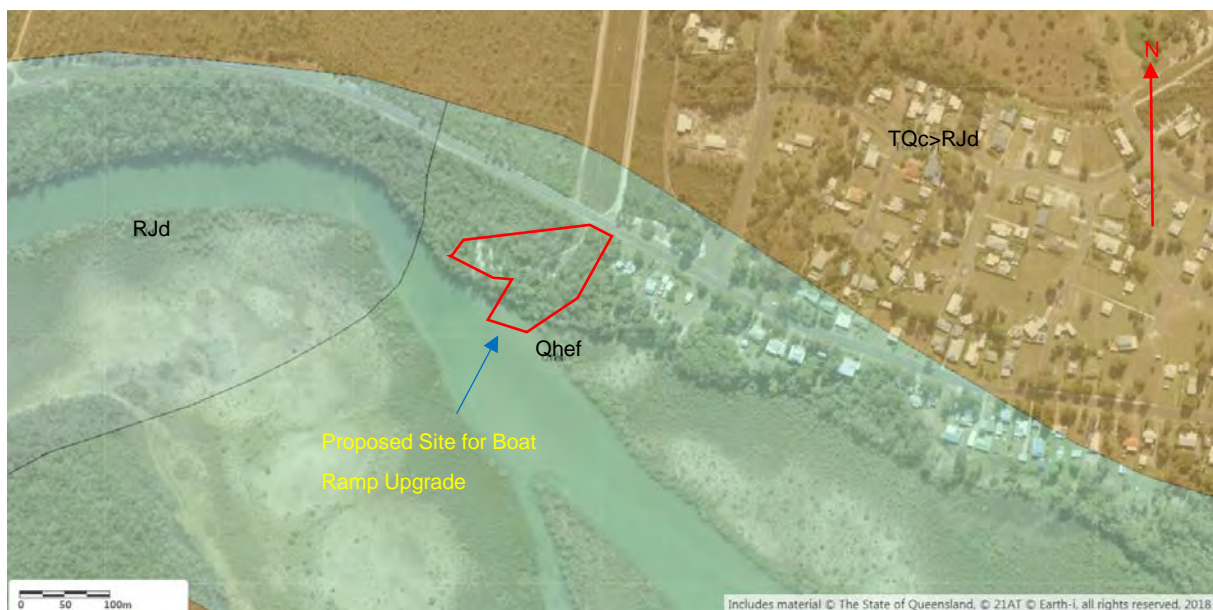
Figure 2 – Published Geology near Poona Boat Ramp Upgrade Project Site

Figure 2 shows the published geology near the proposed upgrade site.

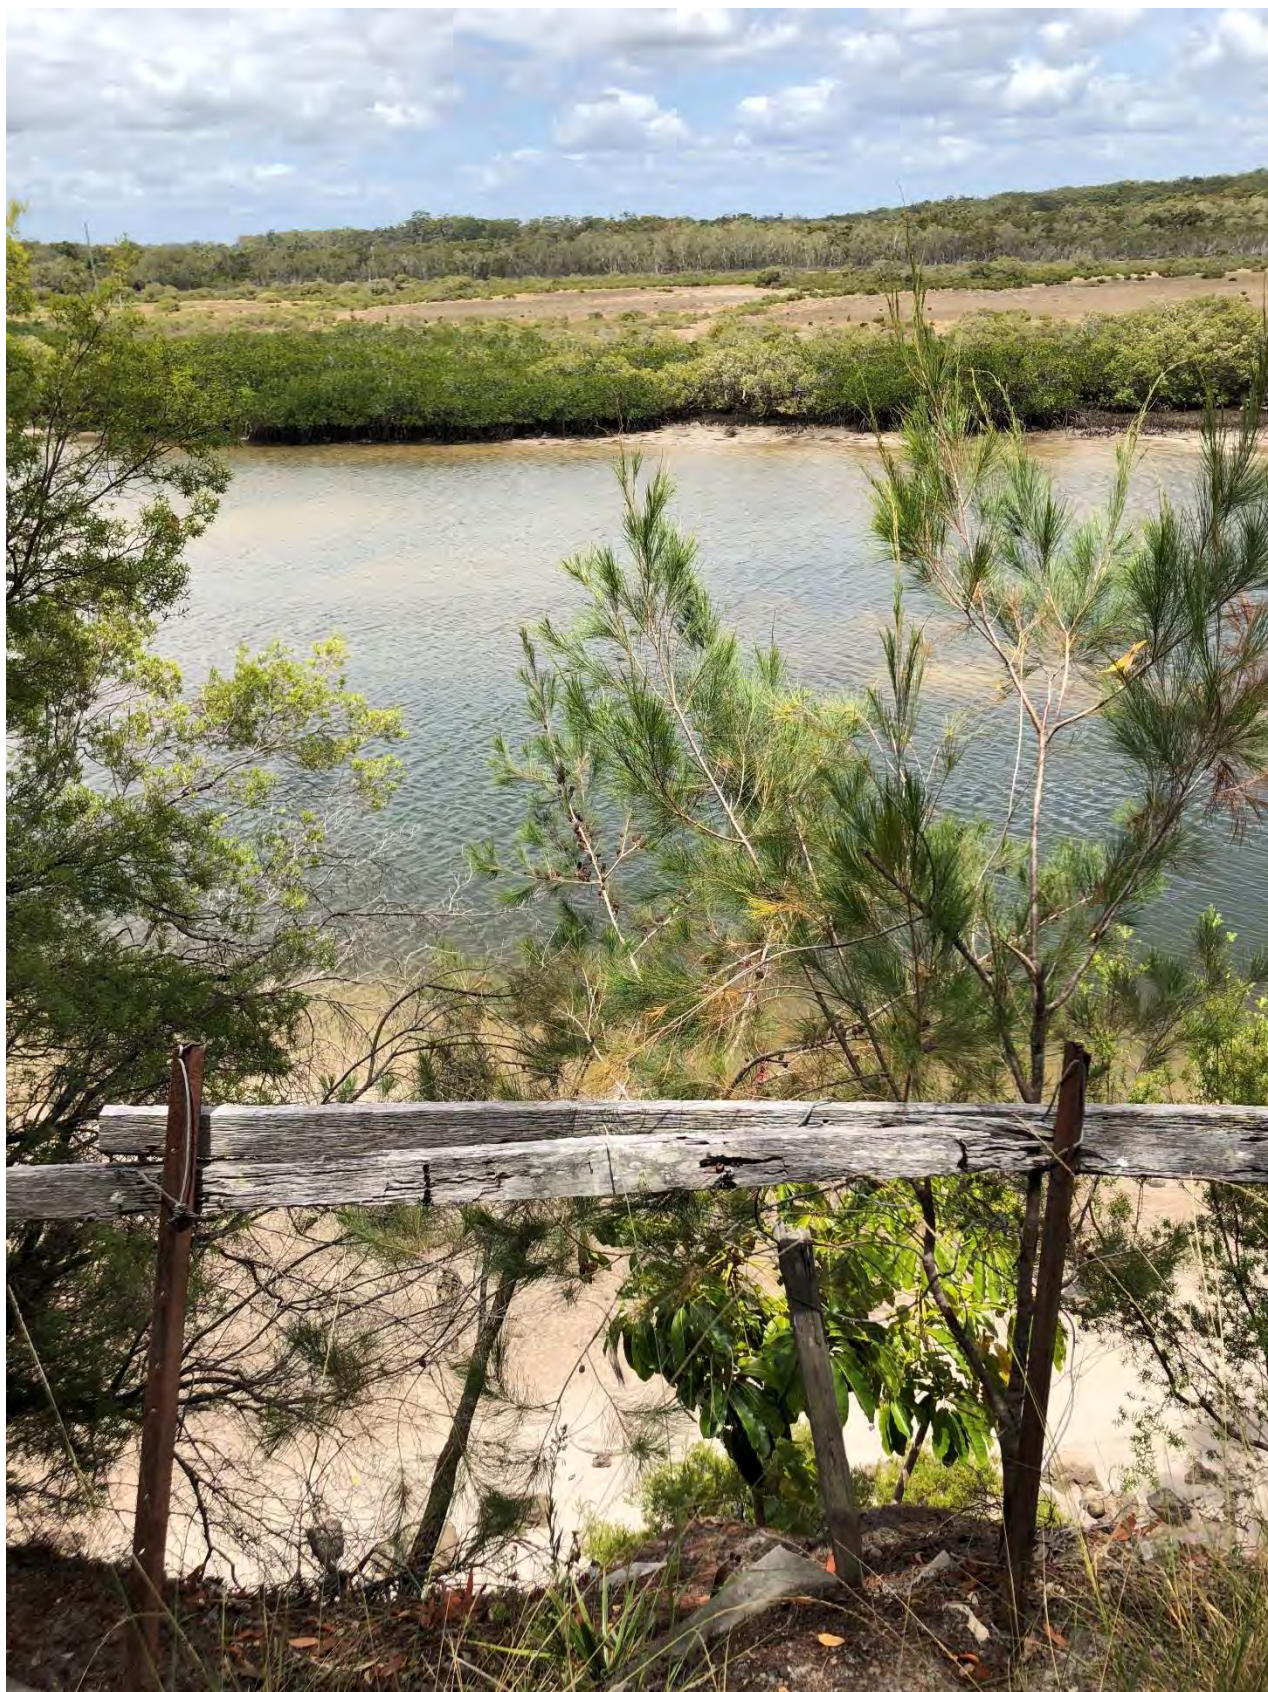
View looking south-west from the approximate location of TP01.

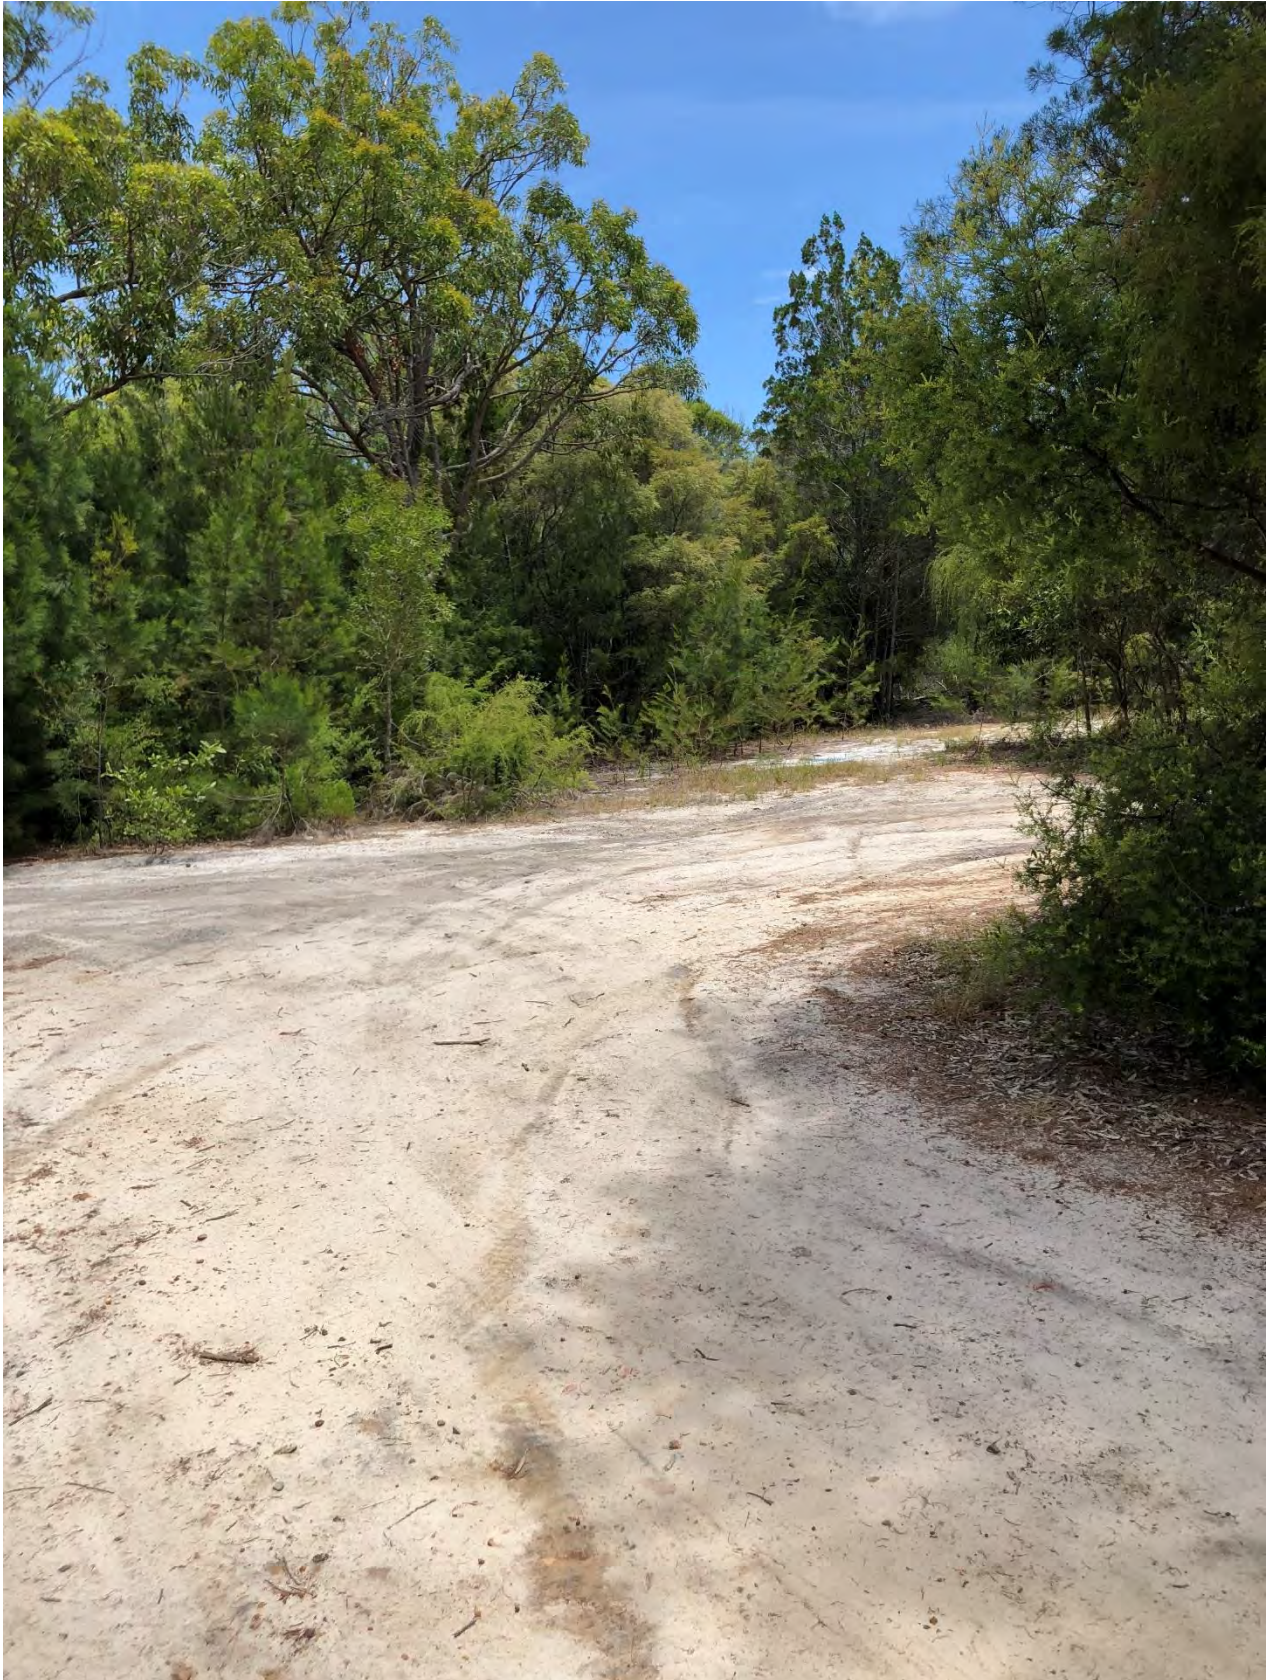
View looking west from the approximate location of TP03.

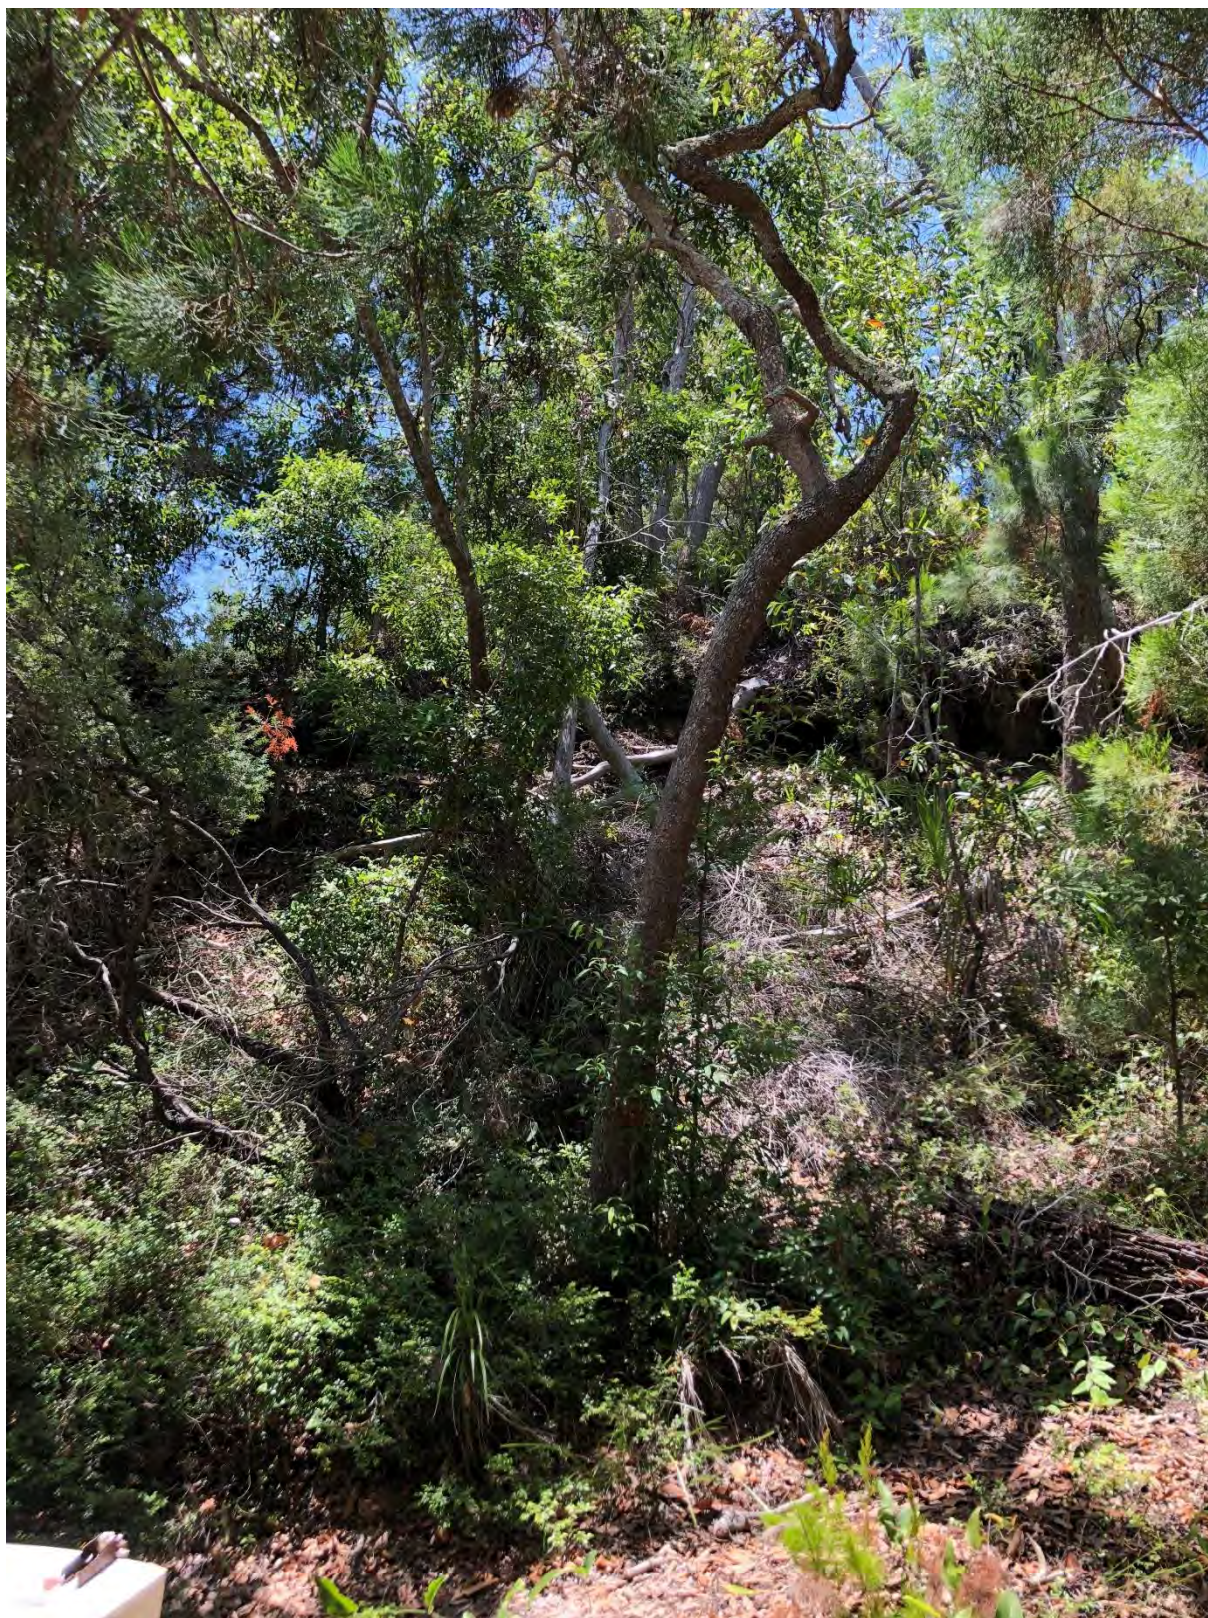
View looking east towards test locations AH05 & AH06.

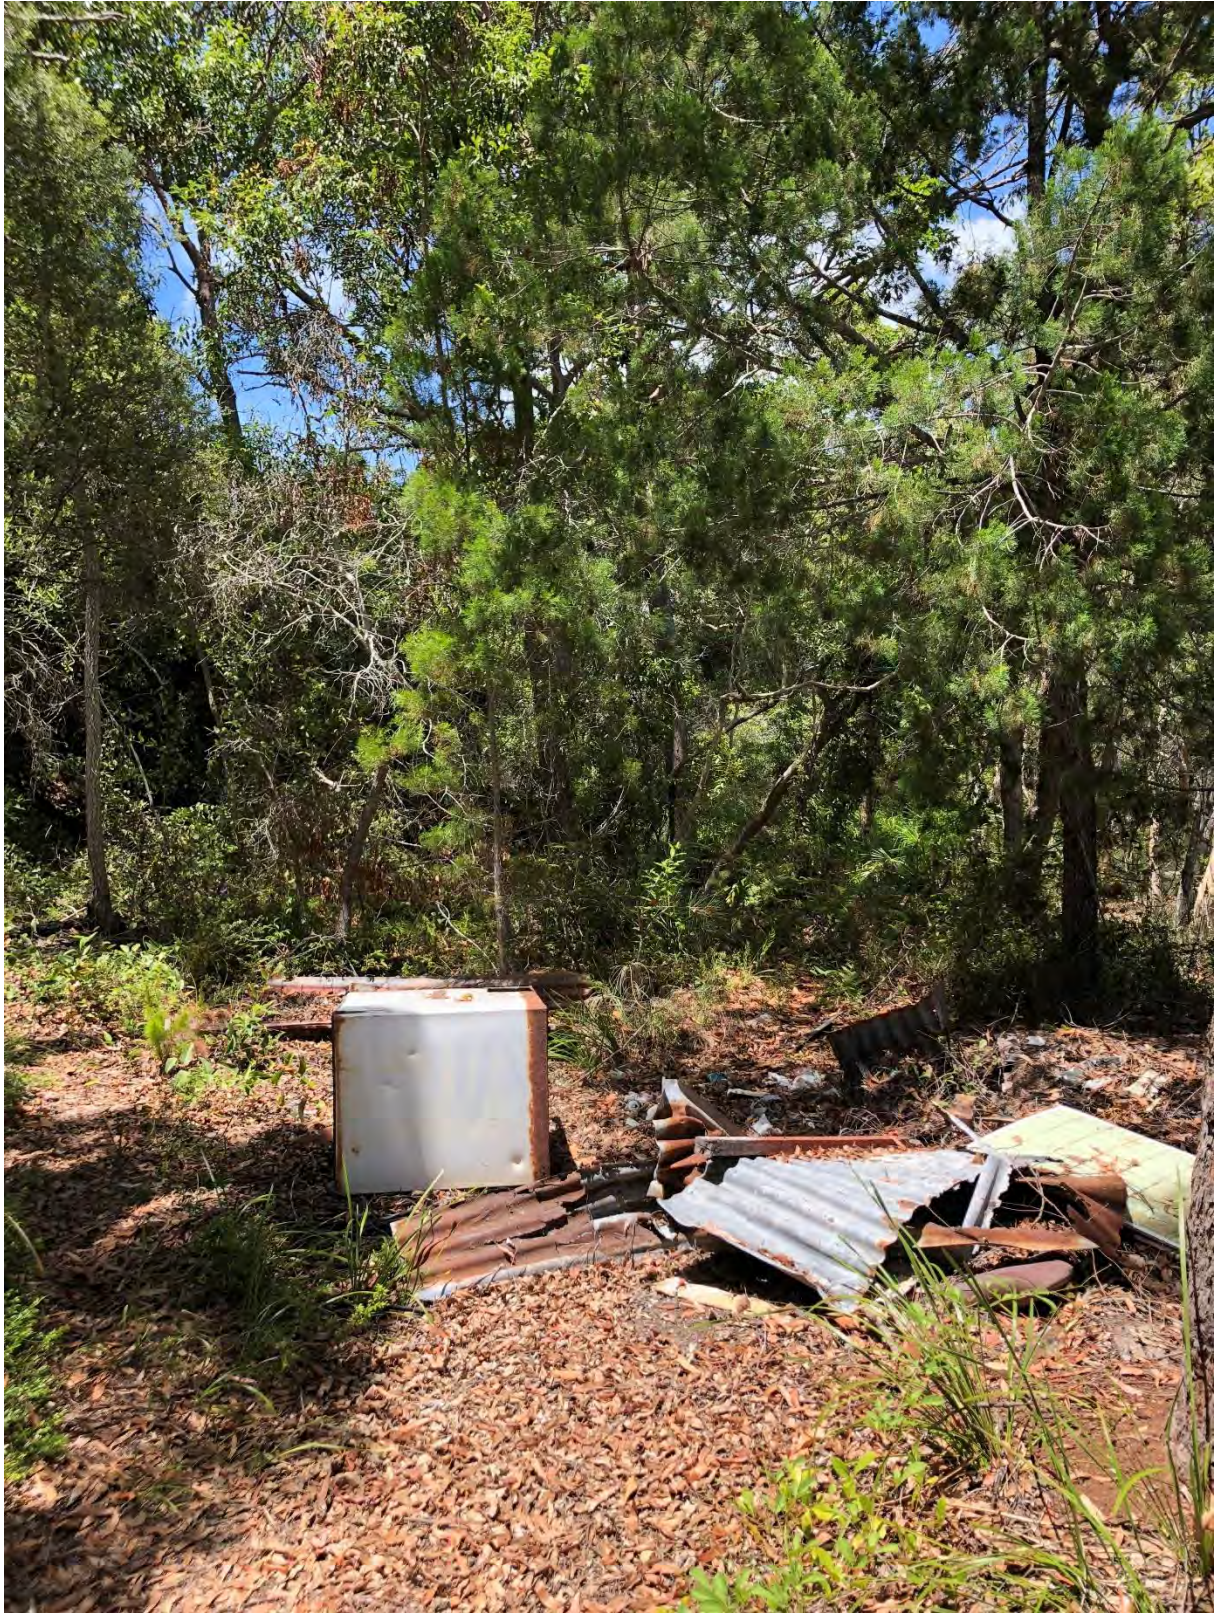
View from lower level in vicinity of AH06, looking in the westerly direction towards rubbish on site.

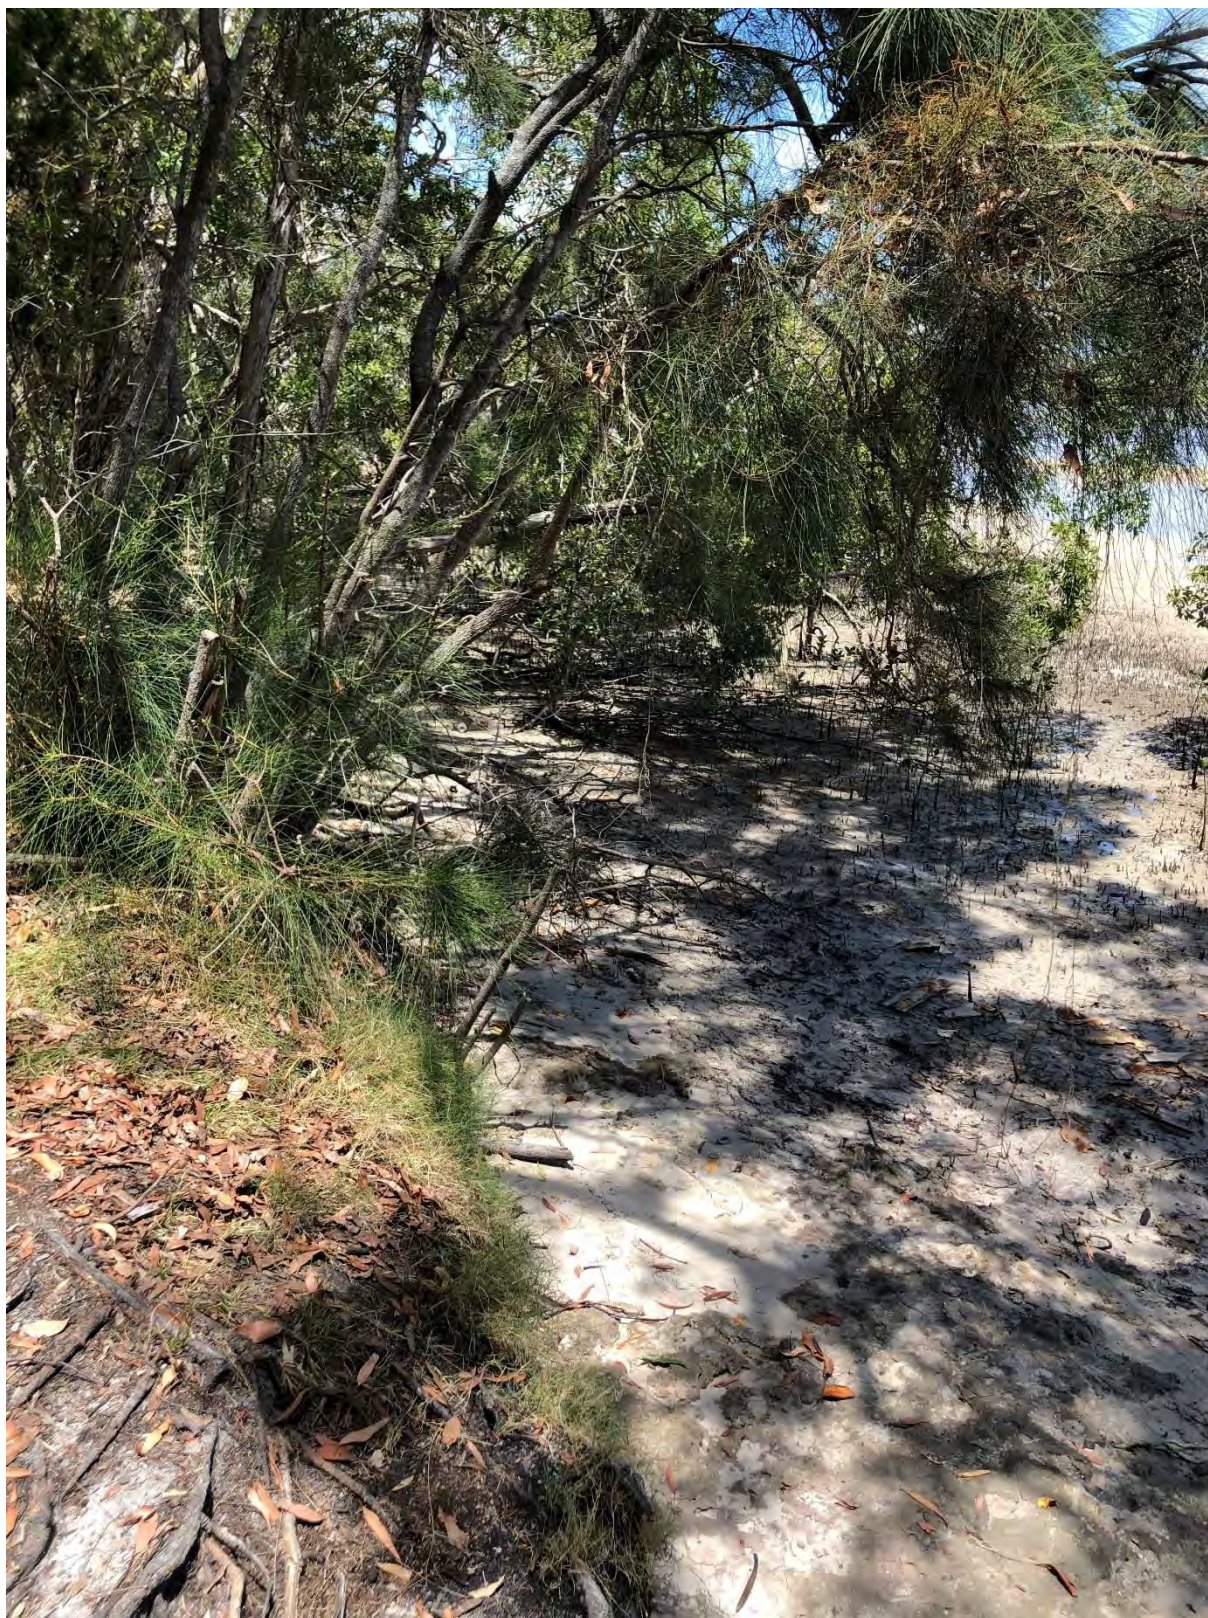
View from the lower level looking south-east along the tidal zone.

The lower level of the site is likely prone to flooding during king tide conditions.

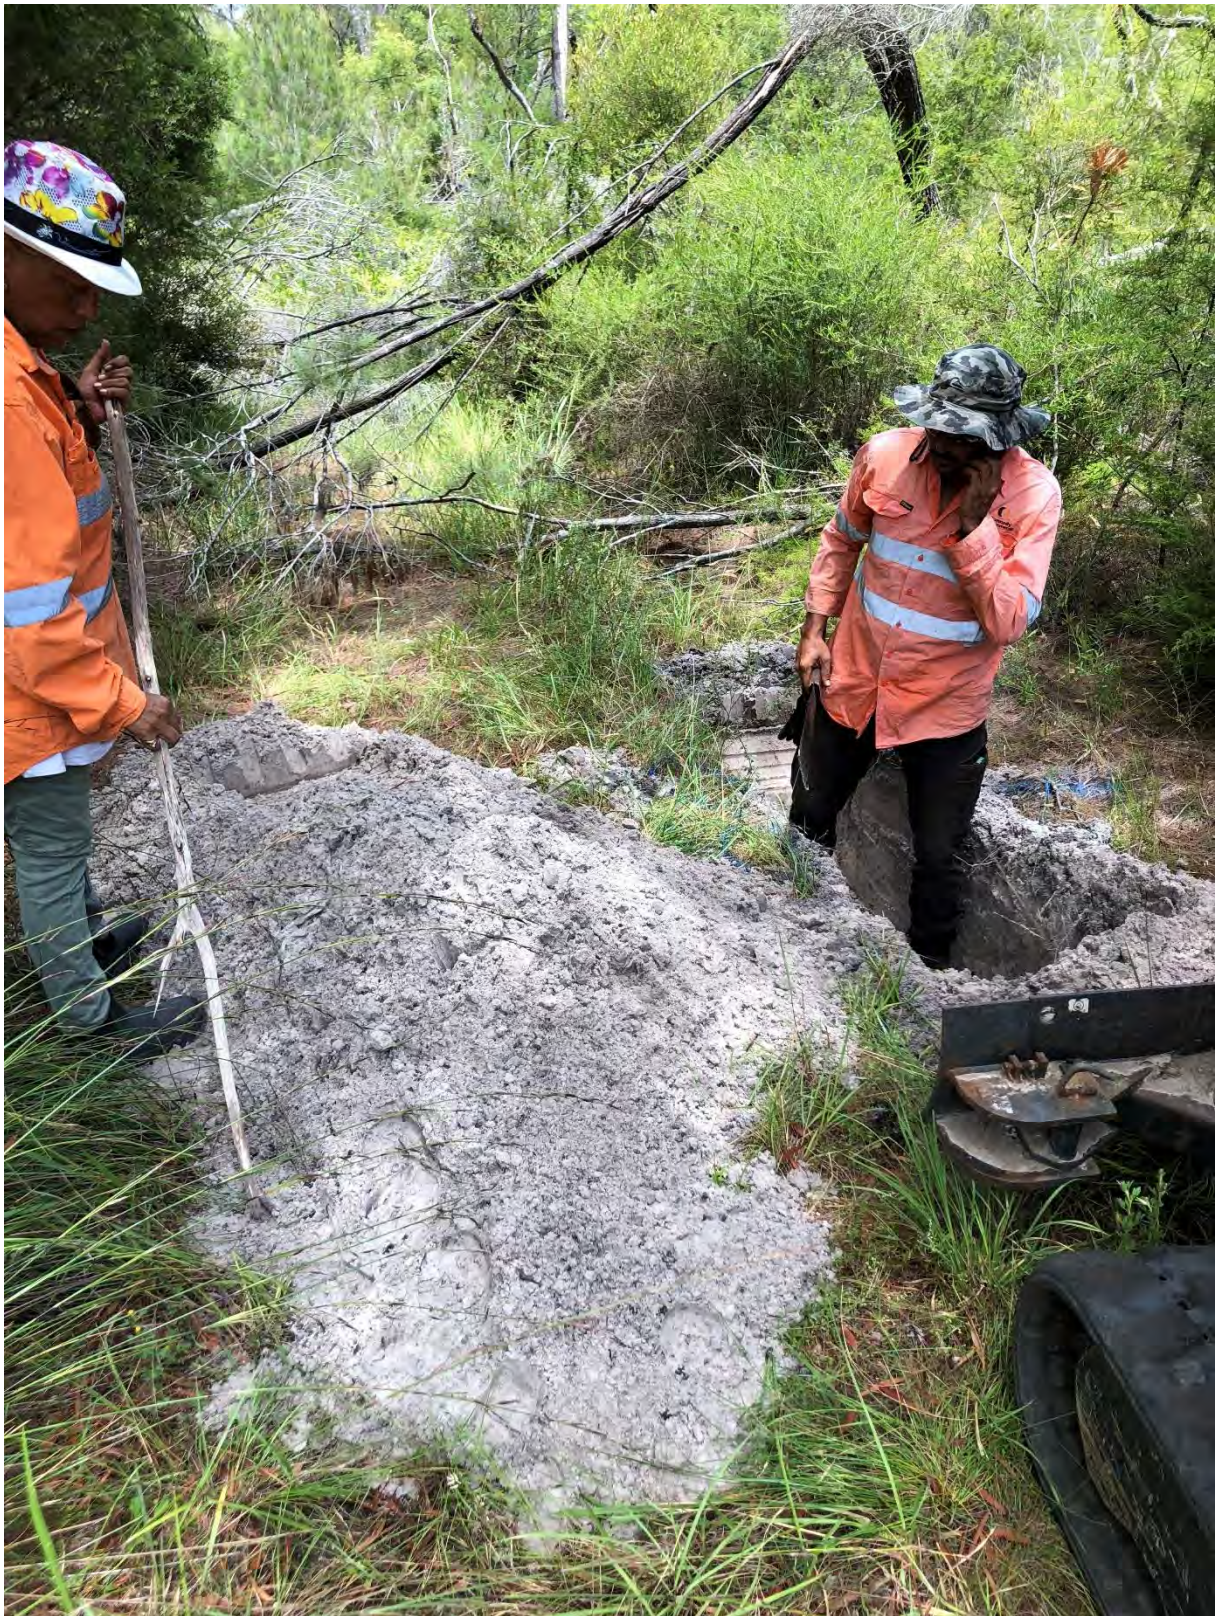
Image shows TP07 being carried out with the assistance of Cultural Heritage monitors.

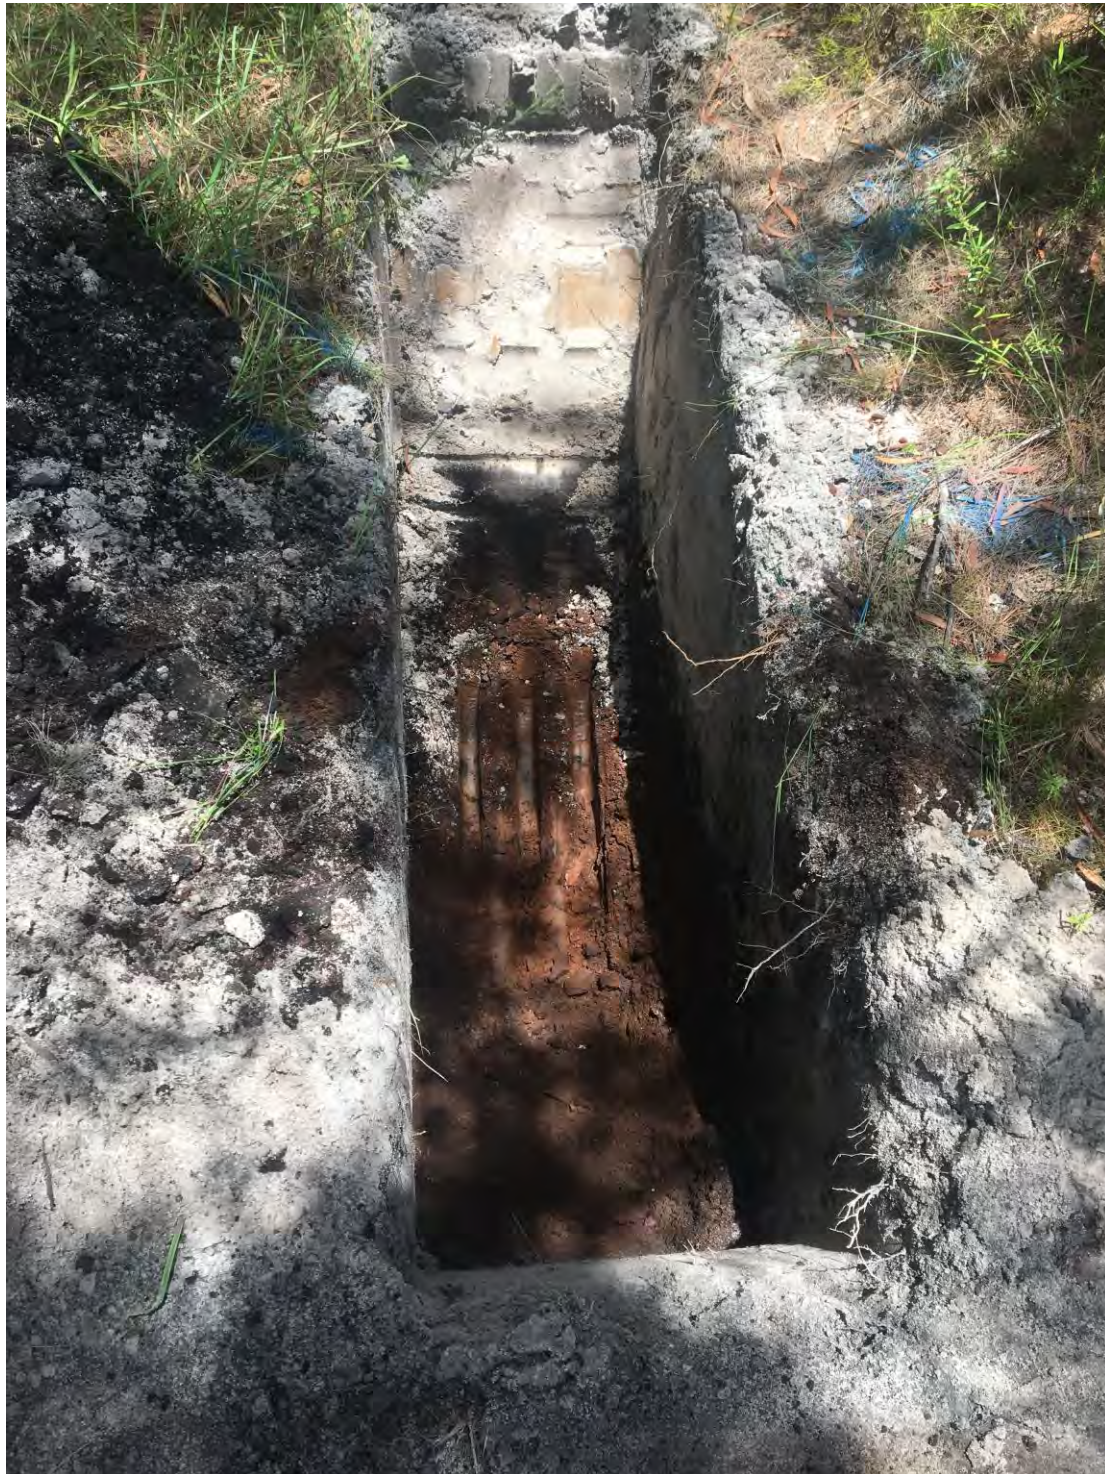
Project Name	Poona Boat Ramp		
Project No.	FG6644	Date	14/03/19
Test Pit No.	TP07	Reference No.

Photograph 1: Test pit profile

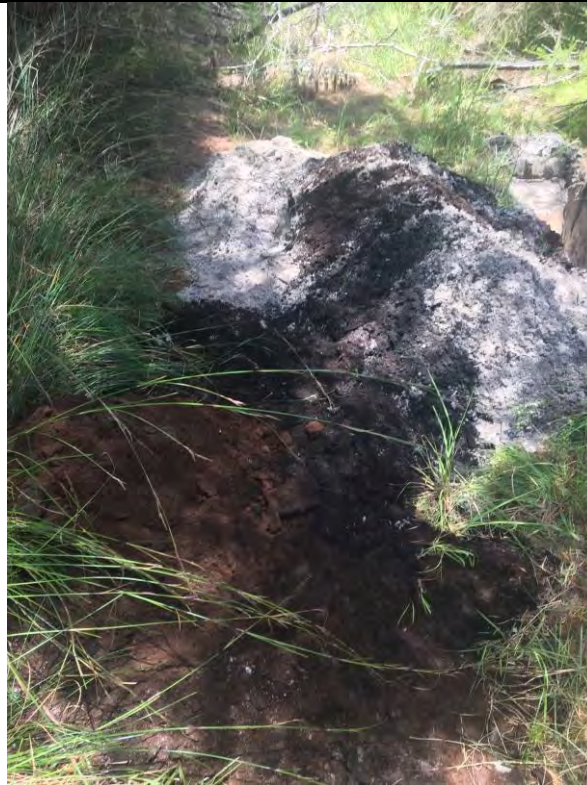
Photograph 2: Excavated Materials

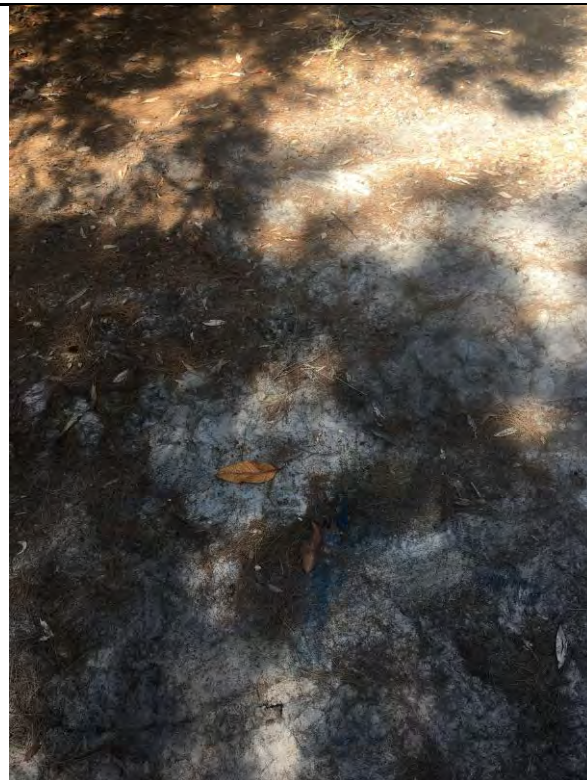
Photograph 3: Site After Excavation

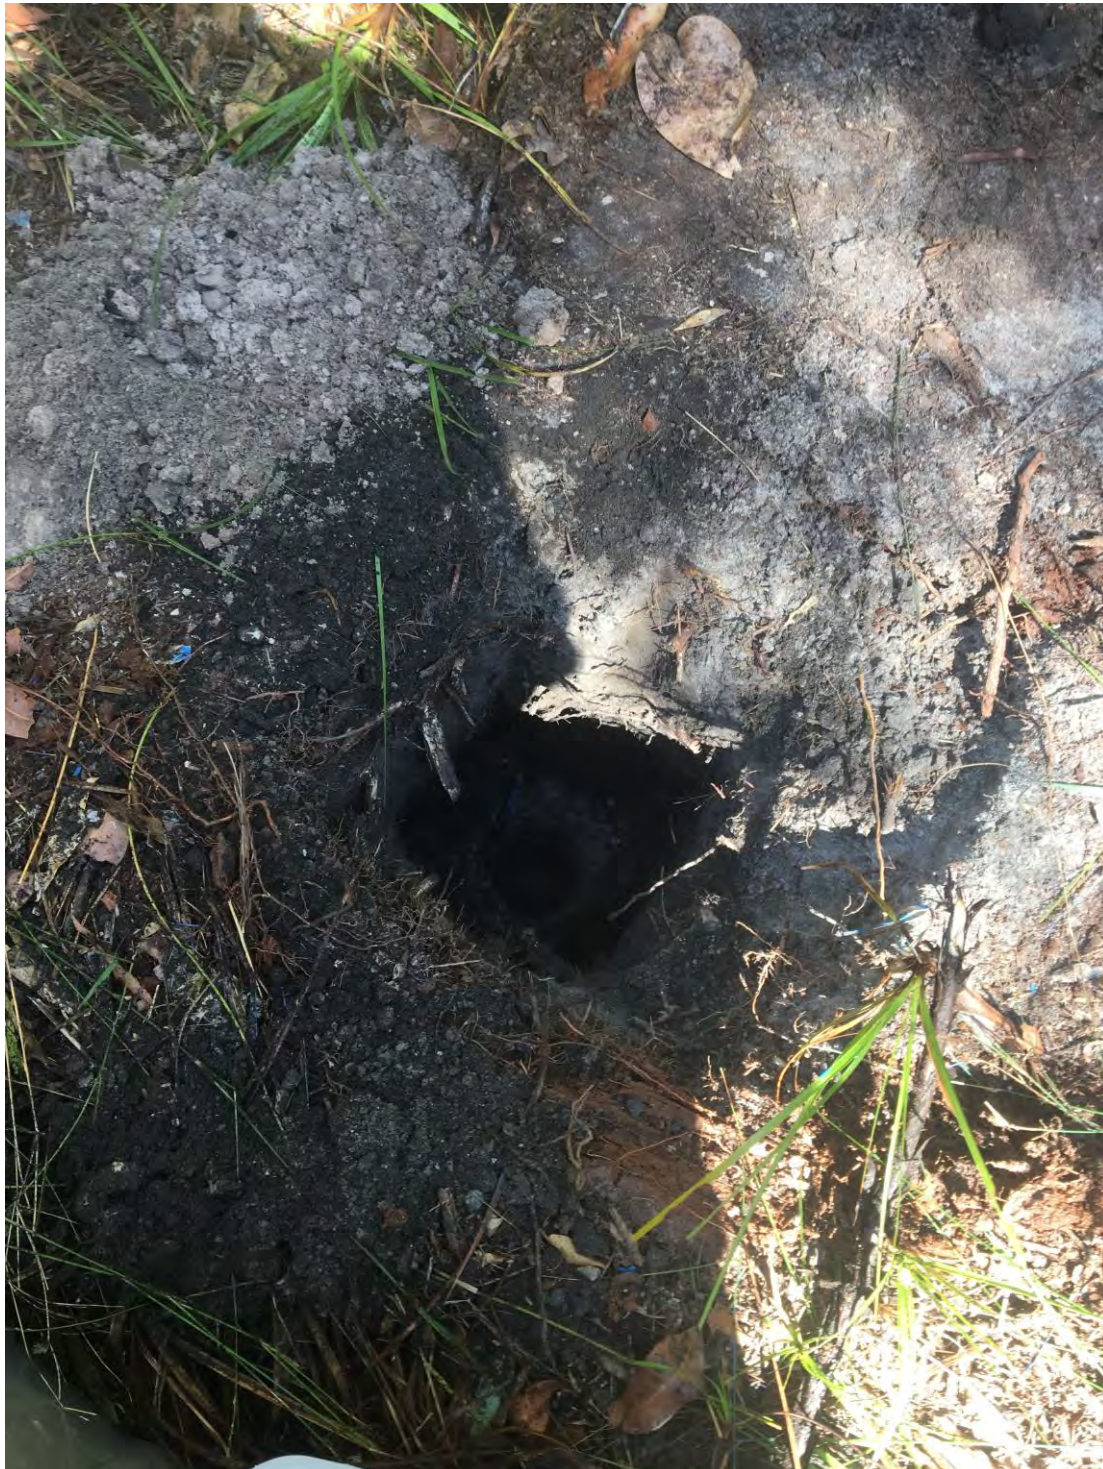
Project Name	Poona Boat Ramp		
Project No.	FG6644	Date	12/03/19
Test Pit No.	AH06	Reference No.

Photograph 1: Test pit profile

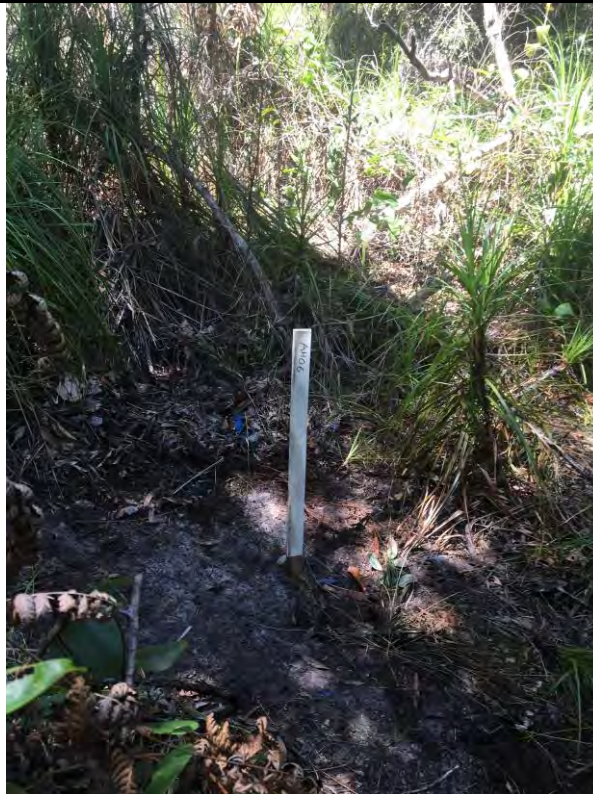
Photograph 2: Site photograph after excavation

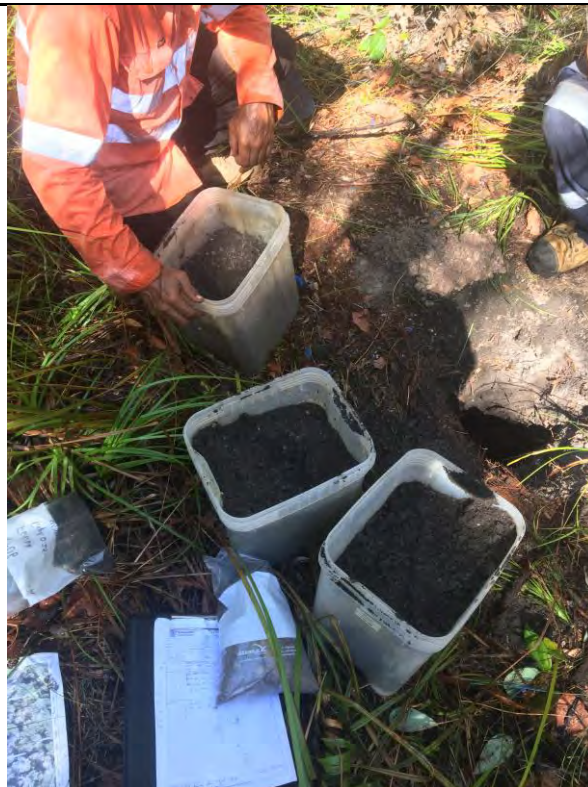
Photograph 3: Excavated materials

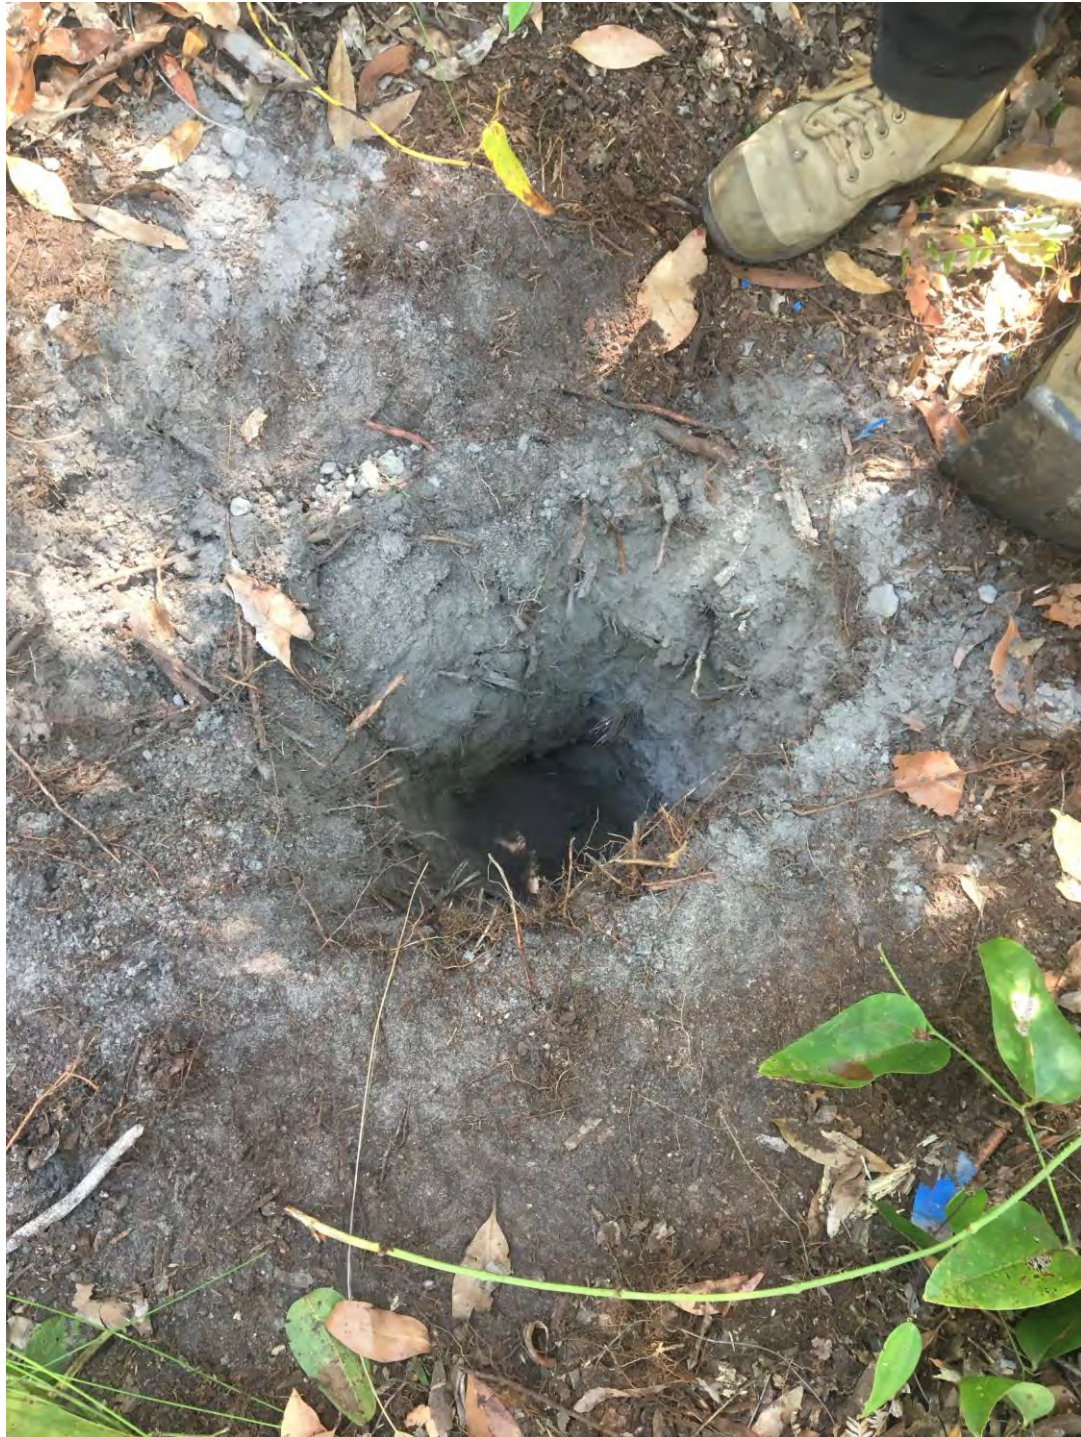
Project Name	Poona Boat Ramp		
Project No.	FG6644	Date	12/03/19
Test Pit No.	AH05	Reference No.

Photograph 1: Test pit profile

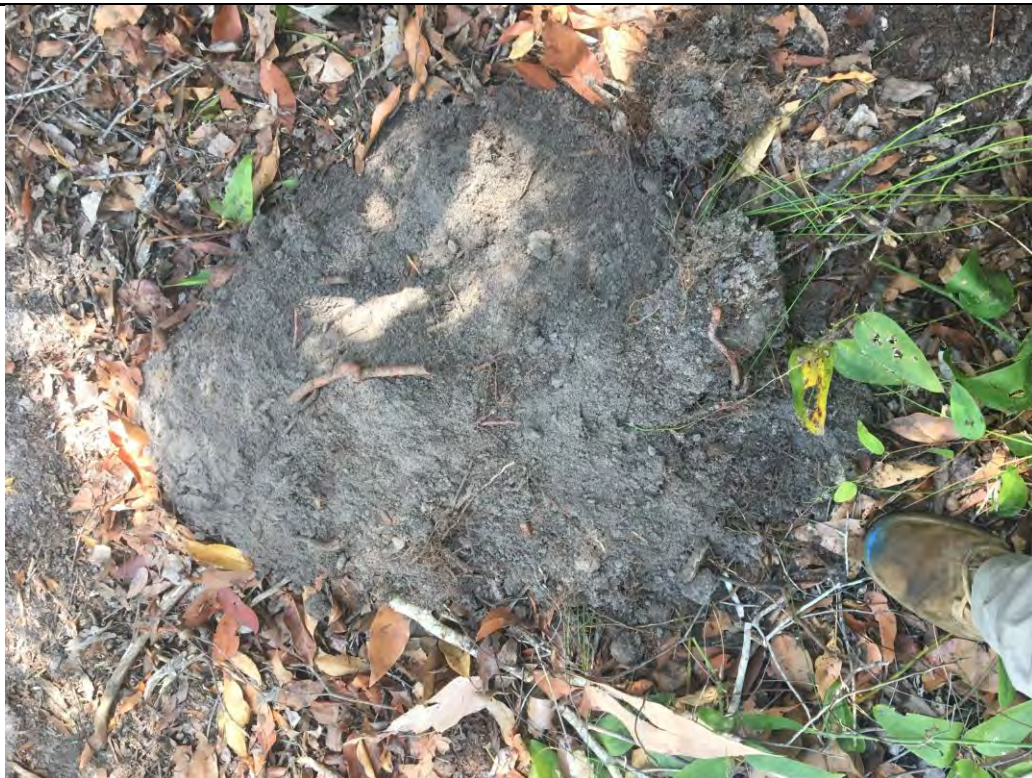
Photograph 3: Excavated materials

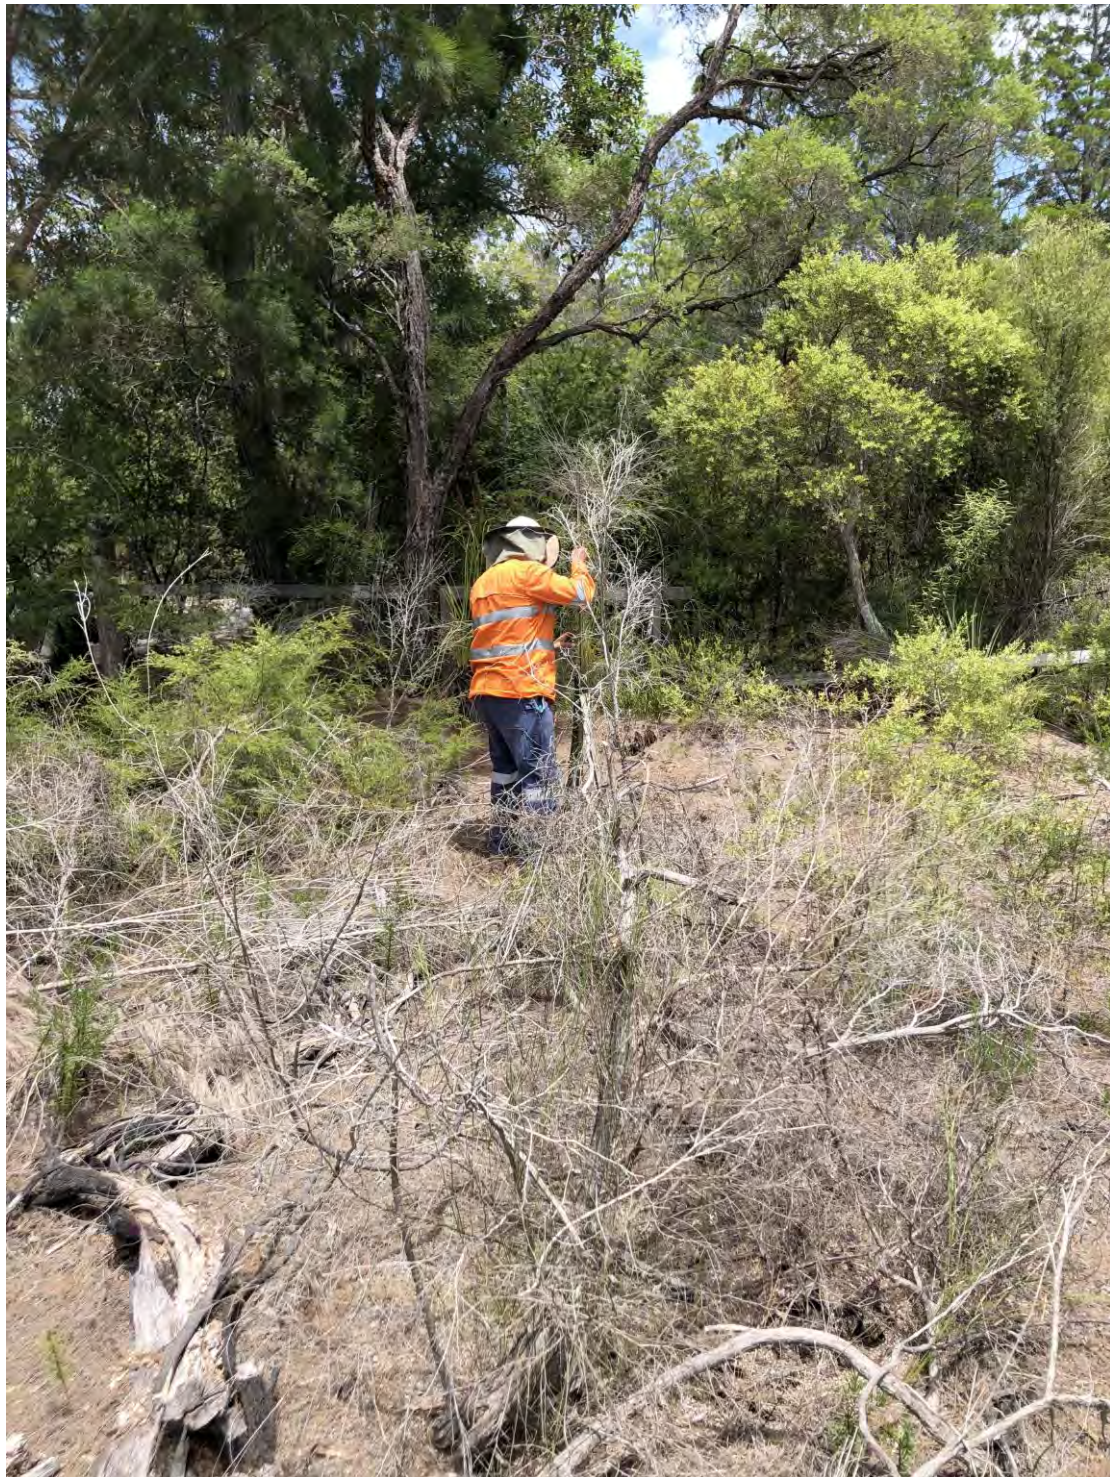
Project Name	Poona Boat Ramp		
Project No.	FG6644	Date	12/03/19
Test Pit No.	TP04	Reference No.

Photograph 1: TP4 Location
