Geotechnical Investigation Report R19000

Poona Boat Ramp Upgrade Project

April 2019

Poona Boat Ramp Upgrade Project - Geotechnical Investigation

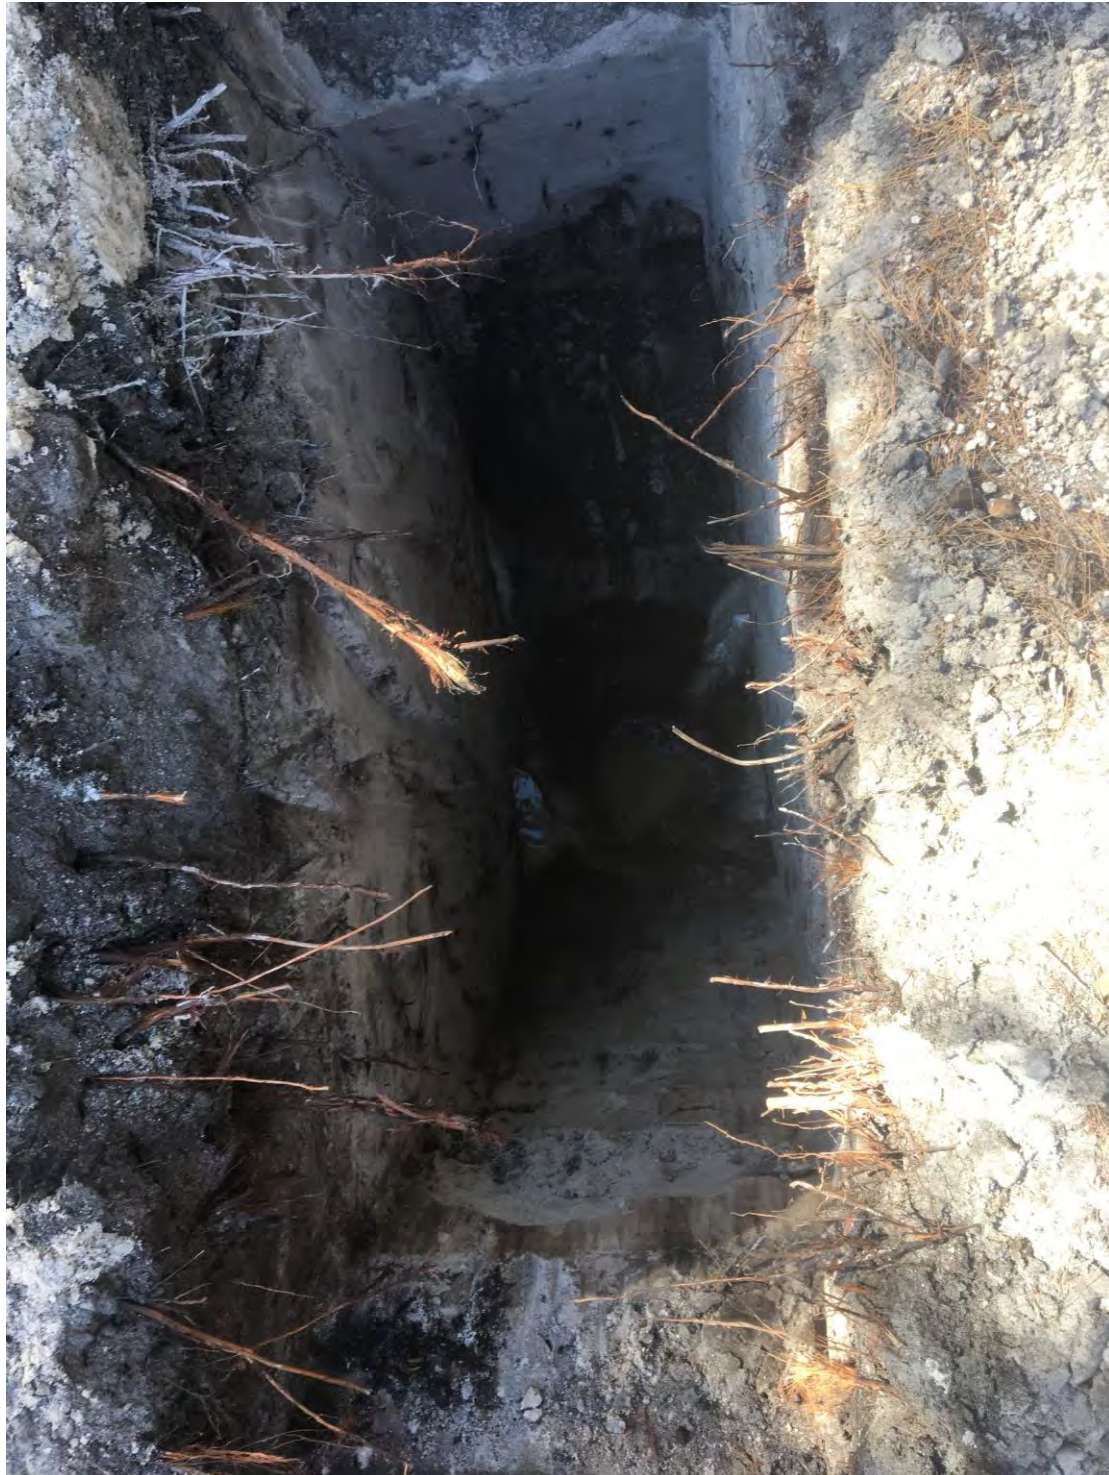
Project Name	Poona Boat Ramp		
Project No.	FG6644	Date	12/03/19
Test Pit No.	TP03	Reference No.

Photograph 1: Test pit profile

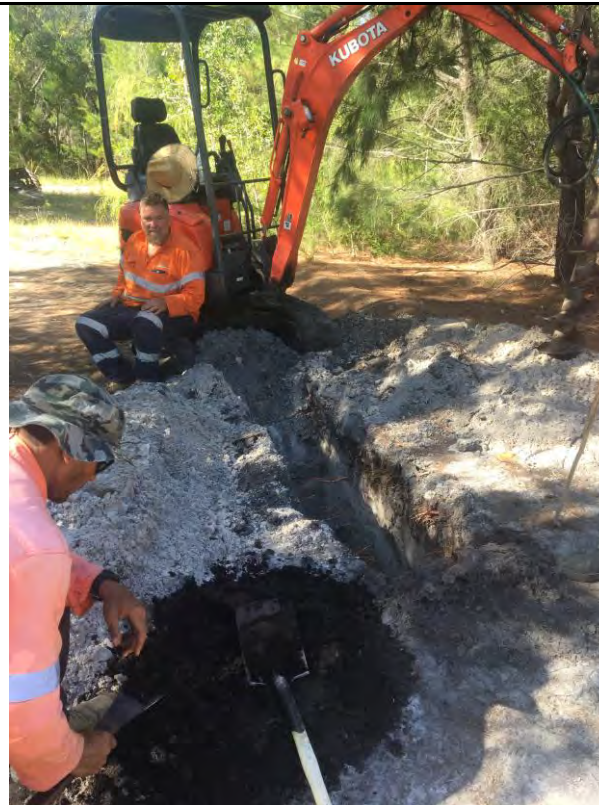
Photograph 2: Excavated materials

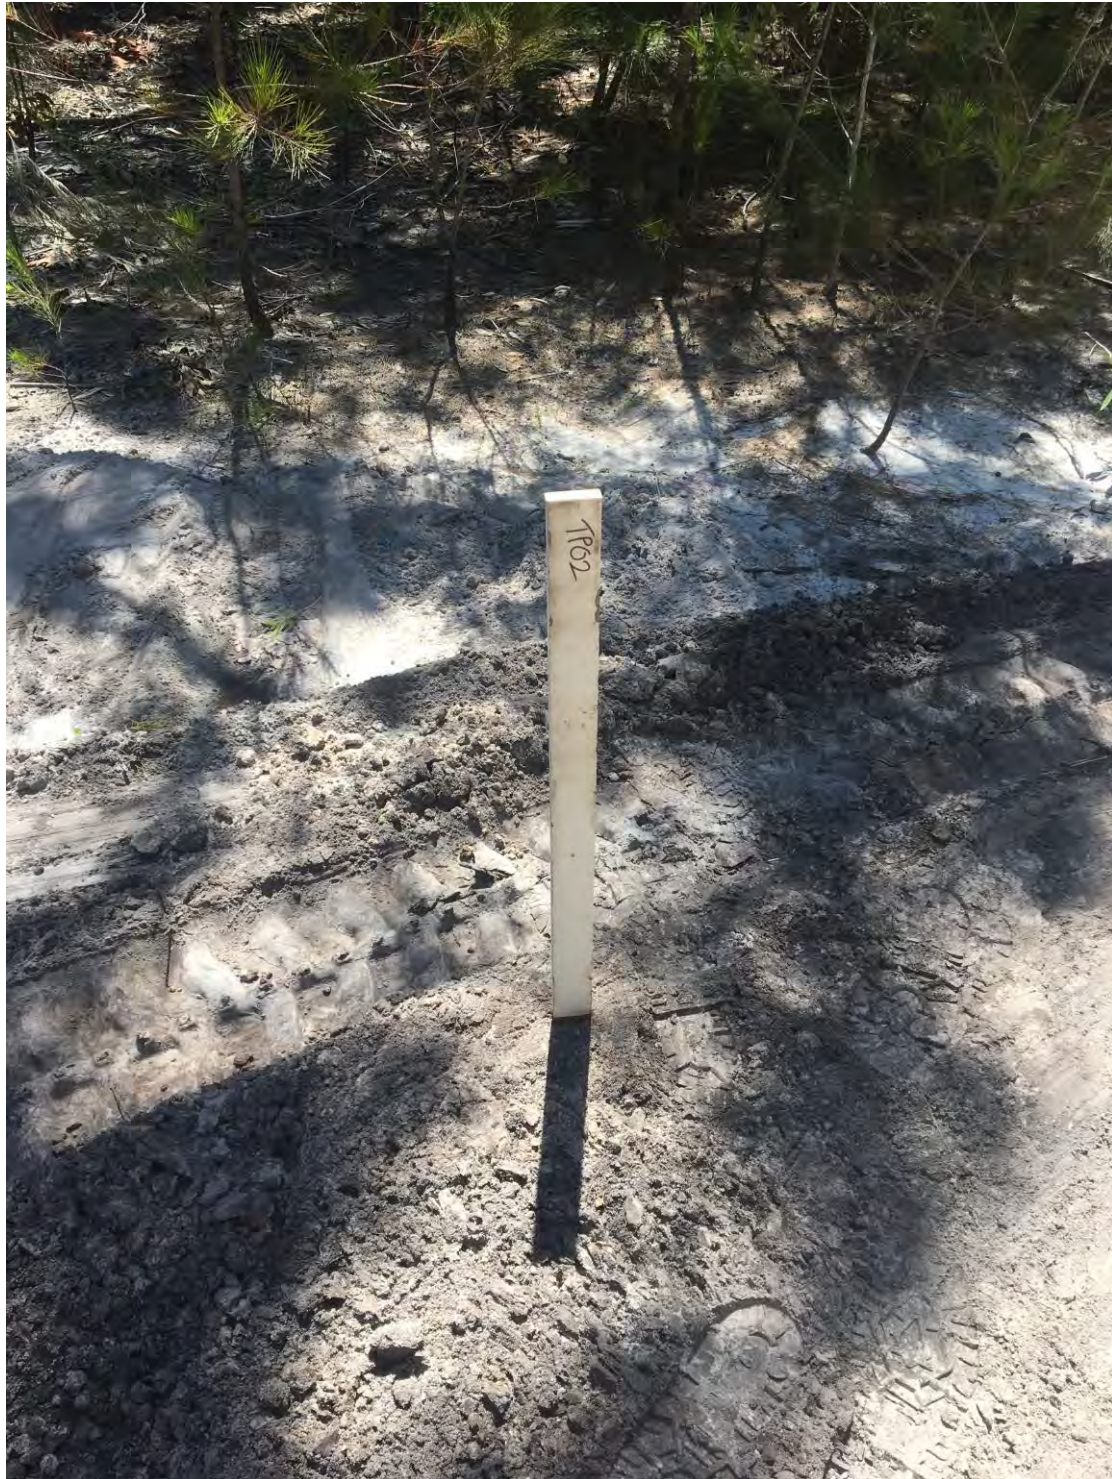
Project Name	Poona Boat Ramp		
Project No.	FG6644	Date	12/03/19
Test Pit No.	TP02	Reference No.

Photograph 1: Test pit after excavation

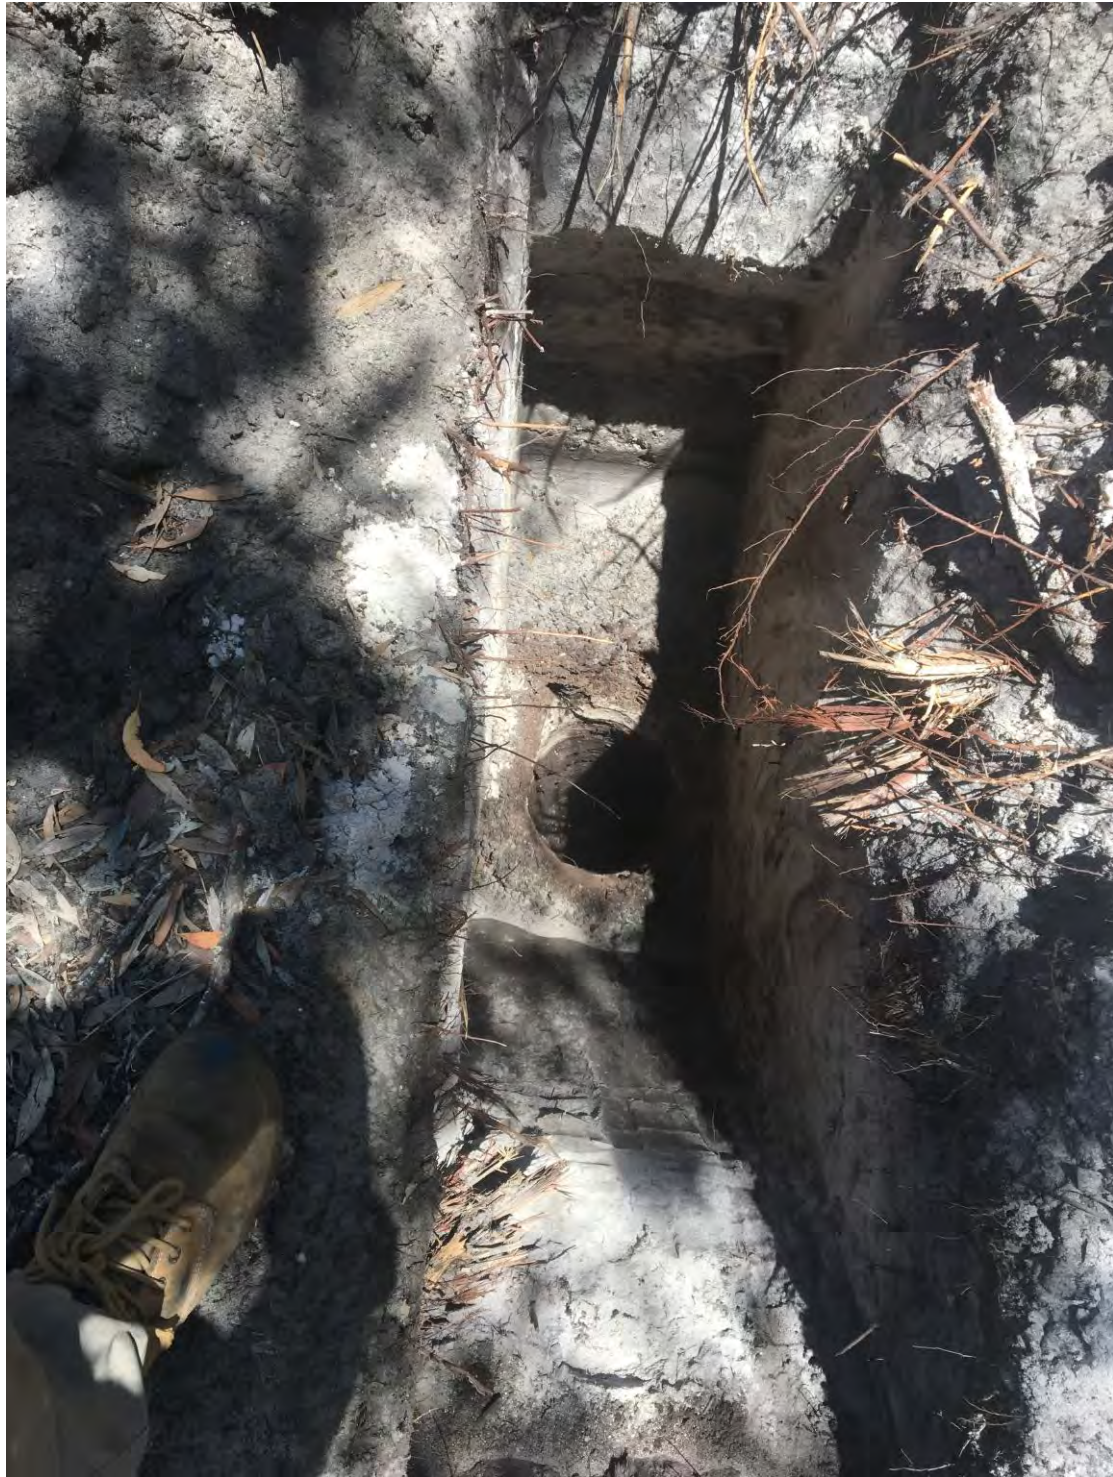
Project Name	Poona Boat Ramp		
Project No.	FG6644	Date	14/03/19
Test Pit No.	TP01	Reference No.

Photograph 1: Test pit profile

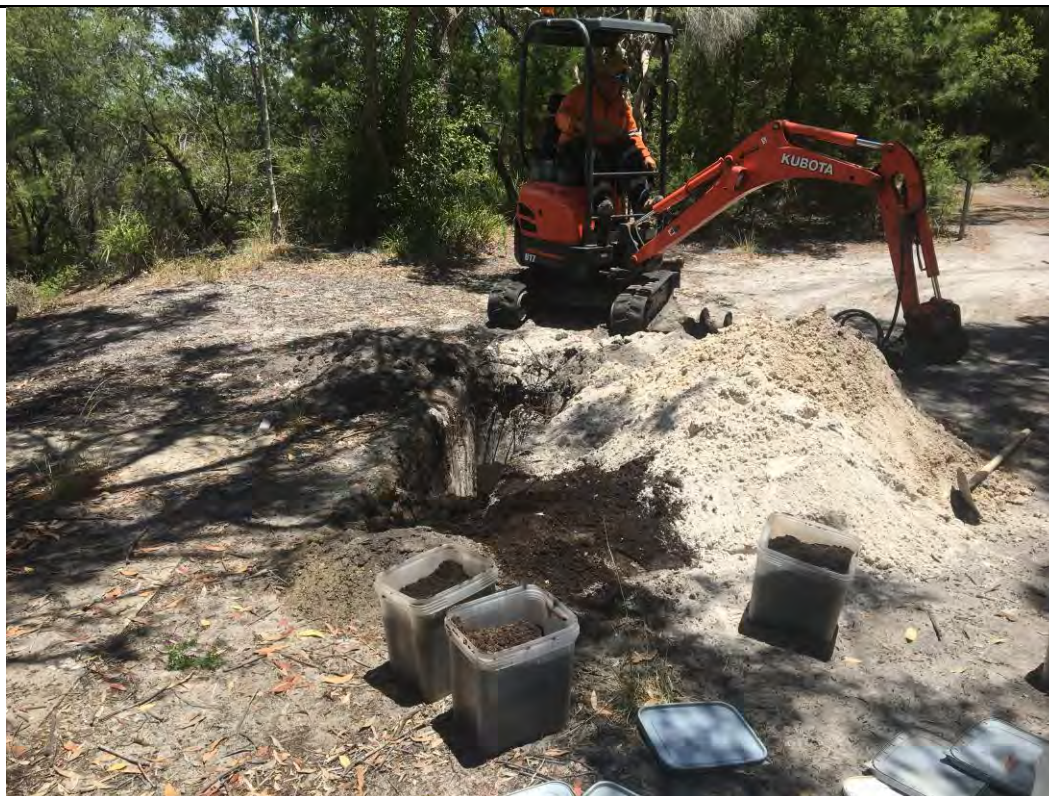
Photograph 3: Excavated materials
