# ULULAH LAGOONS WATERBODY MANAGEMENT PLAN

DesignFlow  
Prepared for Fraser Coast Regional Council  
February 2021

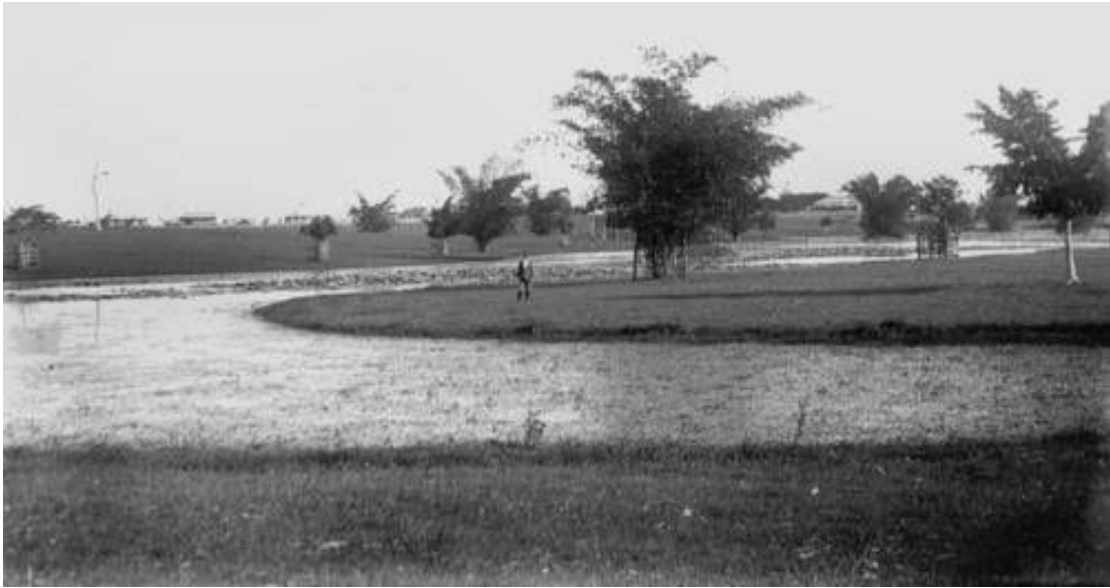
Figure 2-1 Historical photo of Ululah Lagoons in 1916 showing dense growth of water lilies (sourced from [www.pinterest.com.au](http://www.pinterest.com.au)).

Ululah Lagoons was originally a natural wetland system that was utilised by the local indigenous people. In the 19th century, European settlers to the Maryborough area constructed a large weir across the southern end of the wetland, thereby forming the large waterbody that exists today (Figure 2-1 and Figure 2-2). It is understood that the waterbody was initially used for water supply and recreational activities, however in more recent times, it has become a high profile regional waterbody, associated with passive recreation, tourism, and wetland habitat for a diverse range of native wildlife. The three smaller waterbodies upstream of the main Ululah Lagoon were not constructed until approximately 1990-1993.

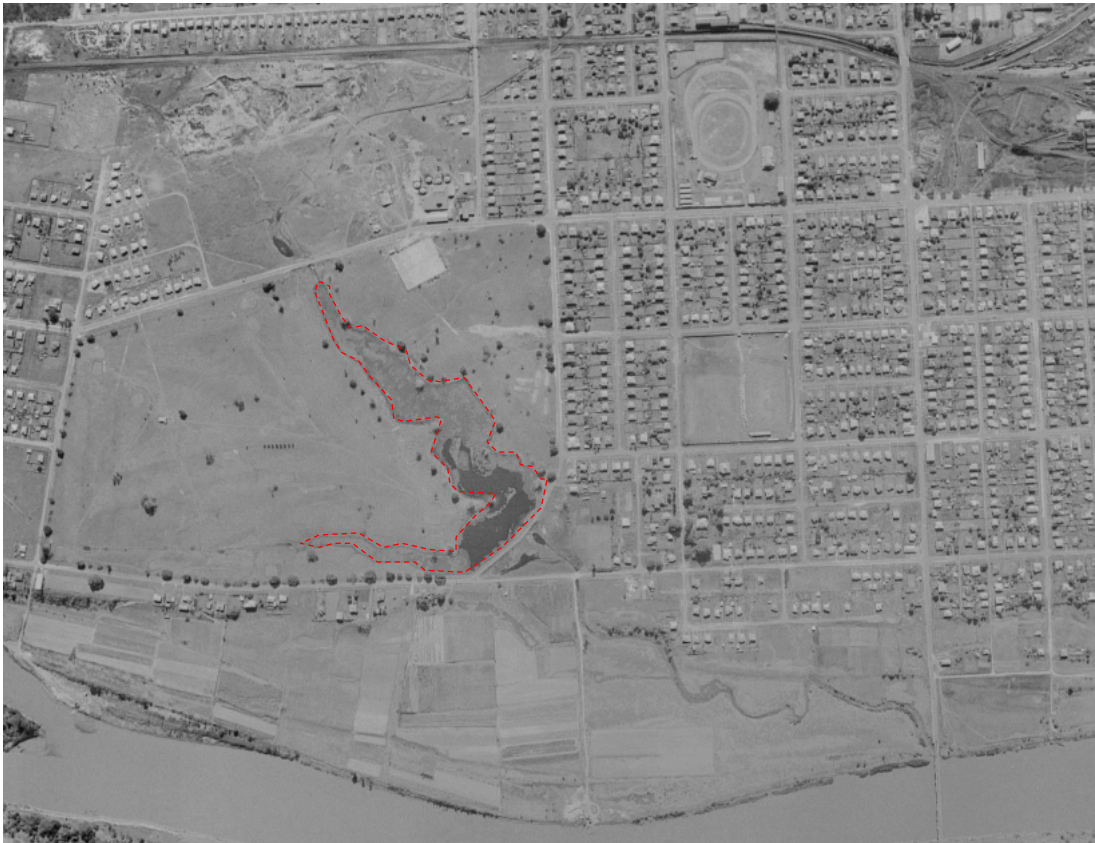
Figure 2-2. Aerial image from 1959 showing Ululah Lagoon. Waterbodies north of Alice are not yet constructed.

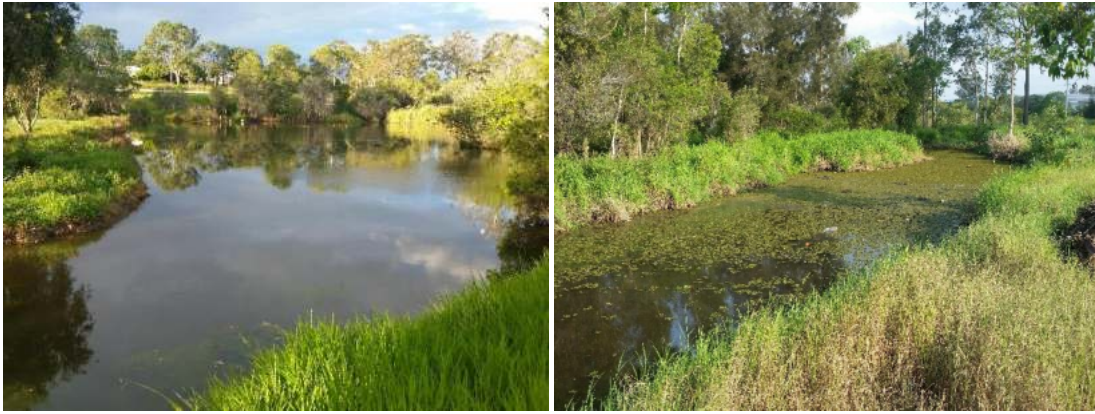
**Figure 3-1 Waterbody A – a) Main waterbody, and b) Channel connecting Waterbodies A and B.**

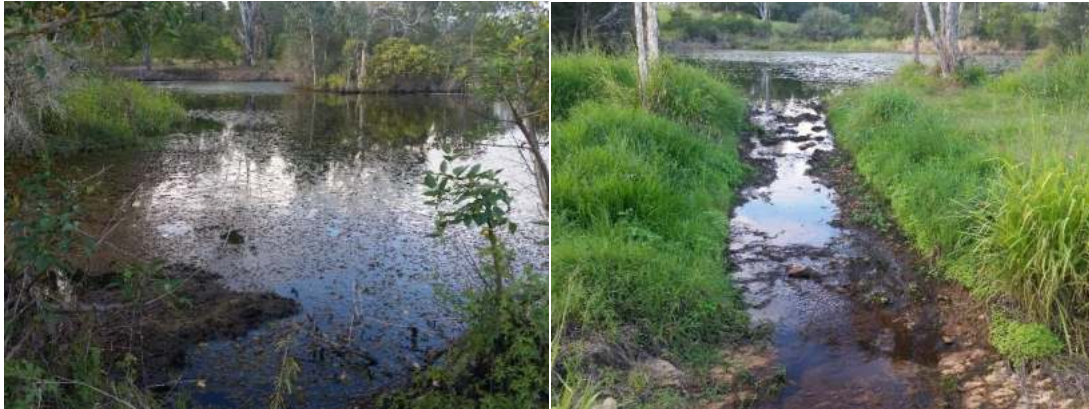
**Figure 3-2 Waterbody B – a) Main waterbody, and b) Overflow weir and outlet channel.**

- Repair leaking overflow weir to maintain permanent water level.
- Remove accumulated sediments to provide formal sediment storage volume.
- Construct formal maintenance access ramp to enable future sediment removal.
- Re-vegetate the batters with riparian groundcovers.

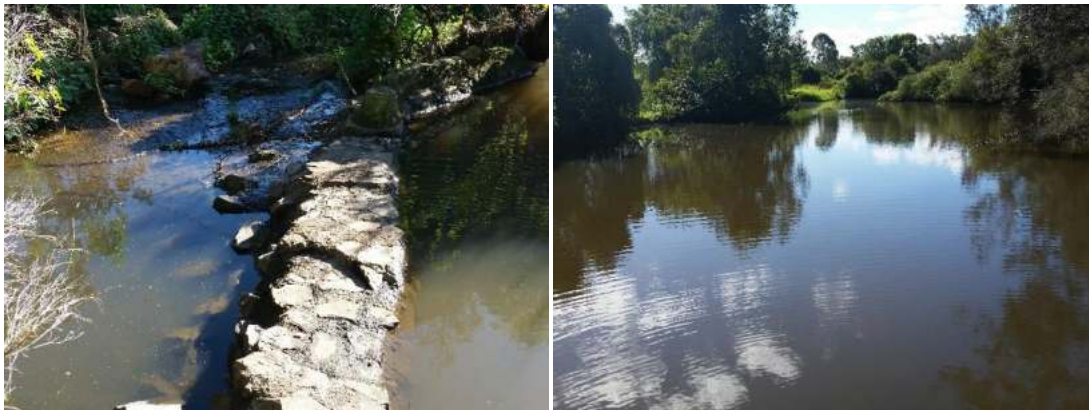
**Figure 3-3 Waterbody C – a) Overflow weir, and b) Shallow waterbody upstream from the overflow weir.**

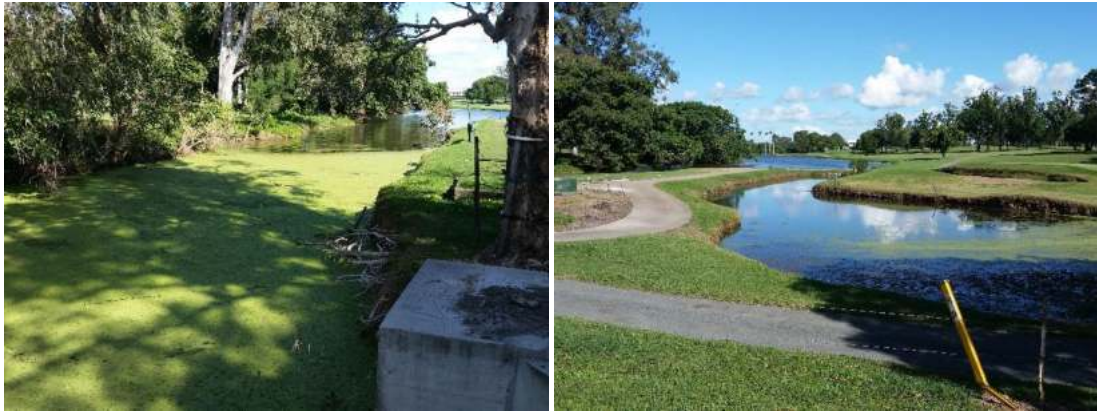
**Figure 3-4 Ululah Lagoons – a) Inlet channel below Alice St, and b) Enclosed lagoons within the golf course adjacent to waterbody inlet.**

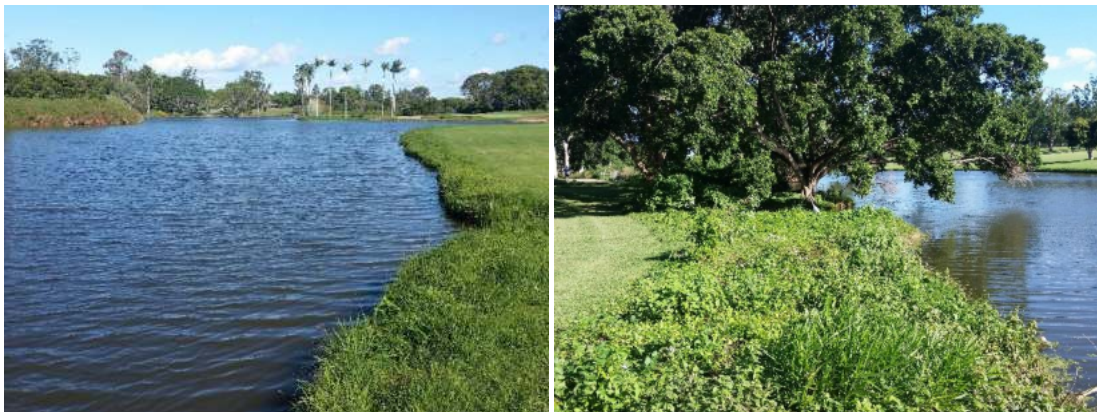
**Figure 3-5 Ululah Lagoons – a) Main waterbody, and b) Buffer zone along edge adjacent to Anzac Park.**

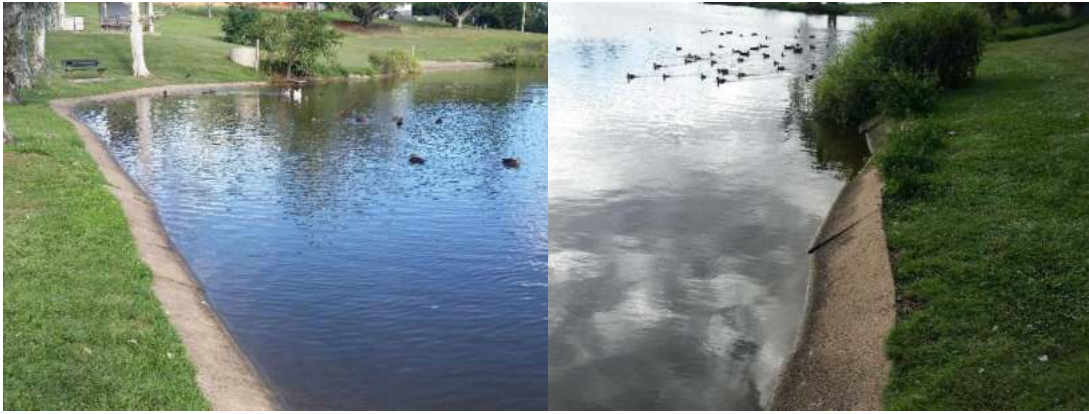
The edges in south-east corner of Ululah Lagoon comprise of concrete revetments which slope from the mown grassed edge into the water to approximately 0.4-0.5 m depth (Figure 4-1). In several locations, the concrete revetment has collapsed resulting in a steeper entry into the water (1:1-1:2 in some locations). Where this has occurred, the revetment slope and presence of deep water would make exiting the waterbody difficult.

**Figure 4-1 Concrete revetment in the SE corner of Ululah Lagoon: a) Main section, and b) Collapsed section towards the northern end.**

Undertake detailed batter safety risk assessment: A detailed batter safety risk assessment should be conducted to review safety around waterbodies to both the public and for Council workers. The field condition assessment identified some areas around Ululah Lagoons where steep batters lead directly into deep water, and where a potential drowning risk is present. A detailed audit is required to investigate all of the waterbody edges, including the Golf Club, to assess high risk locations where intervention is required to manage public safety risk and minimise the risk of persons falling into the waterbodies.

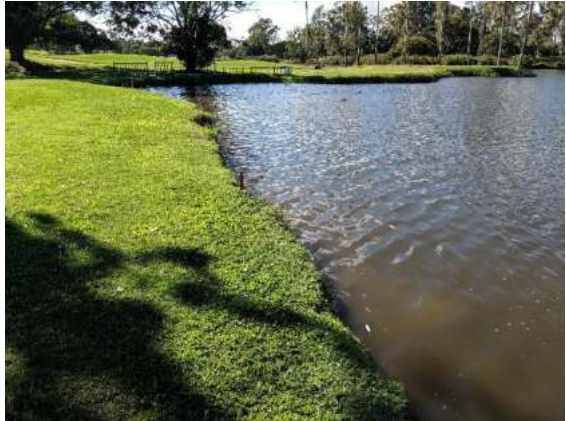
Edge Type	Comments/notes	Photo
Gentle batter +/- sharp drop off into shallow water	Generally >1:3 batter slope, mown grassed edge +/- sharp drop off into shallow (<0.3m) water. Moderate risk but shallow depth of water means exiting is fine. <u>Safe</u>

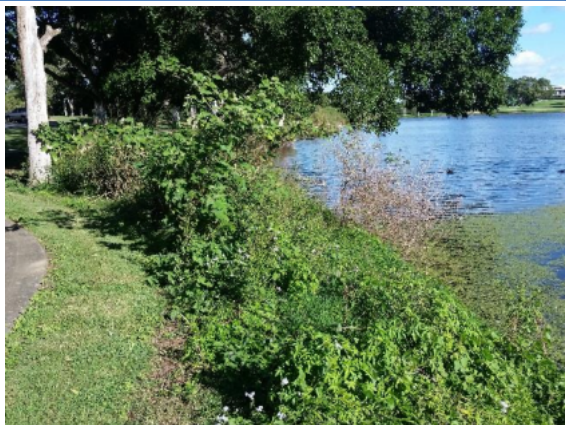
Gentle batter +/- sharp drop off into deep water	Generally >1:3 batter slope, mown grassed edge +/- sharp drop off into deep (>0.3m) water. High risk as deep depth of water means exiting may be difficult. <u>Potentially Hazardous</u>

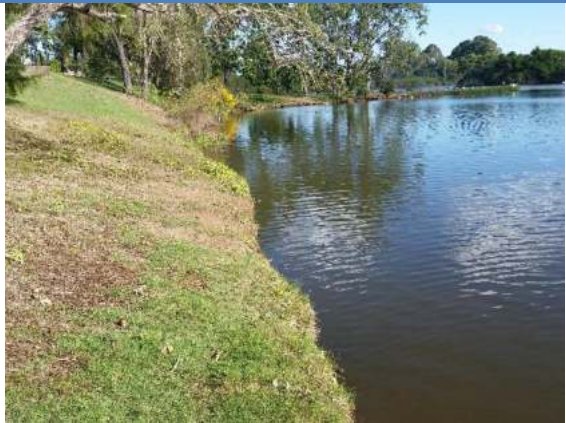
Steep batter +/- sharp drop off shallow water	Generally <1:3 batter slope, +/- sharp drop off into shallow (<0.3m) depth water. Moderate risk but steep batter slope may make it very difficult to exit the water (and easy to fall back in). High drowning risk <u>Potentially Hazardous</u>

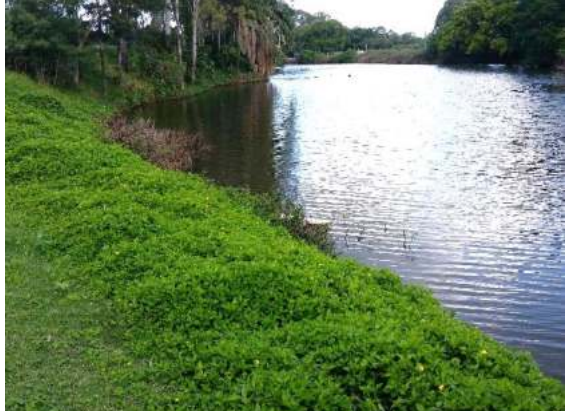
Steep batter +/- sharp drop off deep water	Generally <1:3 batter slope, +/- sharp drop off into deep (>0.3m) water. High risk as steep batter slope and deep depth of water means exiting is extremely difficult (and easy to fall back in). High drowning risk <u>Hazardous</u>

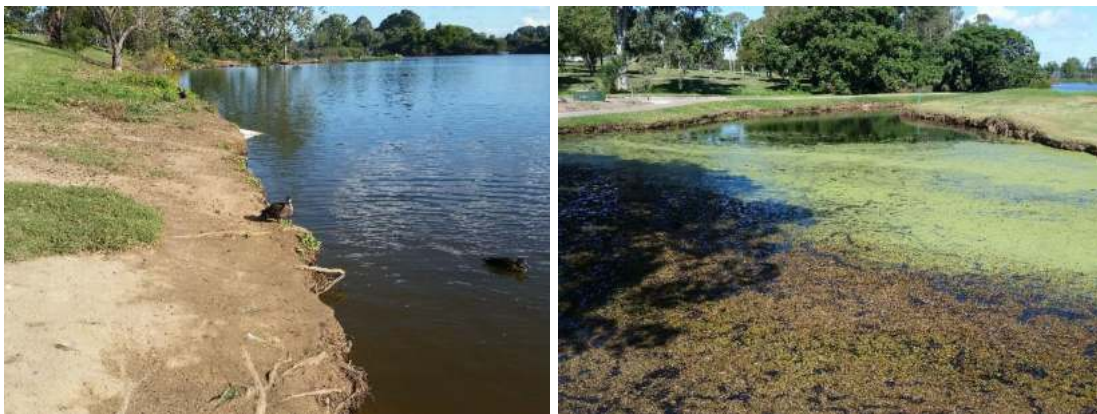
The majority of the publicly accessible edges in Ululah Lagoons (adjacent to Anzac Park), comprise of either mown grass or a vegetated buffer. In most locations, wave action or waterbird activity has resulted in minor scour and the development of shallow vertical edges (Figure 4-2). These edges are relatively stable but are susceptible to further instability due the presence of the bare soils along the exposed edges.

Figure 4-2 Minor scour present below grassed edges creating shallow vertical edge.

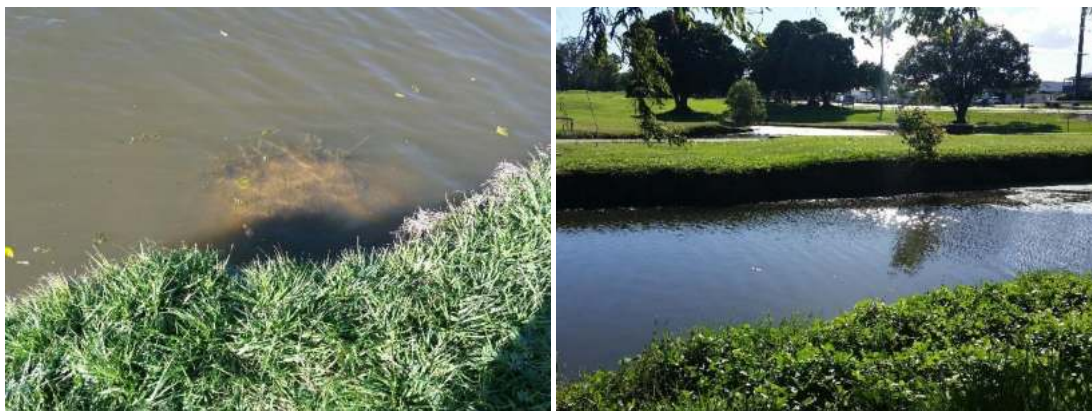
The waterbody edges adjacent to the golf course are grassed and vary in slope from a gentle batter slope to the water's edge to steep vertical drop-offs. The presence of rock protection below the water surface in most cases renders the edges reasonably safe. There are several sections where localised erosion of the waterbody edge has occurred resulting in slumping and the creation of vertical edges (Figure 4-3).

Figure 4-3 Localised edge erosion occurring adjacent to the golf course near the inlet to Ululah Lagoon.

- Re-profile bank edges and revegetate with native submerged and emergent water plants
  - Stabilise eroded areas (rock or other)
  - Modify unsafe steep edges to make them safer (fencing or landscaping).

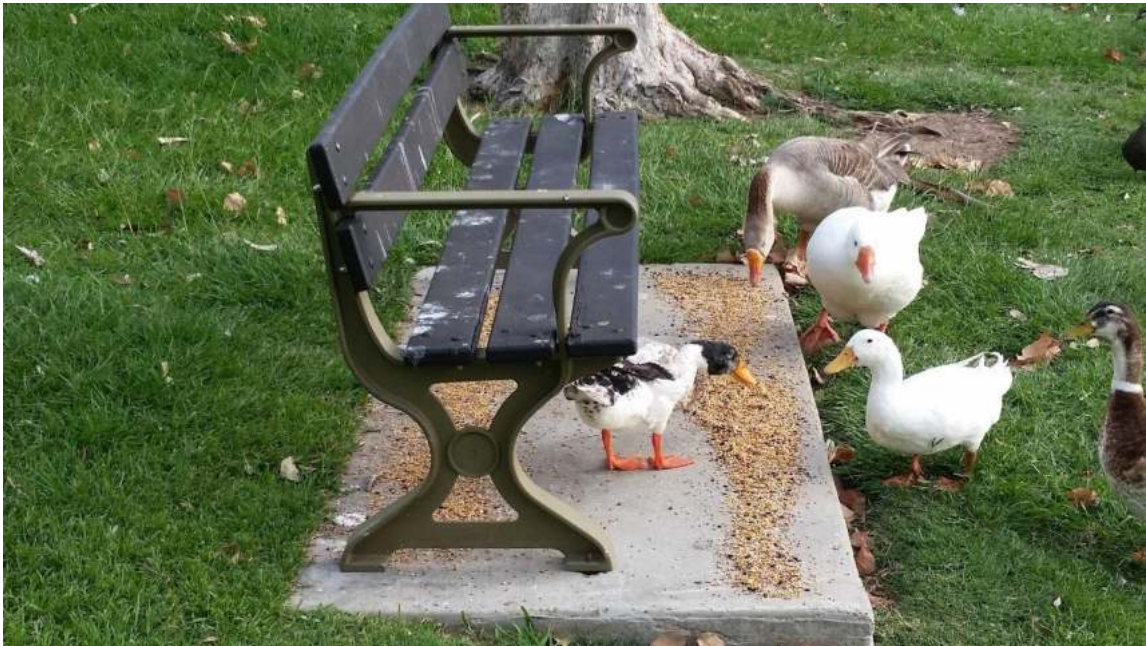
- **Water quality** – Bird faeces entering the waterbody is likely to contribute a significant nutrient load and promote the growth of algae and floating water plants.
- **Public safety** – The large volume of bird faeces present represents a potential public health risk from direct exposure to excreta or indirect exposure to waters contaminated by faeces or associated algal blooms.
- **Public amenity** – Many of the grassed areas around the waterbodies are used by the birds for loafing and are generally covered by excreta resulting in smell and reduced amenity.

Figure 4-5 Bird feeding within Anzac Park, particularly around public seating areas, represent a potential public health risk.

- Remove or modify the signage present on Alice St which promotes waterbird feeding areas within Anzac Park.
- Install signage in the primary bird feeding areas to discourage feeding. An example of signage that could be erected in these areas is illustrated in Figure 5-1.
- Implementing phased removal of Broad-leaved Pepper trees from the margins of the Ululah Lagoons system (and island) will effectively reduce waterbird nesting habitat. Where practical, Broad-leaved Pepper trees should be replaced with native tree species with low nesting habitat potential such as Melaleucas and Eucalypts.

- Establish vegetated barriers to prevent the waterbirds from accessing the main feeding areas within Anzac Park and to limit roosting and loafing areas within Anzac Park.
- Creating a diversity of habitat within and around Ululah Lagoons to promote waterbird diversity (rather than large numbers of a limited number of species). This could be achieved by:
  - Lowering the permanent water level to create shallow areas for foraging.
  - Establishing native waterplants and riparian species along the edges of the waterbody.
  - Installing permanent habitat structures such as large dead trees in selected areas of the waterbody.
  - Installing nesting boxes/platforms.

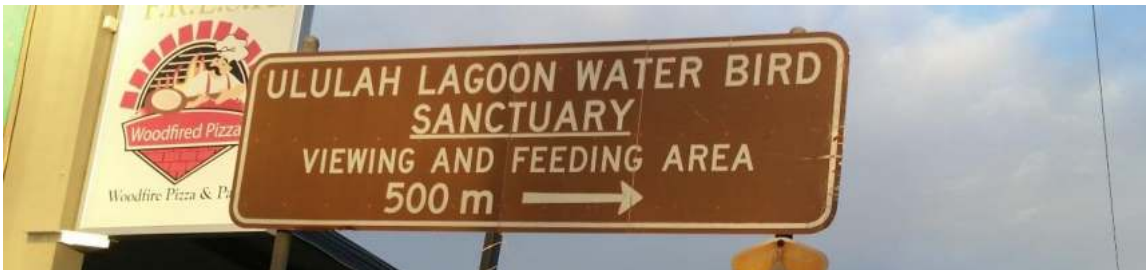
Figure 4-6 Information sign on Alice St promoting the feeding of waterbirds within Anzac Park.

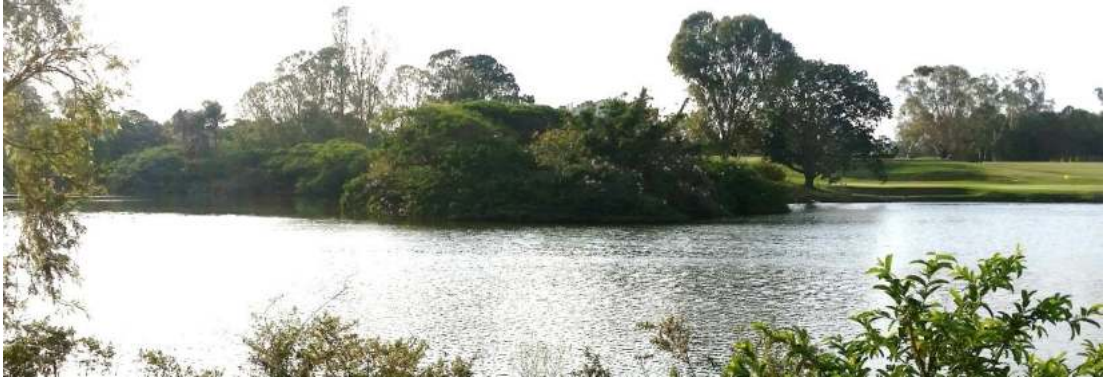
**Figure 4-7 Ibis rookery present on the island adjacent to the Golf Clubhouse.**

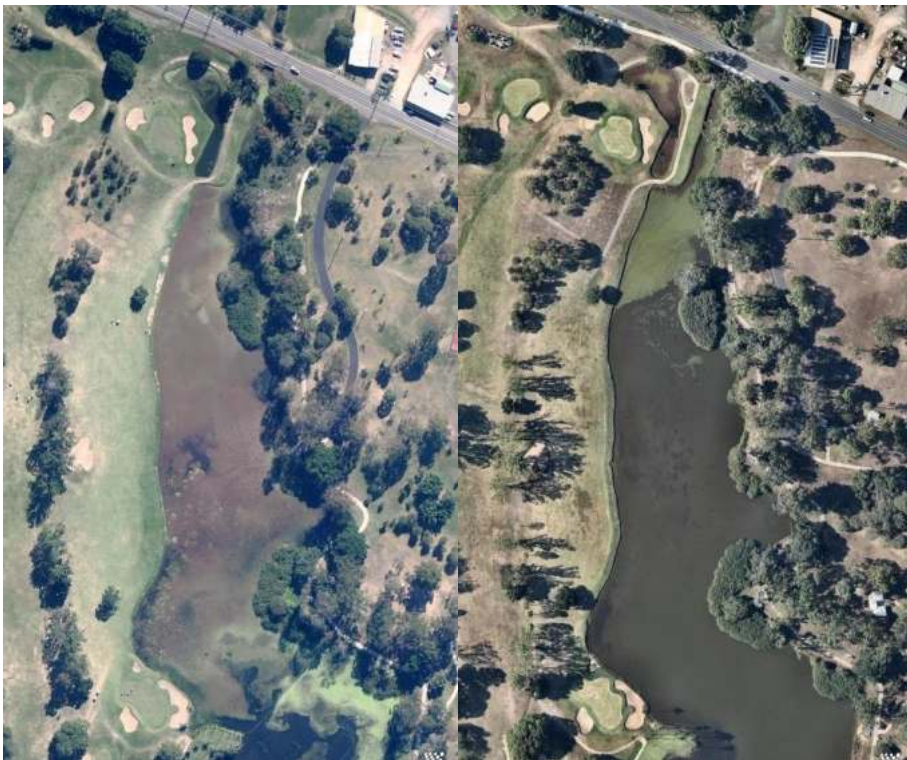
**Declared weeds** - A number of declared aquatic weeds were observed during the waterbody condition audit including: *Salvinia molesta*, *Cabomba caroliniana* and *Hygrophila costata*. A declared terrestrial species, Broad-leaved Pepper tree, was also observed growing throughout the Ululah Lagoons system. Discussion with Council staff and a review of historical aerial imagery indicates that growth of *Salvinia* regularly occurs within all of the waterbodies, and is an ongoing management issue (Figure 4-8).

**Figure 4-8 Historical aerial imagery indicating *Salvinia* blooms present within Ululah Lagoons in: a) 2010, and b) 2019.**

*Salvinia* is mechanically removed from Waterbody A using Council's aquatic weed harvester, however *Salvinia* growth in Waterbodies B and C is sprayed with herbicide due to the shallow water depths present. *Salvinia* is also sprayed in Ululah Lagoons due to issues operating the Council harvester in shallow depths near the waterbody inlet. A floating boom is also placed across the centre of Ululah Lagoons to isolate the floating plants to one end of the waterbody.

The growth of *Salvinia* represents a management issue that requires ongoing Council funding and resources. It is recommended that a long term strategy is developed to control *Salvinia* growth within the Ululah Lagoons system. The strategy should adopt a multi-faceted approach to controlling *Salvinia* growth including:

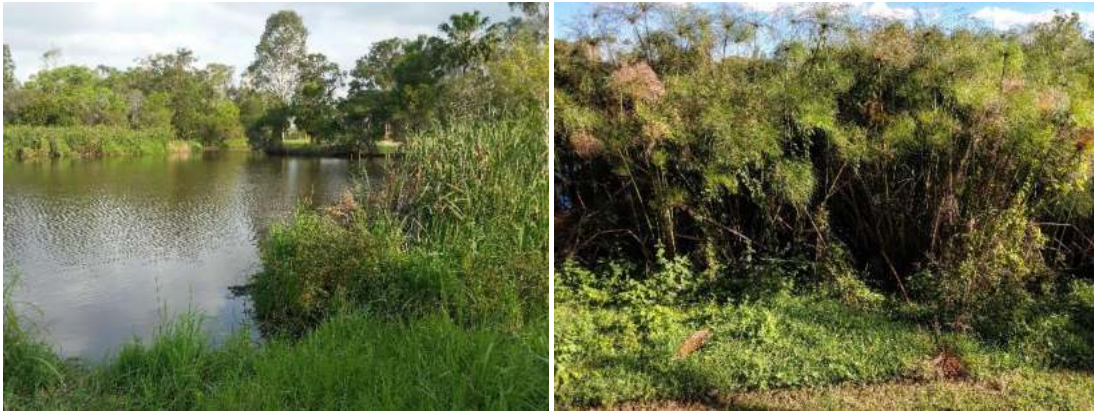
The distribution of emergent waterplants throughout the Ululah Lagoons system is extremely patchy. The reasons for sparse emergent waterplant cover are not clear but may be due to:

- waterbird grazing
- active erosion
- root disturbance by fish
- lack of waterplant recruitment
- steep to vertical batters
- deep water at the waterbody edges
- herbicide overspray (when treating *Salvinia* outbreaks)

**Figure 4-9 Examples of emergent waterplants growing on the edges of Ululah Lagoons system: a) *Typha* sp. (foreground) *Phragmites australis* (background), and b) *Cyperus papyrus*.**

It is recommended that emergent and submerged waterplants are re-established throughout the Ululah Lagoons system to manage nutrient concentrations and turbidity. This will be achieved by:

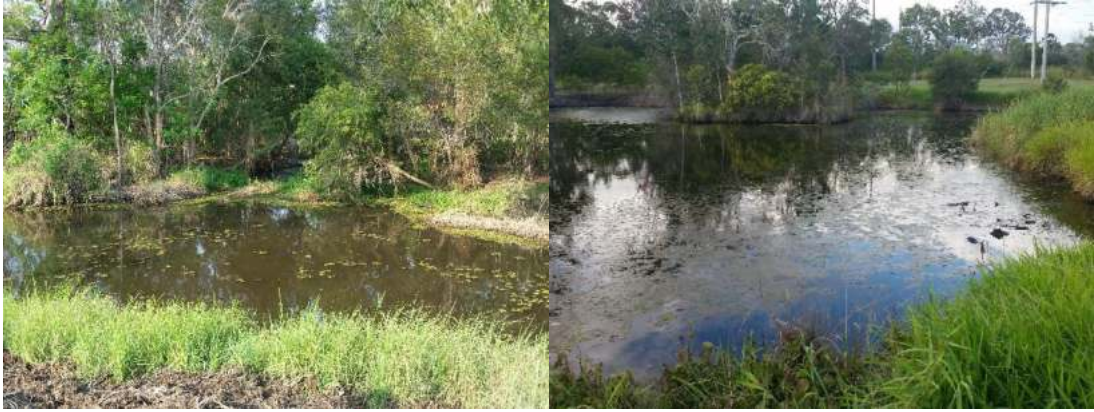
Backwater areas within the waterbodies often have longer residence times as they are poorly flushed. Backwater areas often appear stagnant and are associated with the accumulation and decomposition of organic material. Poorly flushed areas combined with nutrient release from the sediments often results in ideal conditions for incubating algae and floating water weeds. This clearly occurs within the Ululah Lagoons system, particularly in Waterbodies A and B, where stagnant backwater areas provide ideal conditions for *Salvinia* incubation and growth. Several backwater areas are also present in Ululah Lagoons where *Salvinia* growth can occur. This includes the enclosed lagoons within the golf course adjacent to the waterbody inlet, inlet channel areas upstream and downstream of Alice St, and areas associated with the large stands of *Papyrus* within Ululah Lagoons (Figure 4-11).

**Figure 4-10 Backwater areas present within: a) Waterbody A, and b) Waterbody B**

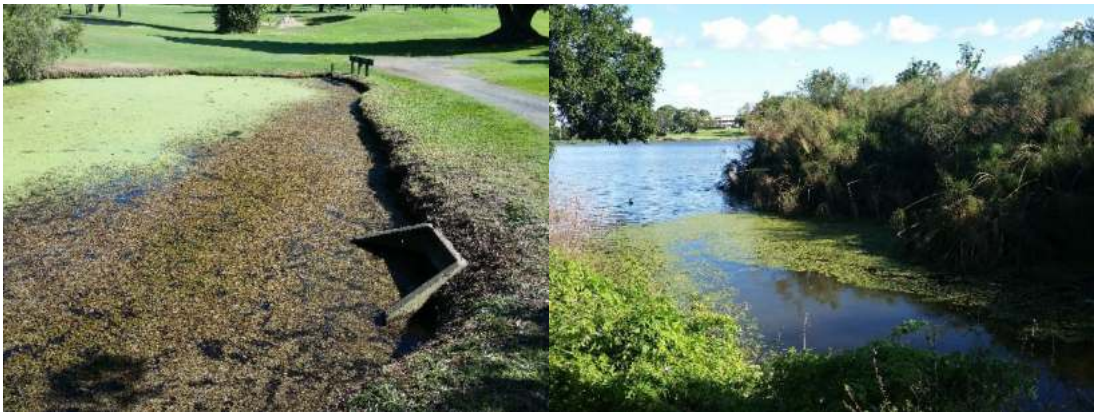
**Figure 4-11 Backwater areas present within Ululah Lagoon: a) Enclosed lagoons within the golf course, and b) Areas within and adjacent to the Papyrus stands (act as incubators for algae and floating waterplants).**

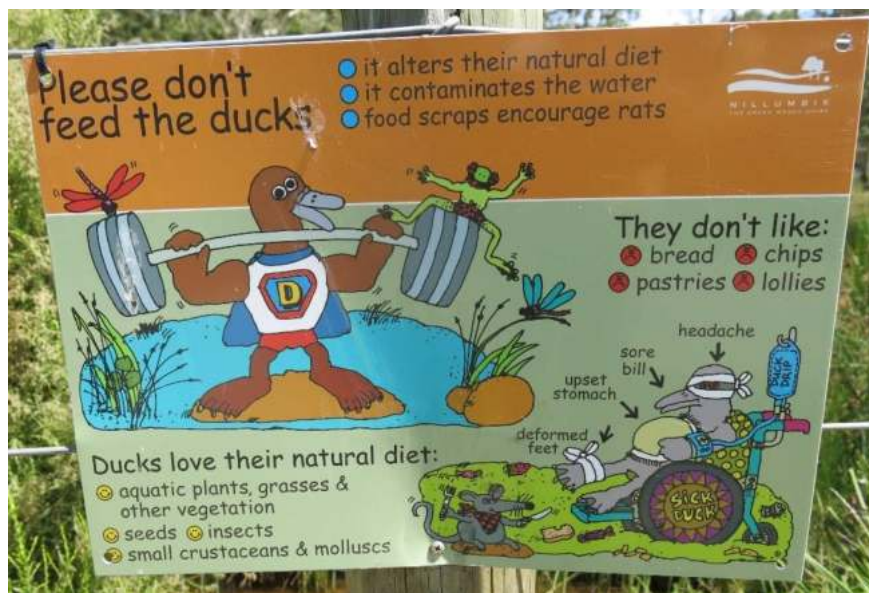
Figure 5-1 Example of direct-education message approach.
