LOWLANDS LAGOONS (ANEMBO LAKES) WATERBODY MANAGEMENT PLAN

VERSION 4

DesignFlow
Prepared for Fraser Coast Regional Council
November 2019

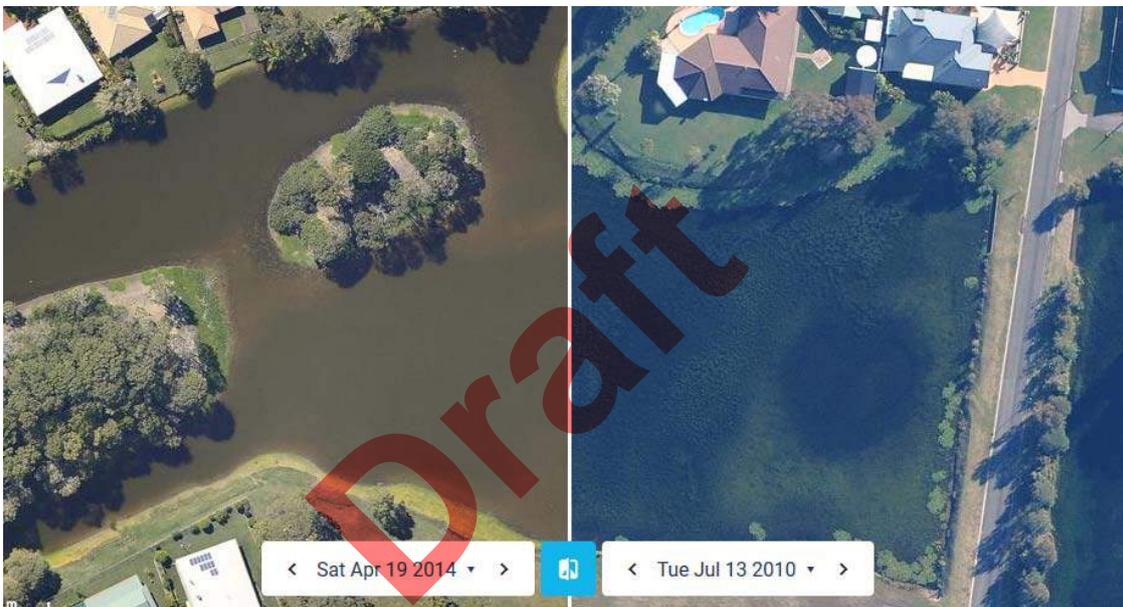
Figure 4-8 Waterbody D – comparison of submerged waterplant cover between 2010 and 2014.

A review of historical aerial images indicates that the bed of Waterbody D was dominated by submerged waterplants in 2010. However by 2014, following multiple *Salvinia* blooms, the waterbody had transitioned to a turbid, floating waterplant/algal dominated system, and it appears that submerged waterplants have been permanently lost from the waterbody (Figure 4-8). A similar loss of submerged waterplants also occurred in both Waterbodies A and E during the same period.

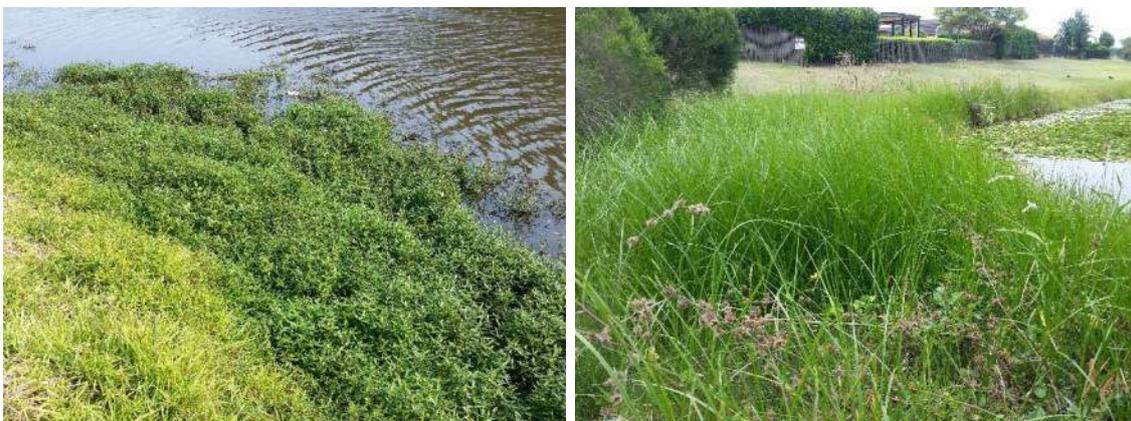
Figure 4-9 Examples of emergent waterplants: a) *Alternanthera denticulata*, and b) *Bolboschoenus caldwellii*.

The distribution of emergent waterplants throughout the waterbodies is extremely patchy. The reasons for limited emergent waterplant cover are not clear but may be due to:

- waterbird grazing
- active erosion
- root disturbance by fish
- lack of waterplant recruitment
- steep to vertical batters
- deep water at the waterbody edges
- excessive mowing/slashing to the waterbody edge
- deliberate removal of the emergent waterplants by residents
