FRASER COAST WATERBODY MANAGEMENT STRATEGY

WATERBODY MANAGEMENT FRAMEWORK TECHNICAL REPORT

Prepared for Fraser Coast Regional Council

November 2019

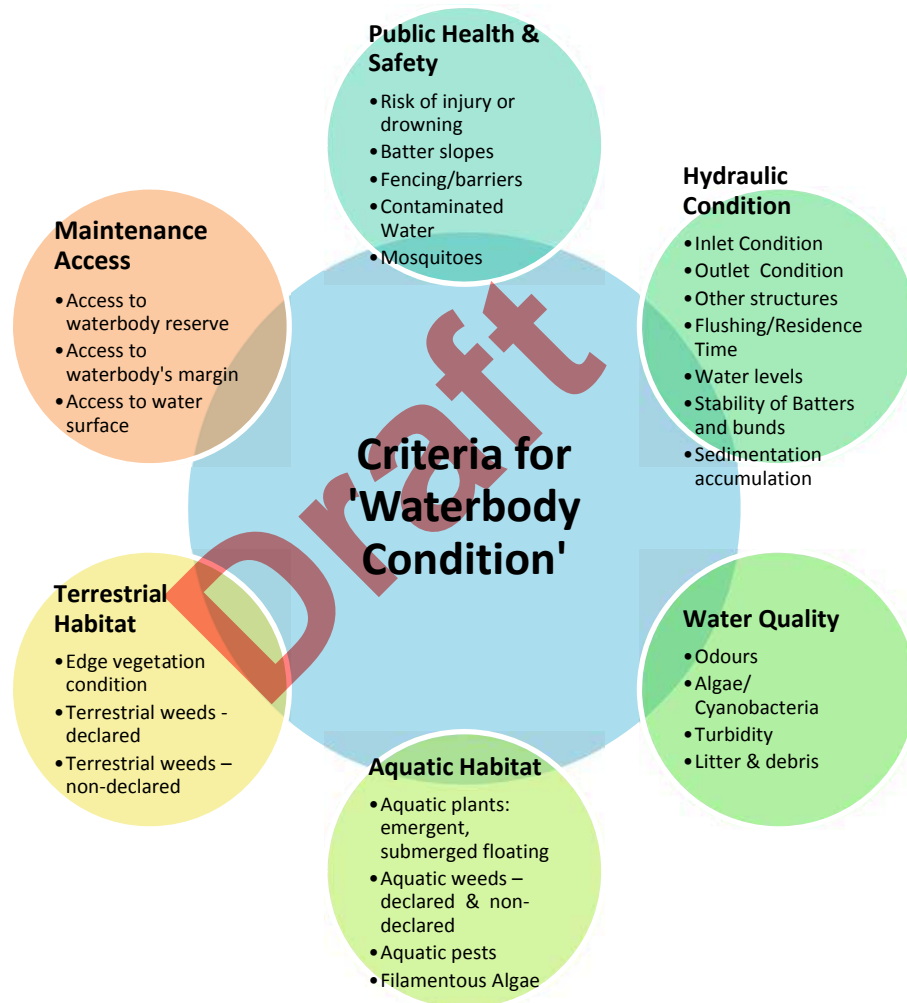
Figure 2 Condition assessment categories used to prioritise waterbodies.

Figure 2 presents an overview of the specific condition assessment criteria that were established based on the range of waterbody management issues and values associated with Council's waterbodies. For each of these criteria a 'performance standard' was defined to enable the waterbodies' condition to be assessed and scored based on the scoring system presented in Table 6. Full descriptions of each condition assessment criteria and associated scoring definitions are presented in the following sections.

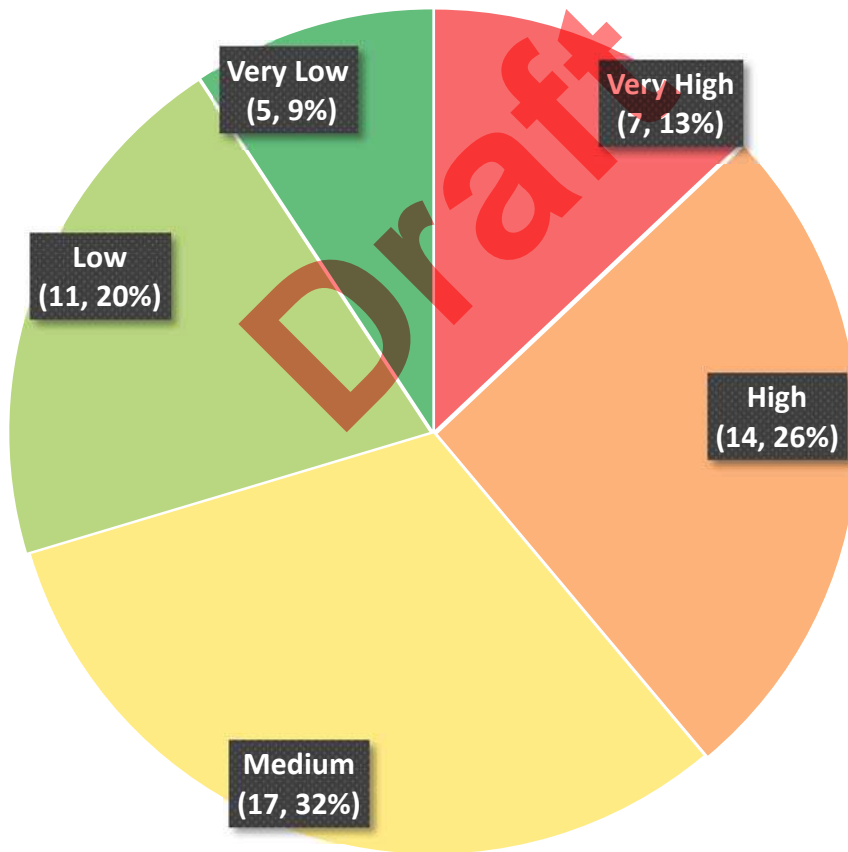
Figure 3. Chart of waterbody management priorities.

A summary of the number of waterbodies in each management priority are provided in Table 17 and shown graphical in the Figure 3.

Management Priority Categories	Number of waterbodies within each Management Rating category (%)
Very High	7 (13%)
High	14 (26%)
Medium	17 (31%)
Low	11 (20%)
Very Low	5 (9%)

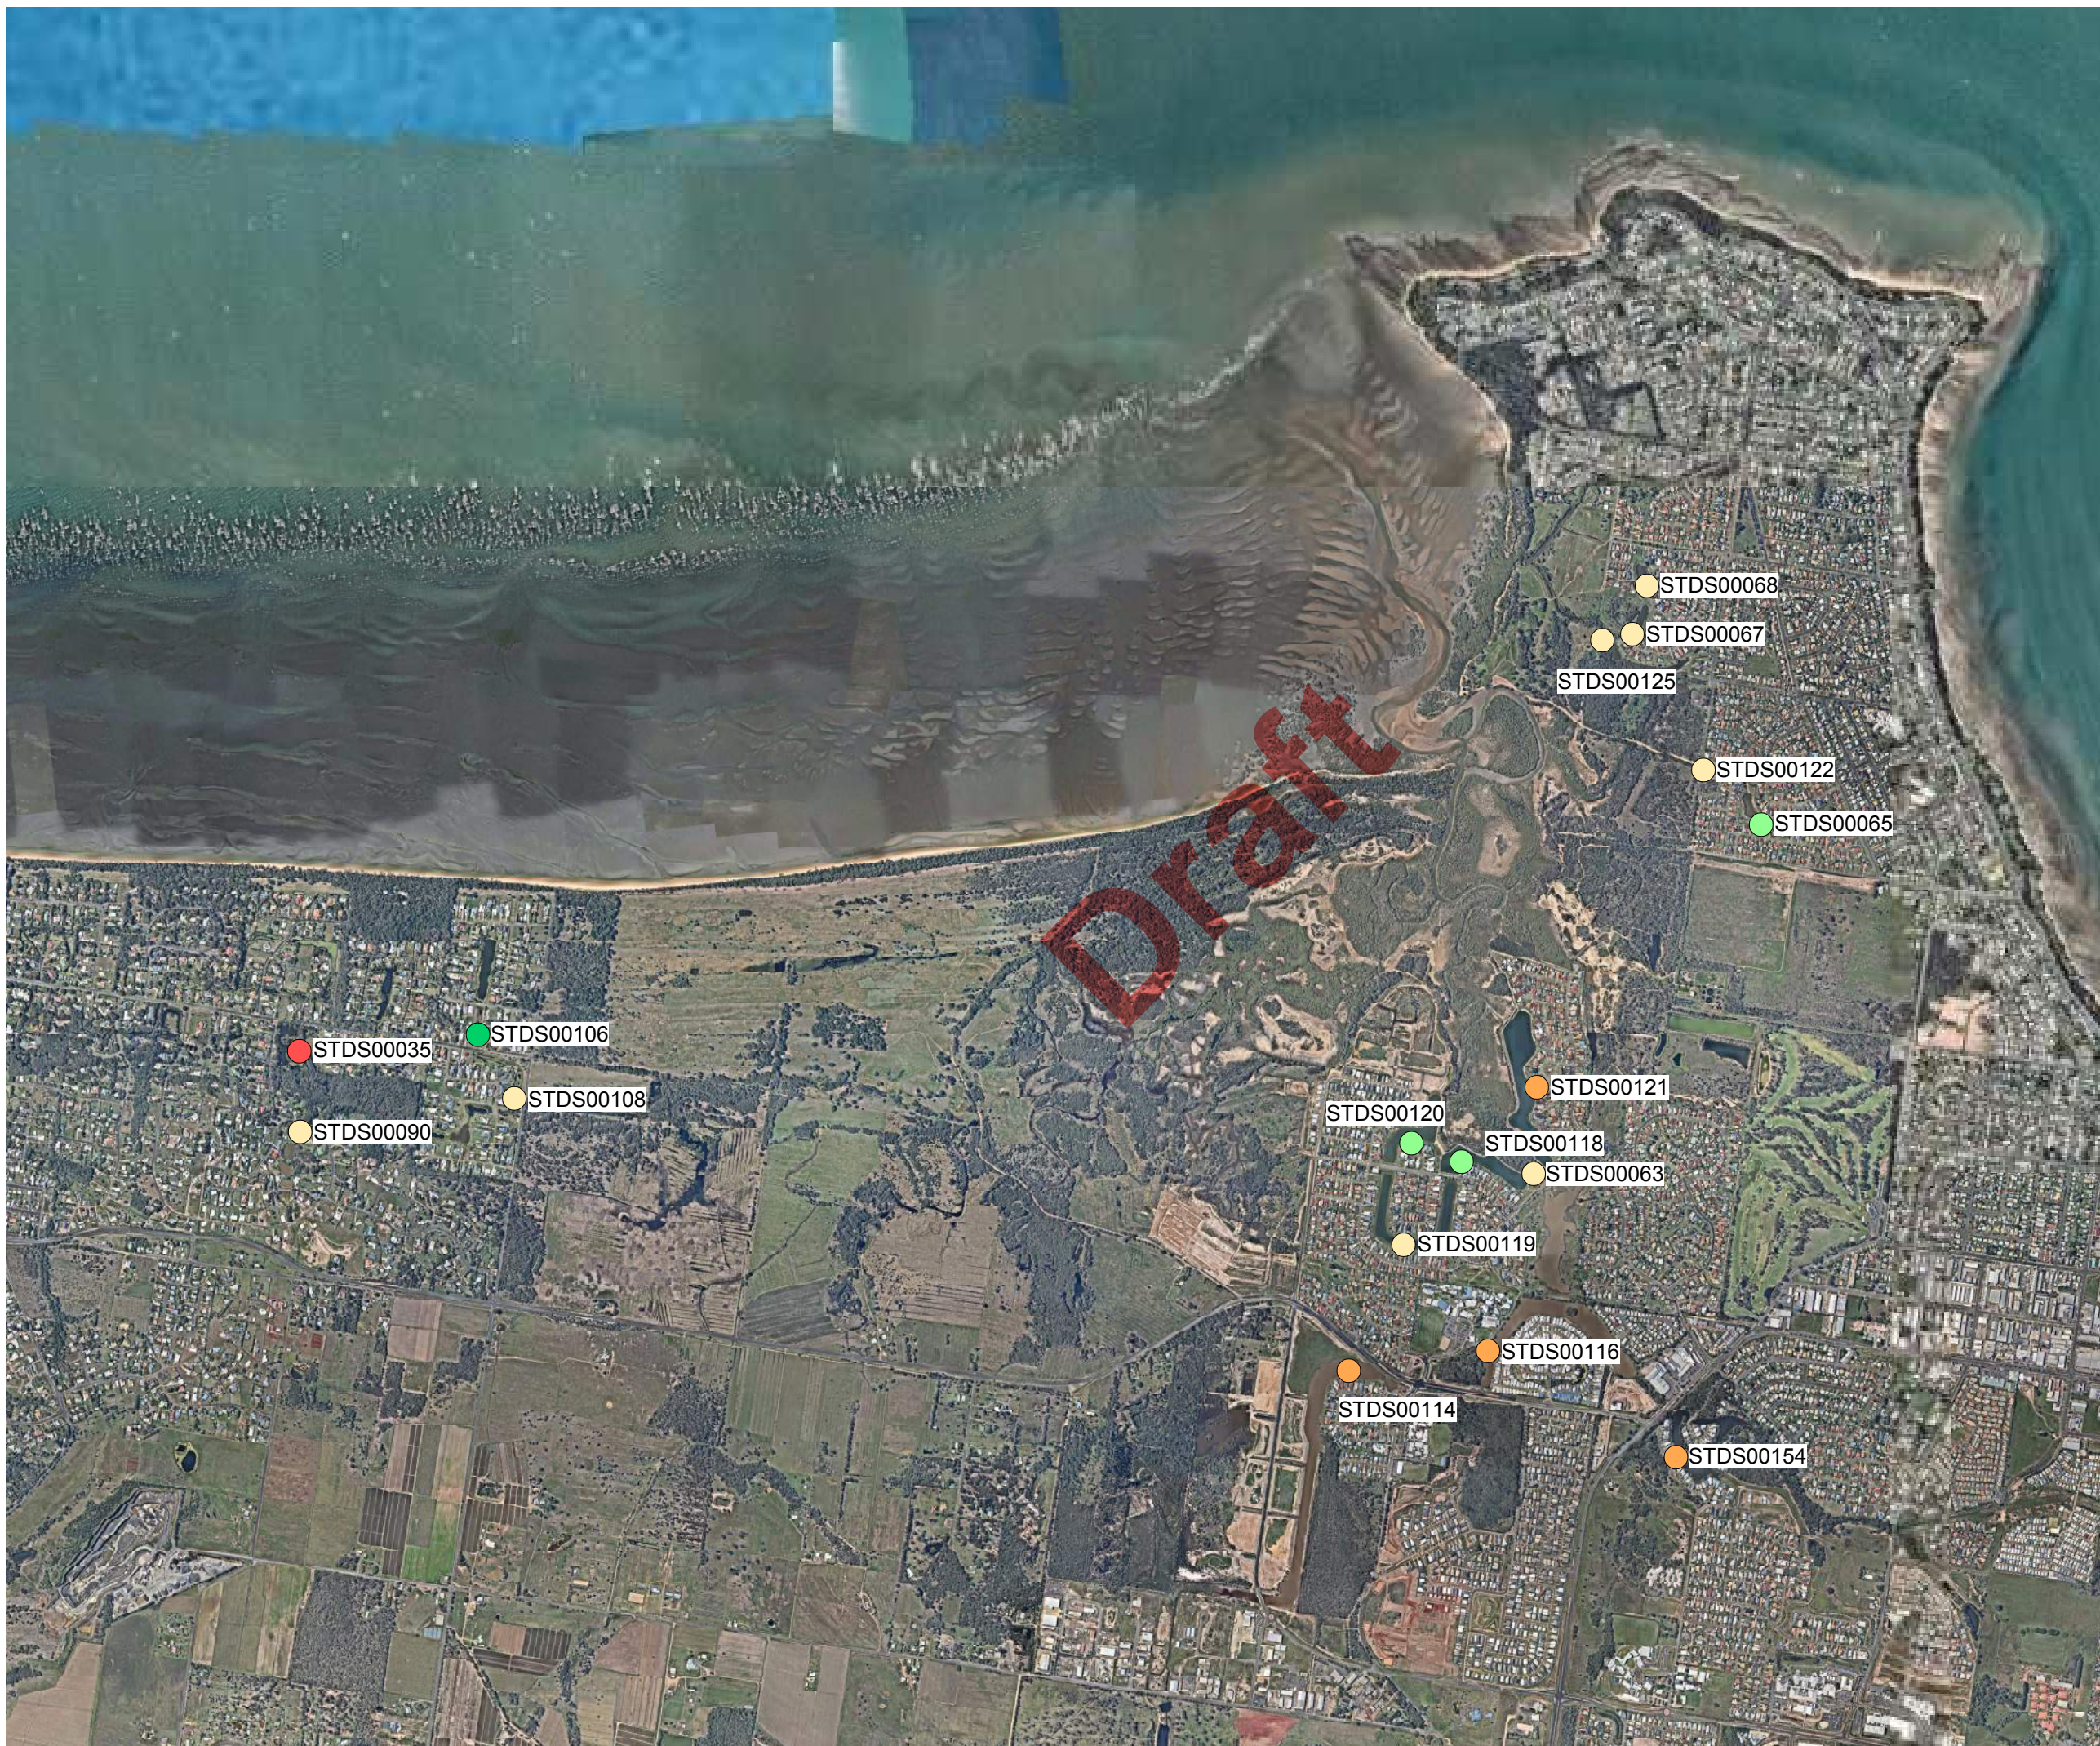
Figure 6. Waterbody Priority Rating Dundowran area)

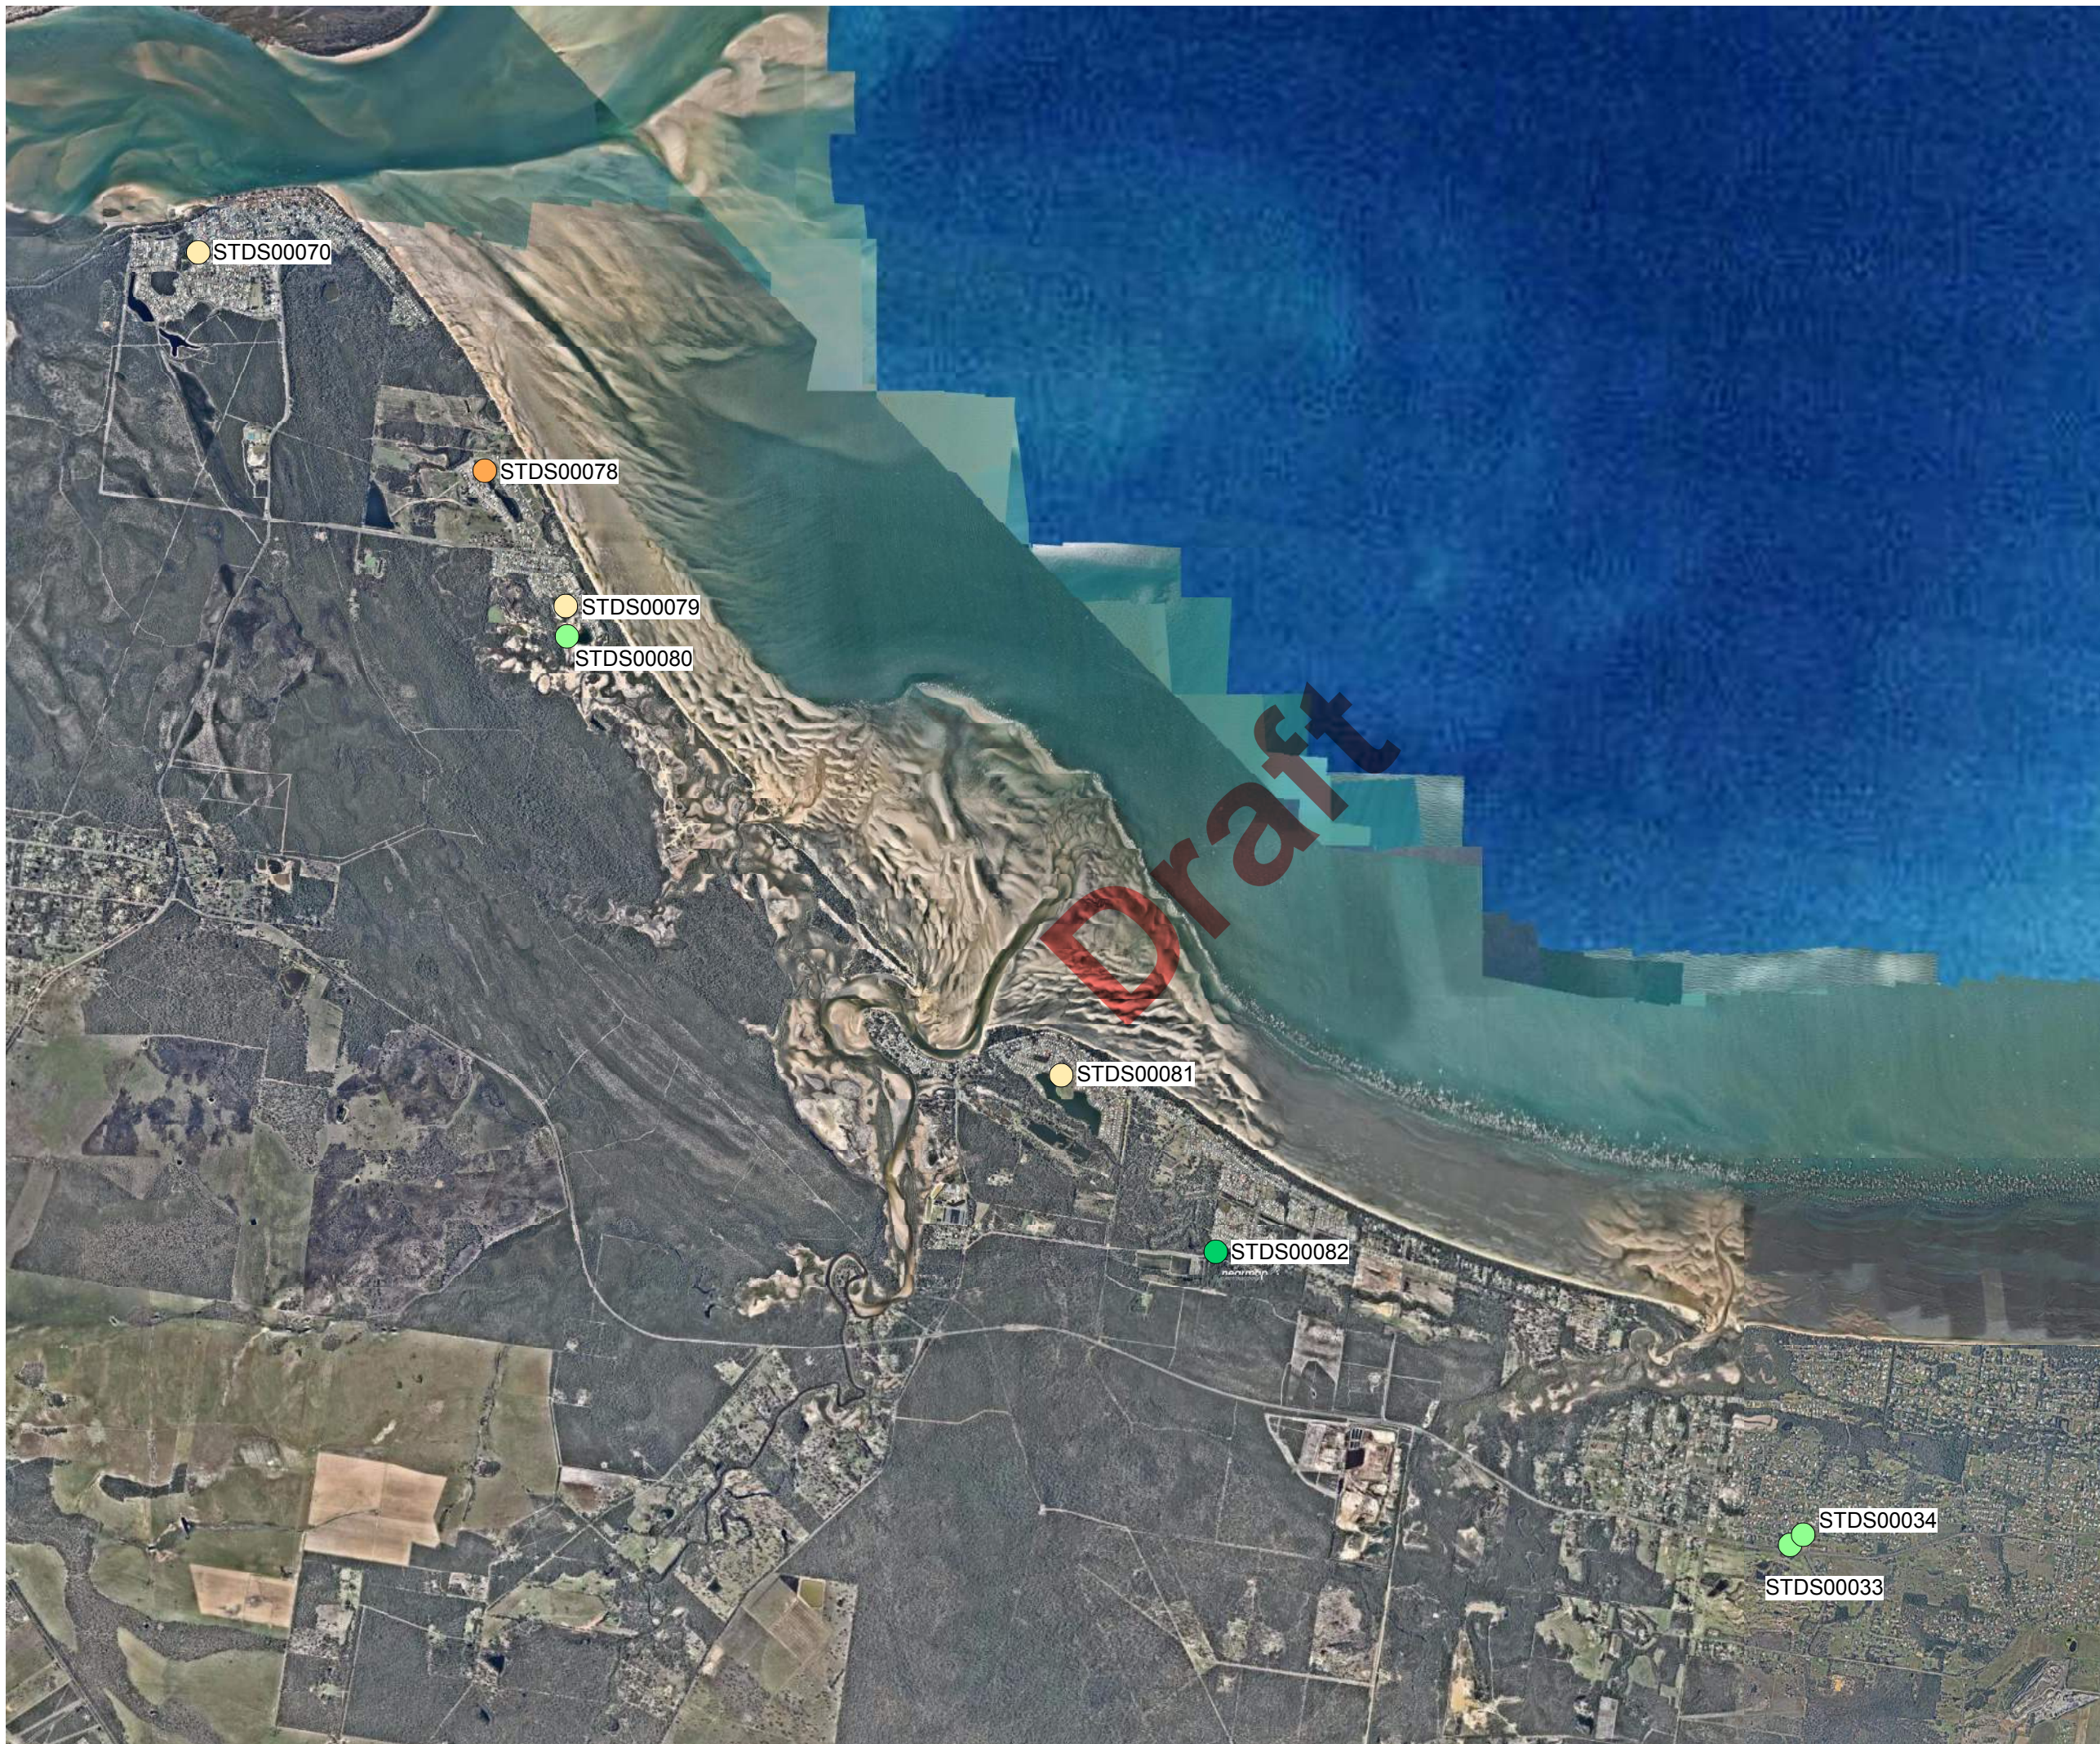
Figure 7. Waterbody Priority Rating (Burrum Heads area)
